Additional Funding Request **Invoice**

WORK INVOICE

CSS #: **23919**

Work Order #: **11785**

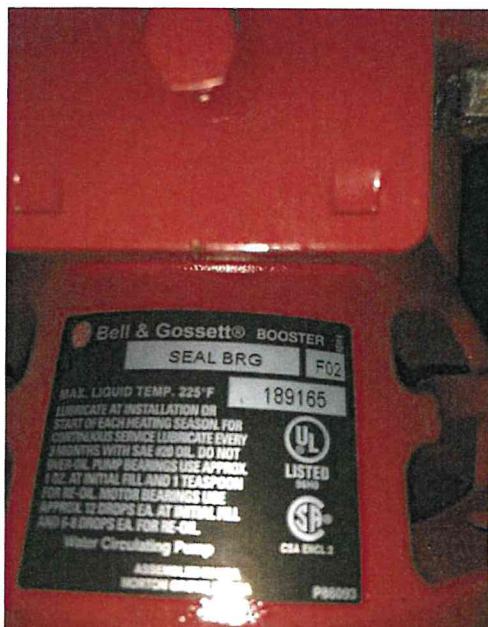
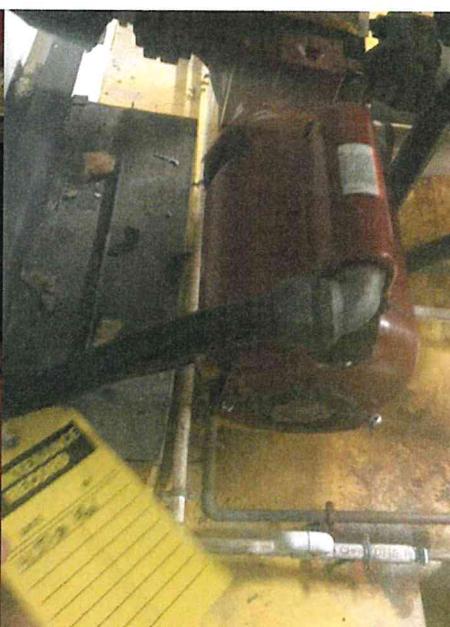
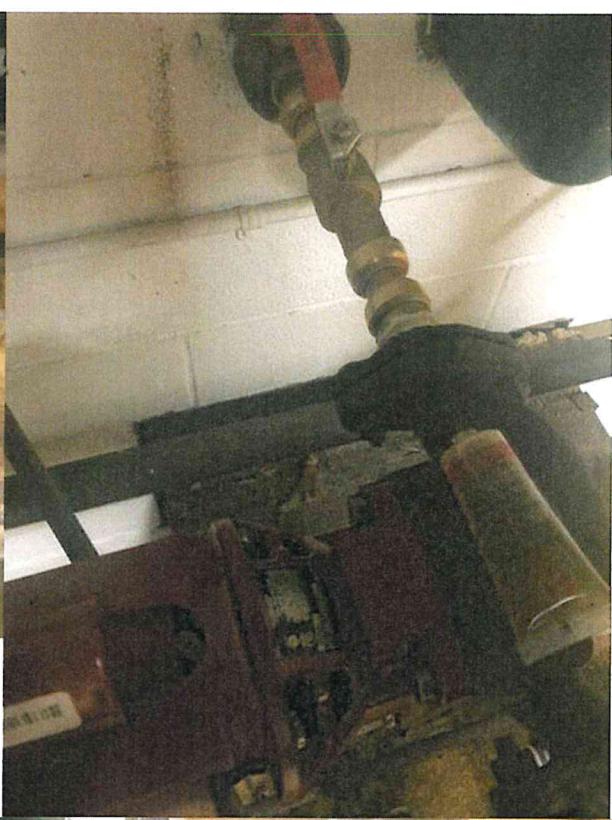
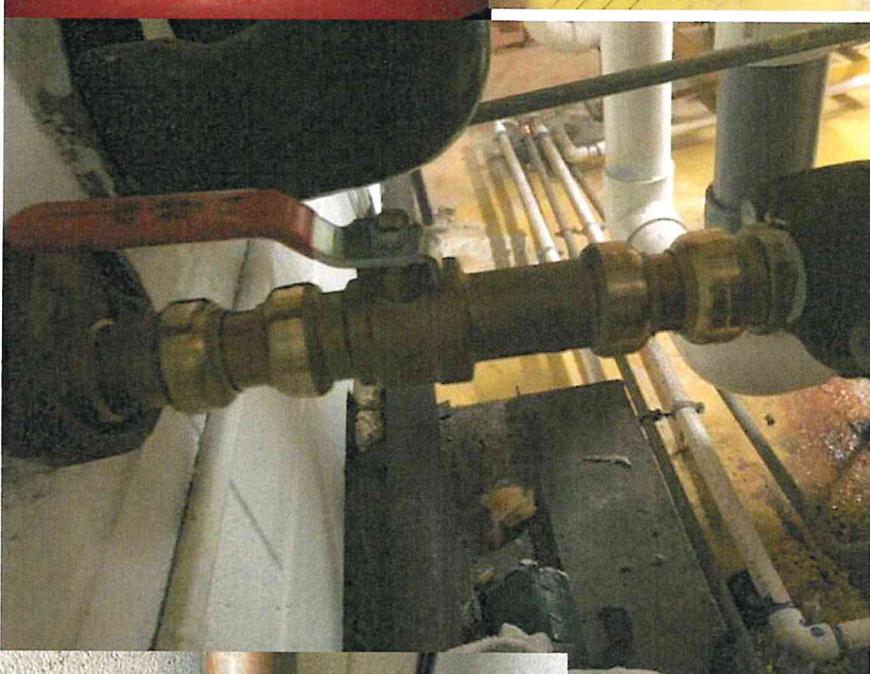
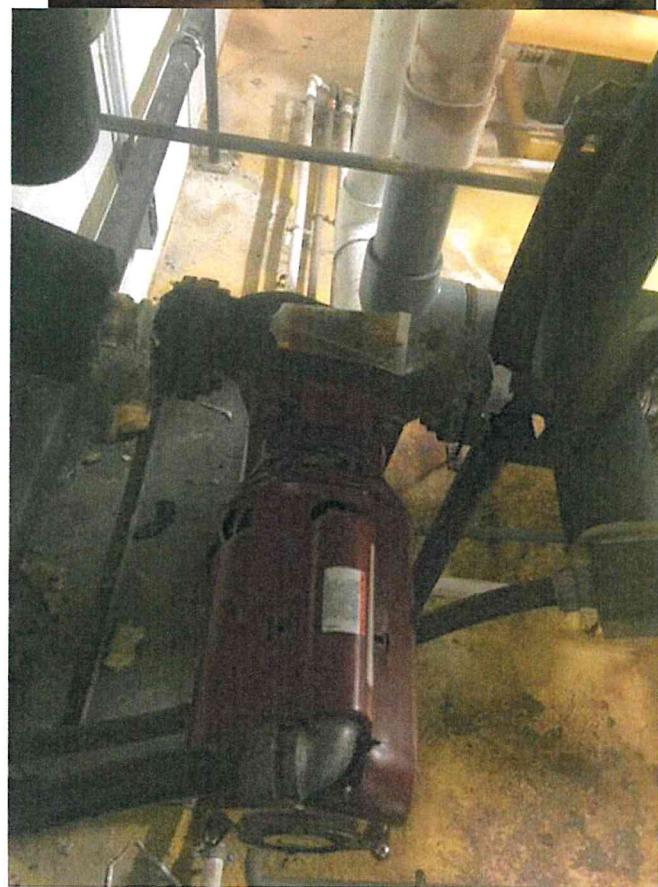
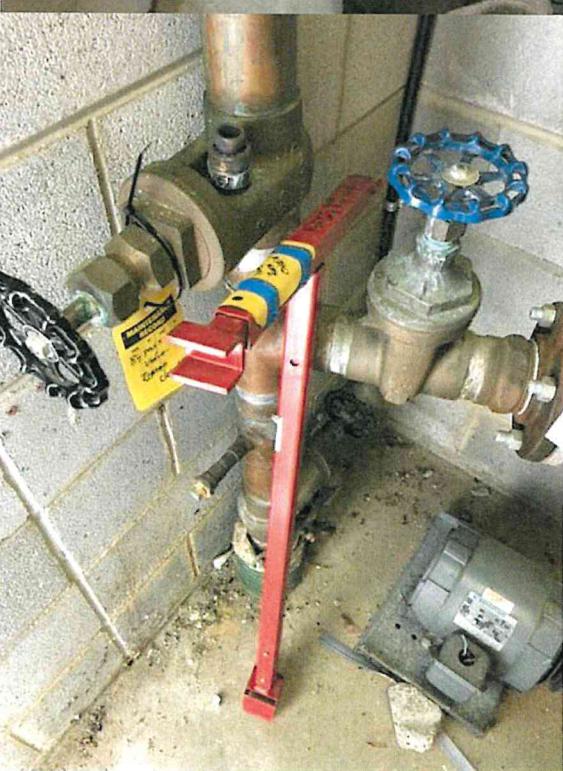
***Update - Arrived on site to perform work. Found that one of the isolation valves that is needed to isolate the pump does not hold. Additional funds are needed to now shut off main water valve to building and replace the isolation valve in addition to the original scope.

*****Update - Once pump was disassembled it was found that the impeller was broken and the pump required replacement. The seal kit was still used in order to stop the pump from leaking while a new pump was ordered. Pump replacement is covered under CSS 24823 WO 12167 however 10 hours of labor are included from it on this ticket to keep both under \$2500.

Installed new 1in ball valve domestic water shut off, and installed new pump and flange gasket and oiled new pump. Turned power back on to pump and checked for operating status, pump is working with no leaks. Purchased water main shutoff key and left in exterior valve room for facility. Also, verified that that the water pressure was at proper levels and all plumbing fixture are working properly.
