Tidewater - USARC 99th - Clarksburg WV009

Inspection Date: Jun 26, 2025

Tested to NFPA 72 Standards

EXECUTIVE SUMMARY

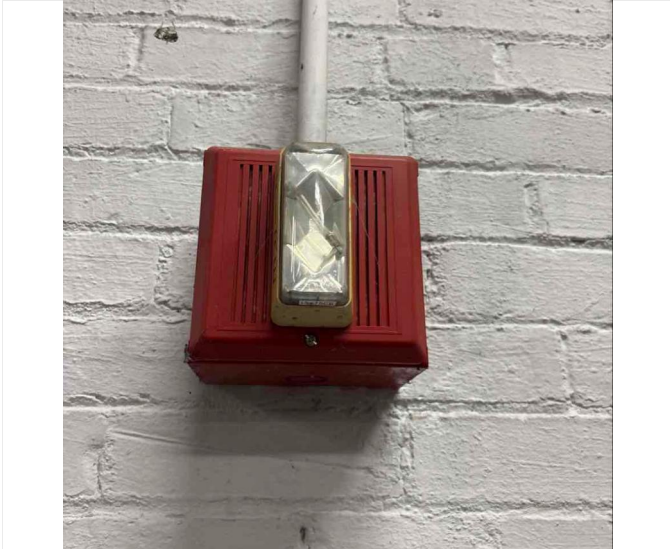
ScanID: 78708631

78708631	Warehouse warehouse wall closest to main building	Failed Operation	1	NFPA72 14.2.2.3.1
78708617	2nd Hallway	Failed Operation	1	NFPA72 14.2.2.3.1

Note	Device Type	Location	Comment	ScanID
INDICATING				
1	Horn/Strobe	Warehouse warehouse wall closest to main building	Failed Operation	78708631
Device isn't flashing when alarm is triggered

Comment: Failed Operation

ScanID	Location	Solution	Model #	Cost	Fix
INDICATING					
Horn/Strobe					
78708631	Warehouse warehouse wall closest to main building	Replace		T/M	<input type="checkbox"/>
78708617	2nd Hallway	Replace		T/M	<input type="checkbox"/>
		Customer WO/PO #: (none)	Internal WO/PO #: (none)	Total: T/M

Solution: Replace

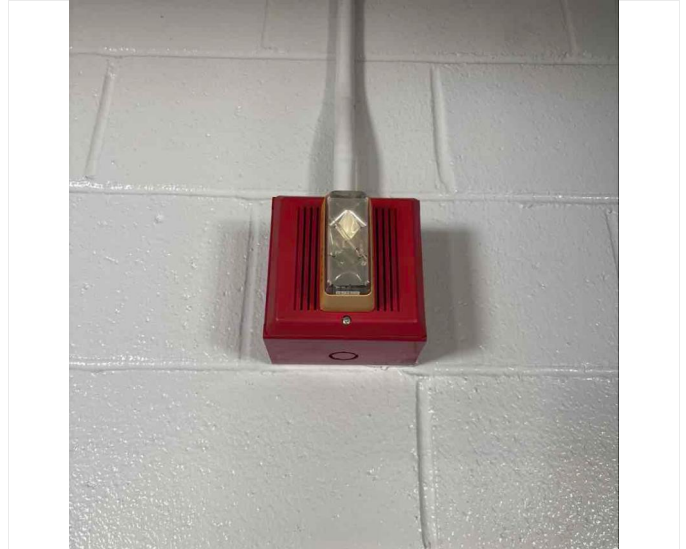
ScanID: 78708617

Comment: Failed Operation

Solution: Replace
