Additional Funding Request

WORK ESTIMATE

Company Name:	Tidewater, Inc.	Facility ID:	DE002
Contractor POC:	Adam Colopy		
Telephone No:	740-819-6207	Building/Location; (e.g., Classroom/Room #)	OMS
E-Mail Address:	adam.colopy@tideh2o.net		
Assigned Technician(s):	John Brown

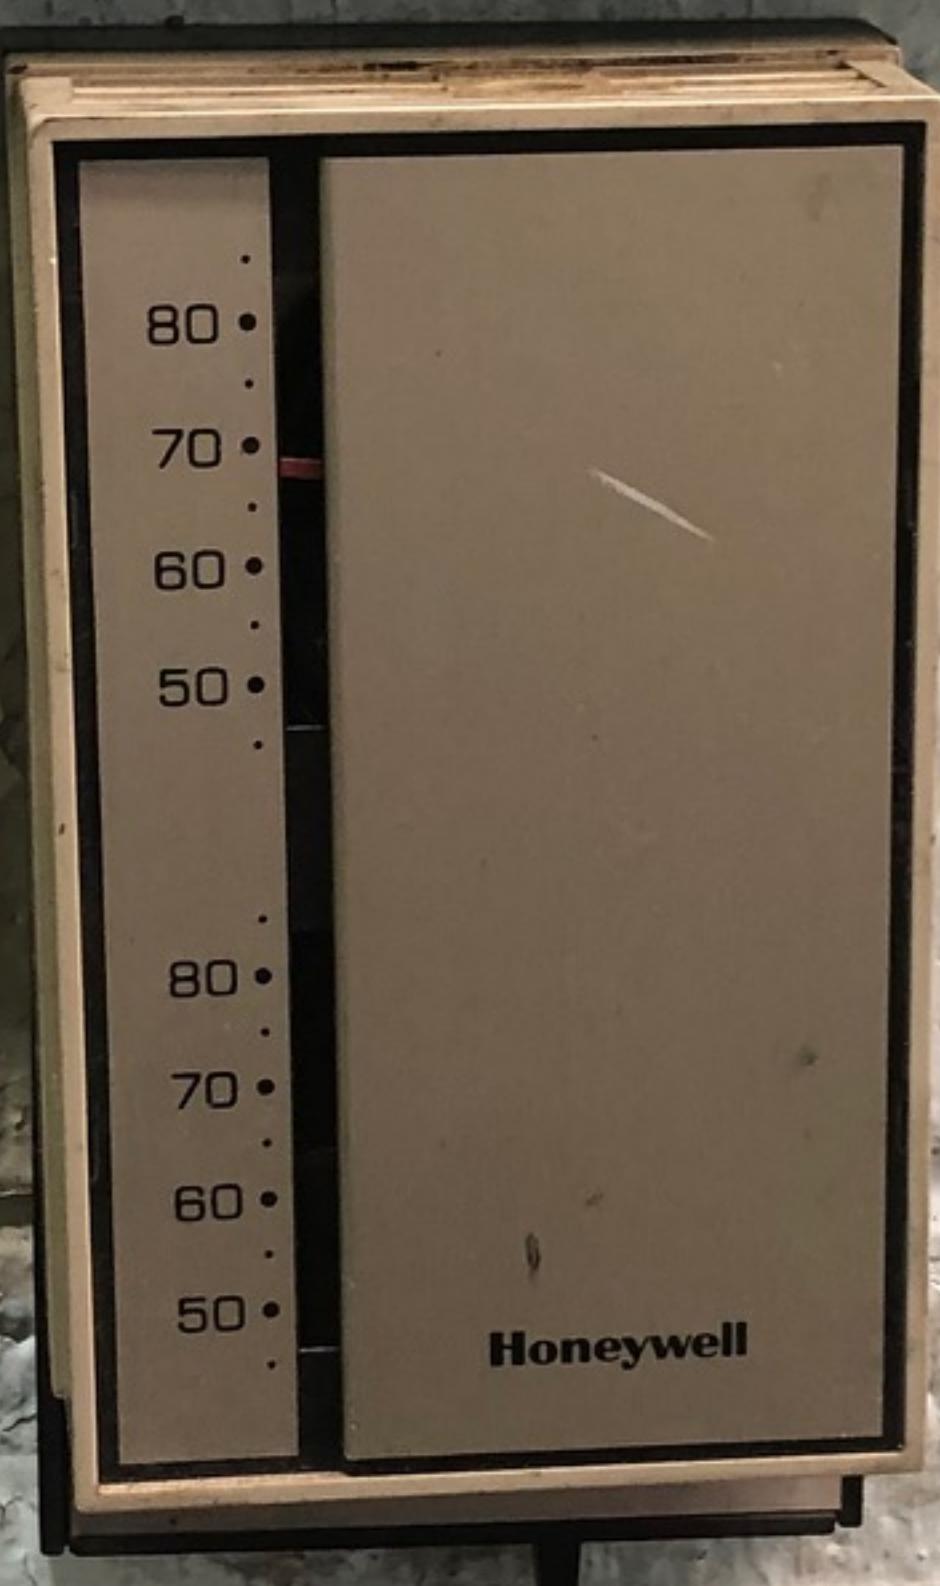
Found boiler 2 working fine and boiler 1 needing reset. Found controller in program mode instead of run mode. Placed VFD for OMS building circulating pump in Auto and % changed to 56% on pump but the pressures stayed the same. Found 3 thermostats in OMS Building only working in hand and not in auto mode, recommend replacing.

AR 420-1 mandates the
following thermostat settings:
Heating = 68°F & Cooling = 76°F

Labor and materials to replace 3 thermostats in the OMS building that are not working in auto mode.
