## Additional Funding Request

<b>Site: NY023</b>	<b>WO# 5655</b>	<b>CSS # 21382</b>	<b>Asset# NA</b>
Description of Repairs	Repair Roof Leak Building 200		
Diagnosis: Initial Work Order <b>CSS# 21382</b>	Roof Leak Building 200		
Explanation of Additional Costs for Repairs	Labor and material to temp stop the leak		
Additional Labor Cost to Perform Repairs	$6 \times \$190 = \$1140.00$		
Additional Material Cost to Perform Repairs	\$350.00		
Total Cost of Repair	\$1490.00

ESTIMATE 0917191 CSS2182

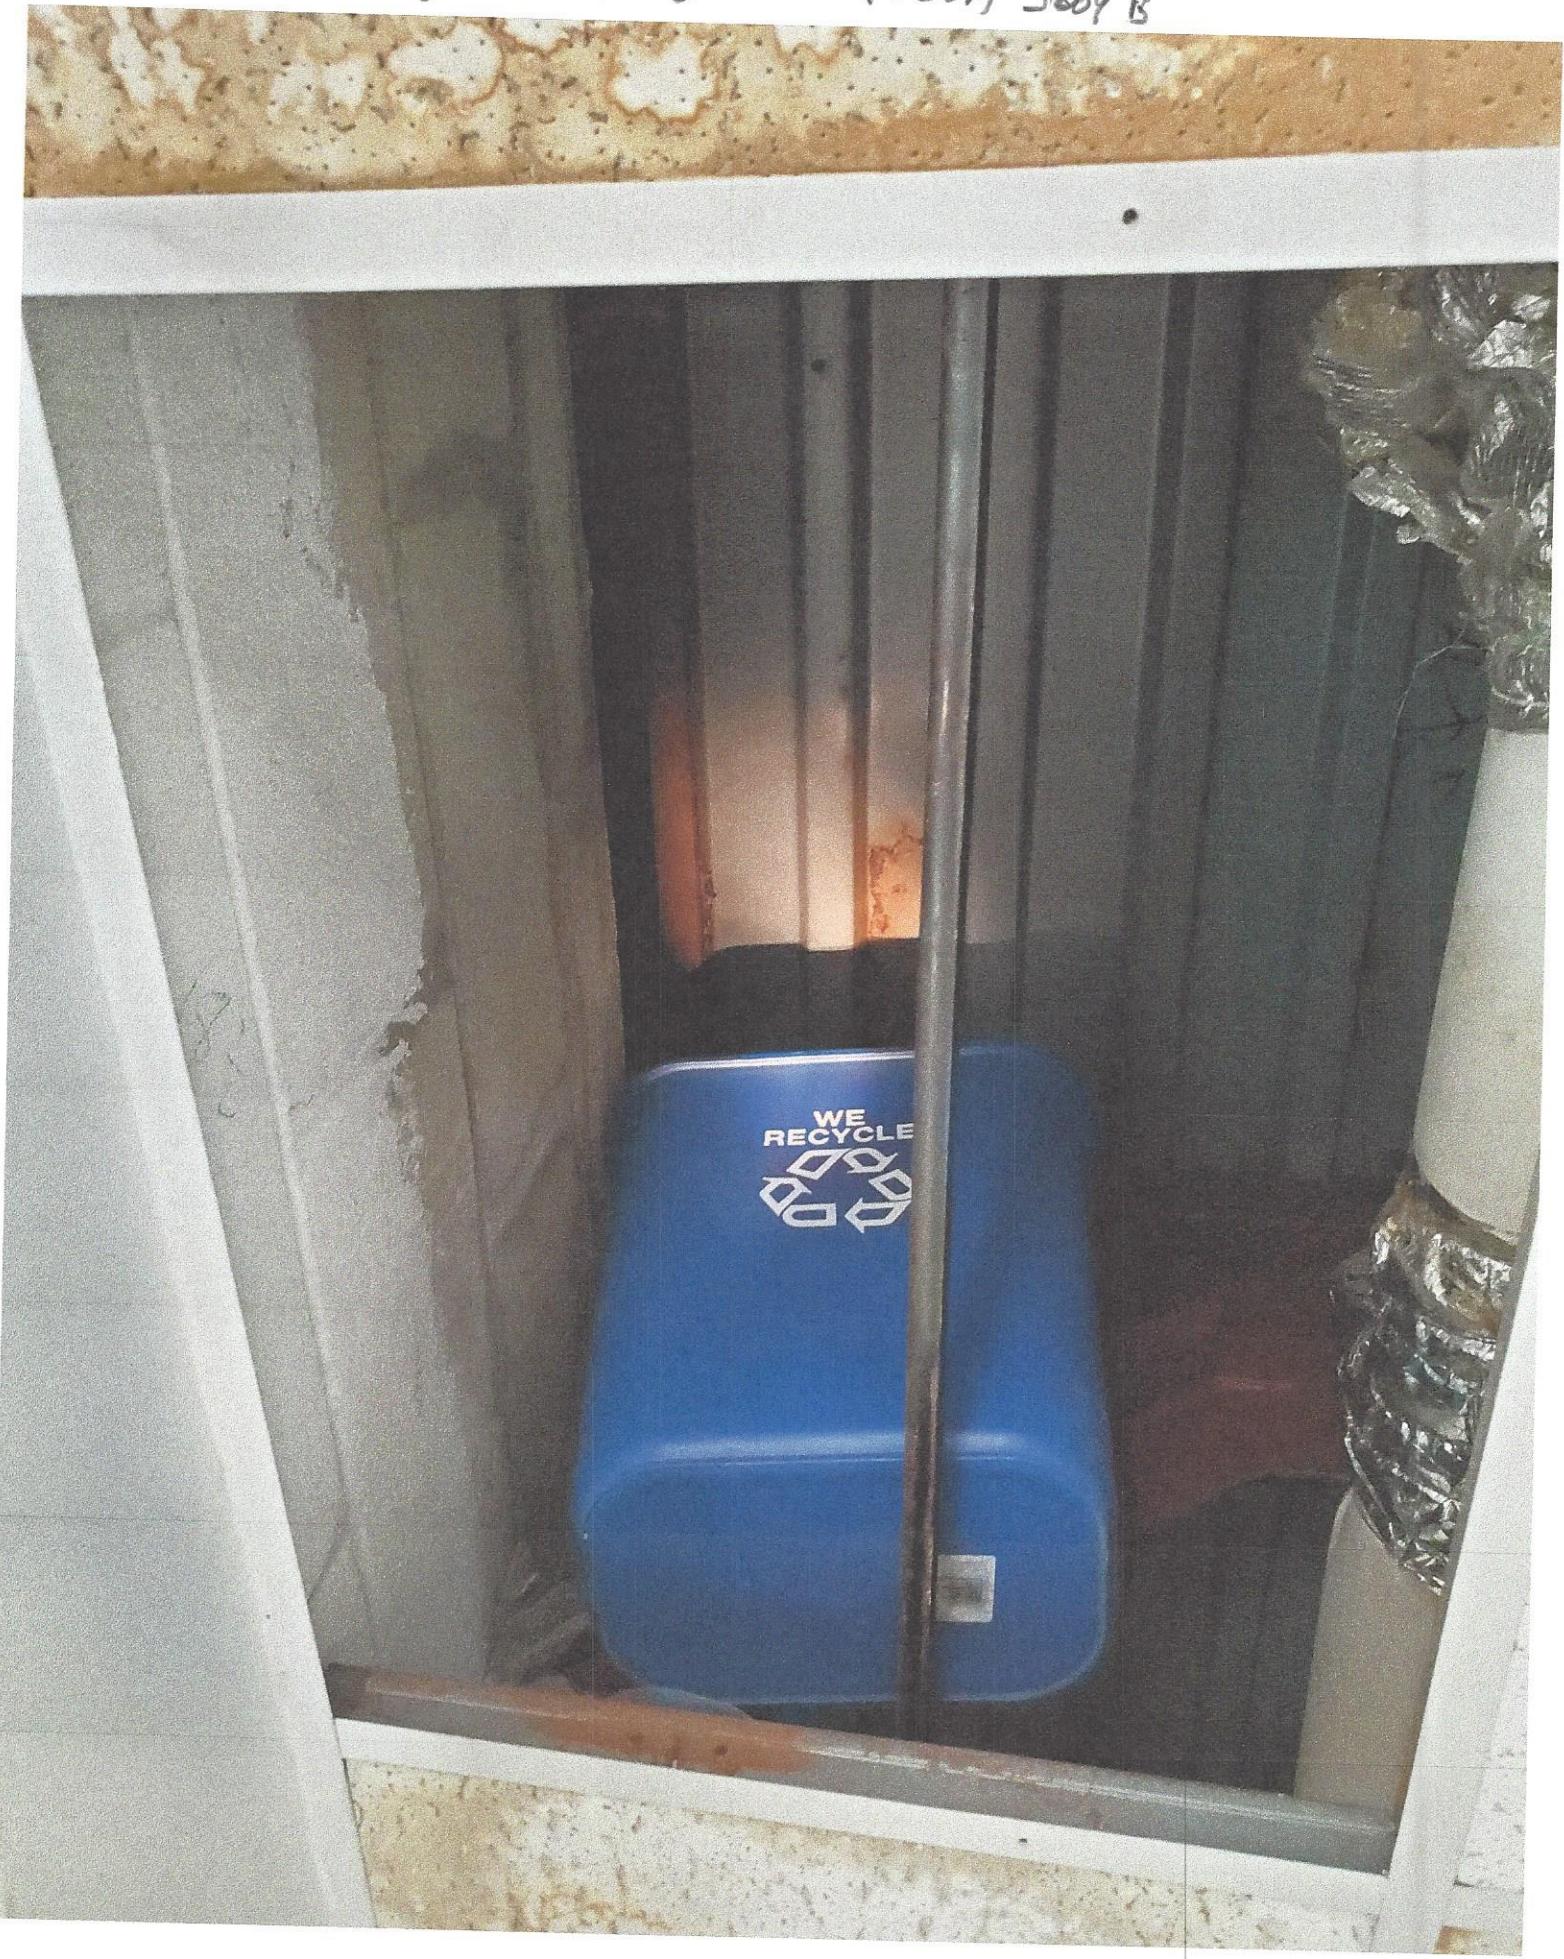
Room 3009 B

Qty.	Item#	Description	Unit Price	Line Total
1	1	<p><b>Building 200 Ft Totten</b></p> <p><b>Room 3009B Possible Roof Leak</b></p> <p><b>Inspected Roof and Ceiling possible</b></p> <p><b>Roof failure is causing water to gather</b></p> <p><b>under the foam insulation on the</b></p> <p><b>rubber roof, Roof might need</b></p> <p><b>replacement.</b></p> <p><b>Recommend trying to temporally stop</b></p> <p><b>the leaks by applying a rubber</b></p> <p><b>waterproofing material to the areas in</b></p> <p><b>question inside the upper ceiling.</b></p> <p><b>Replace damaged ceiling tile.</b></p> <p><b>Material</b></p> <p><b>Labor 6 hrs x \$190.00</b></p> <p><b>TOTAL</b></p>
