# SENTRY MECHANICAL

## INVOICE

RE: CMI Management PA017 - Circ Pump

CSS #17135  
WO #7457

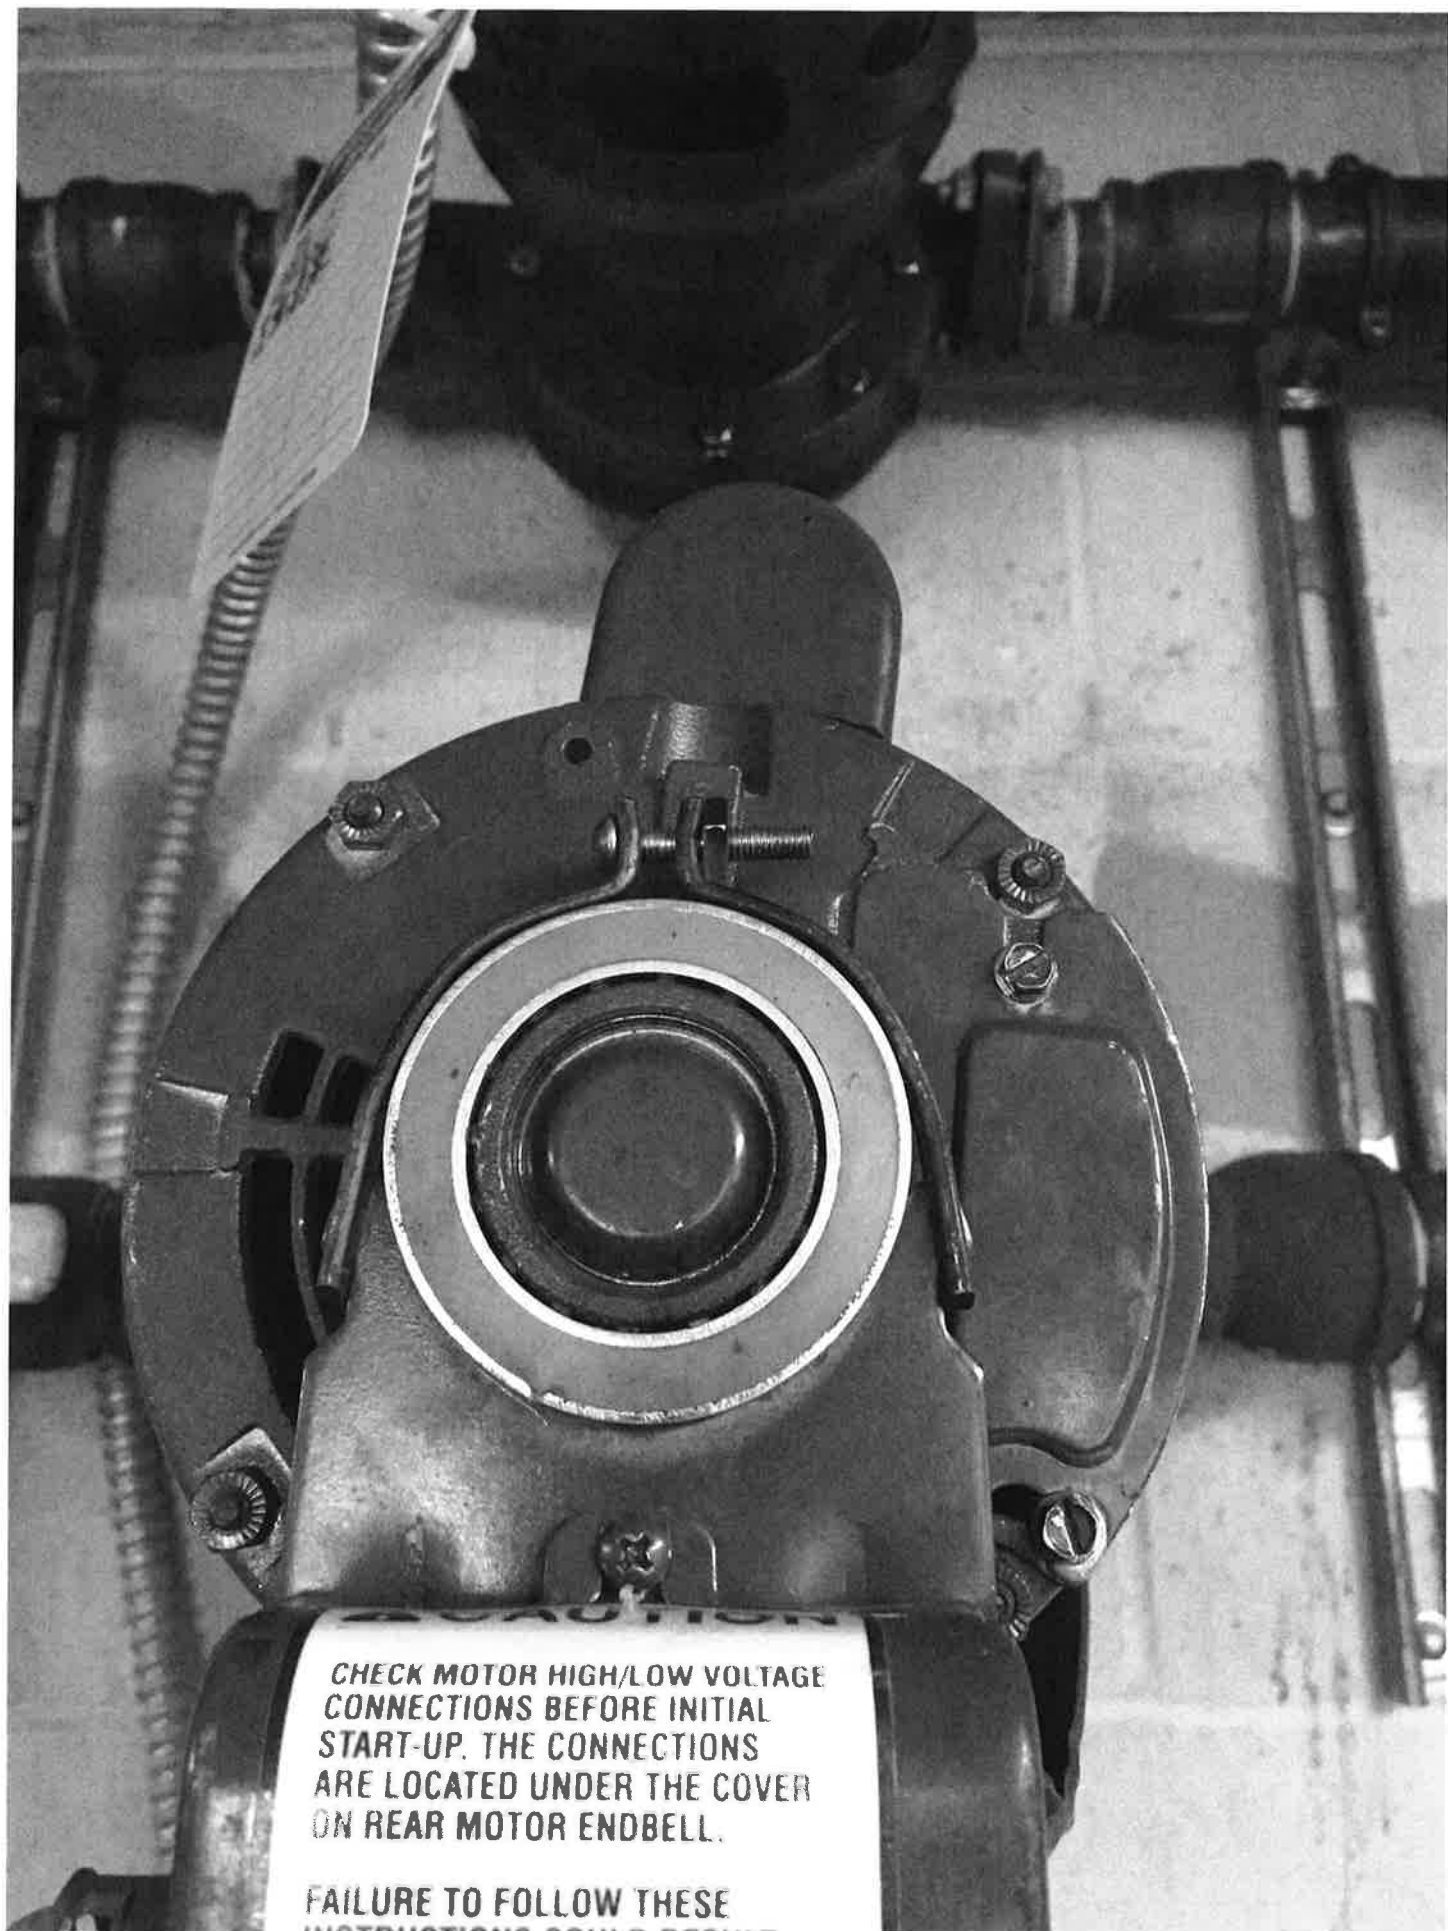
- (Initial Call) found lead at bearing assembly #2 circulating pump
- replace bearing assembly, coupler and motor mount

Work Performed: Replaced a old bearing assembly, motor mount set  
one coupling assembly on a Bell & Gossett pump
