Fratello & Amico, Inc.

December 20, 2018

RE: CSS #13650 VA051 Report of OWS Invasive Investigation; Hall USARC, 1915 Roanoke Boulevard, Salem, VA 24153

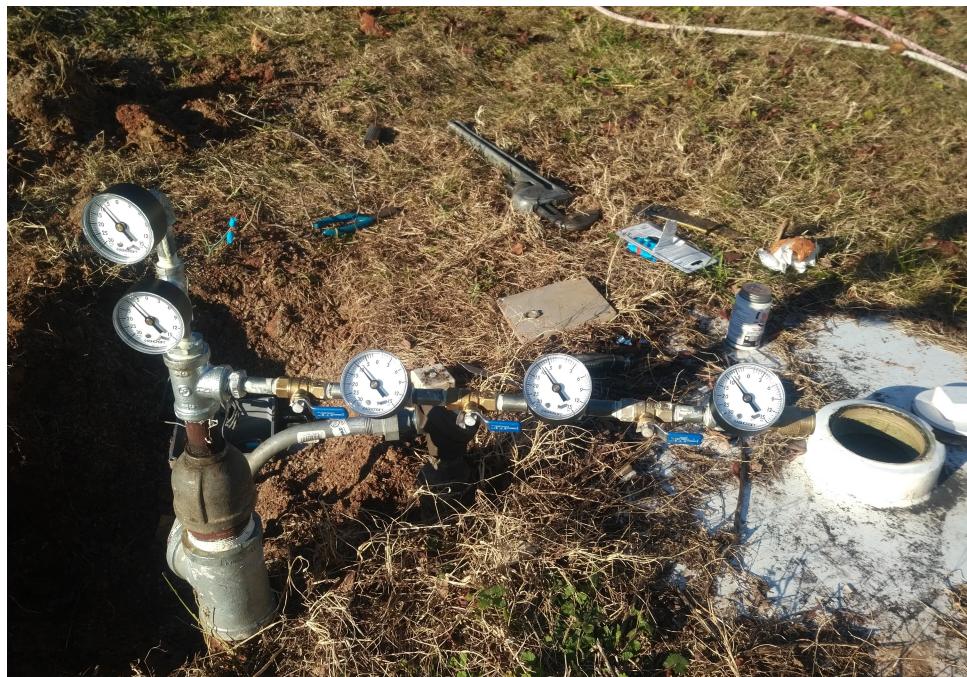
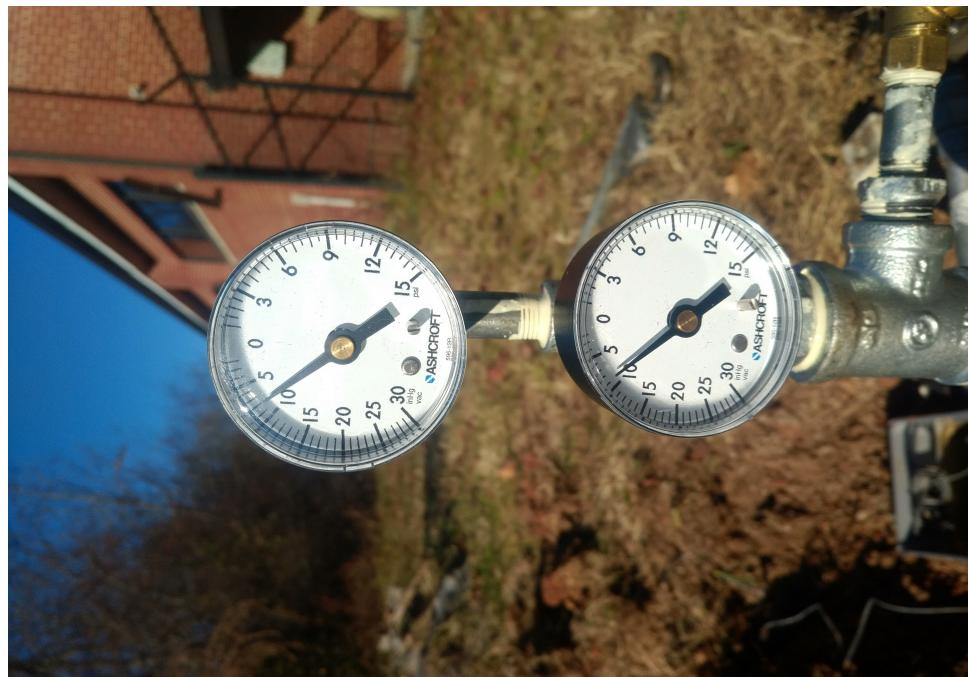
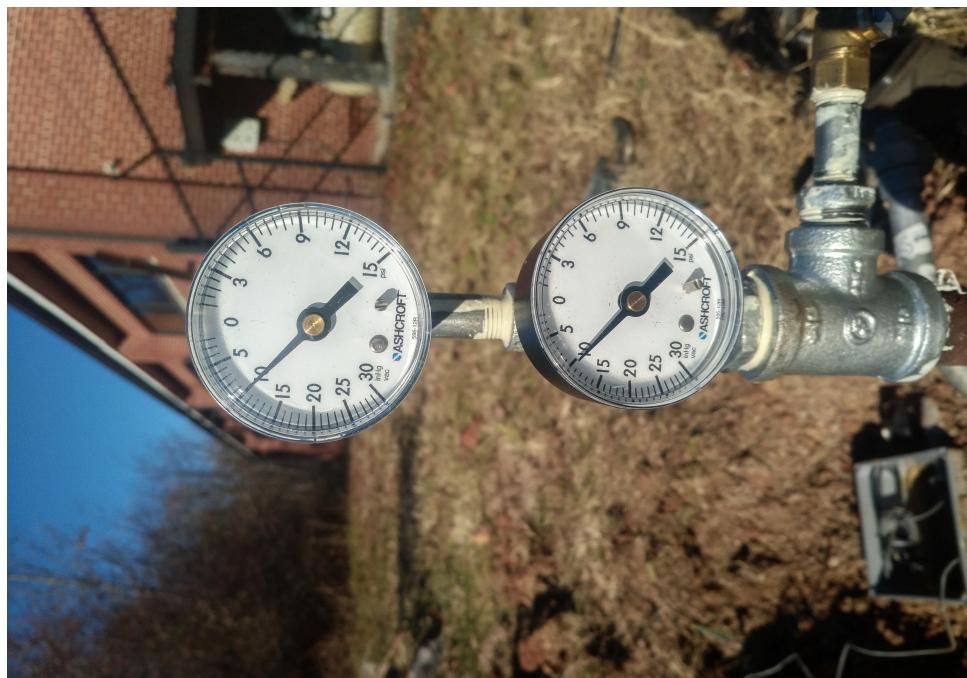
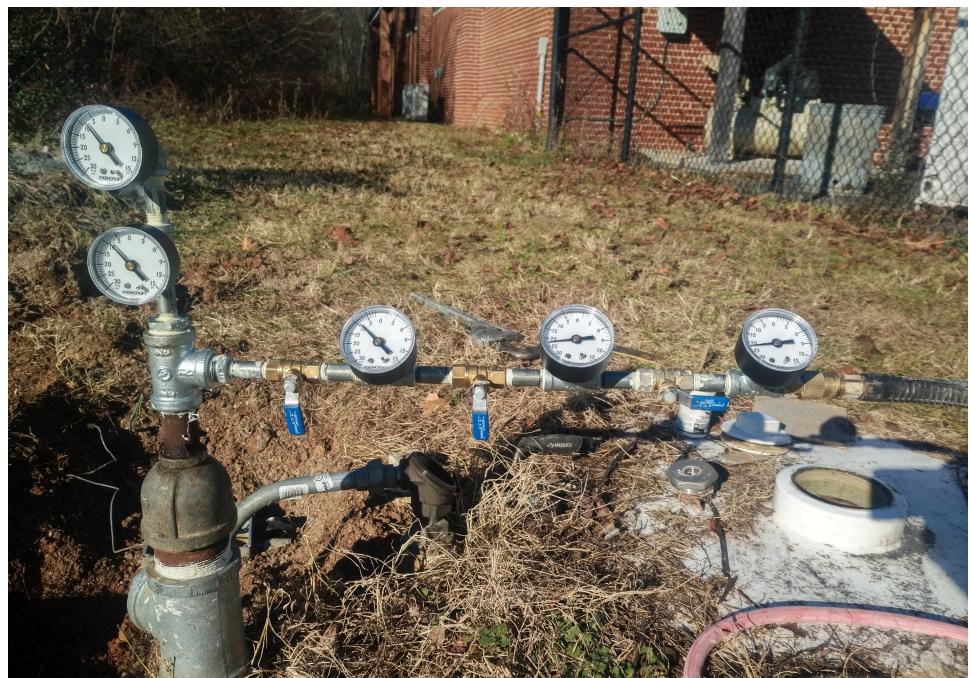
The OWS contained 34" of liquid, appeared to be clear water, just a sheen of oil on the surface. The Interstice contained just 8" of water, although it contained 19" four months earlier. We evacuated the interstice and conducted two back-to-back vacuum tests IAW PEI/RP1200-17 Our initial test commenced at 1:15pm and concluded at 2:15pm, the second immediately thereafter. In order to pass the test, a tank must hold 10" of vacuum for one hour. The first test started at 10" and finished at 8.5", the second test concluded with 9" of vacuum. Obviously both tests indicate a failure of tank integrity. The Panel Alarm was traced to underground PVC conduit that had flooded with water and shorted the wires.

Conclusions and Recommendations: It would appear that the OWS has a leak in the outer shell somewhere between the base and 8" above the bottom. The installation records for this are not available but indications are that it was installed in 2009. We also know that in March of 2016 we visited the facility and found 23" of water within the interstice. The original installation contractor used all PVC conduit which was almost completely destroyed by the mowing contractor as soon as it was in place. While most is underground, the connections on top of the tank were subject to traffic, damage, and ultimately precipitation infiltration.

A proposal for options on how to proceed will be prepared and submitted before the end of the month. Photos of this service are attached, the invoice along with signed COW will be submitted shortly.
