**CERTIFICATION OF WORK
SERVICE CALL**

FACID/Building: WV022 Date of Visit: 4-8-2025

CSS# 97710 WO# 18282

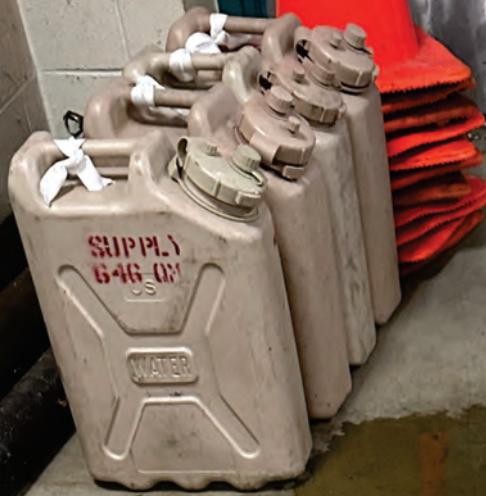
Repaired Frozen Pipe (3/4" copper) above ceiling. Isolated two Hot Water coils that are hooked up to outside louvers. Reset Boiler controls and started boilers. Recirc pumps on boilers are seized up and need replaced and Hot Water coils are busted from freezing and will need replaced. Will send estimate later.
