CERTIFICATION OF WORK SERVICE CALL

FACID/Building: NY070 Date of Visit: 7/29/24 & 7/30/24

Customer US ARMY WEBSTER RESERVE CENTER (86804)

Description Q SCOPE/INVESTIGATE ONLY ~NO REPAIRS. ROOM 131 UH 3&4, ERV1, ERV2, ERV3 PER QUOTE *SEE NOTES ~CSS96209

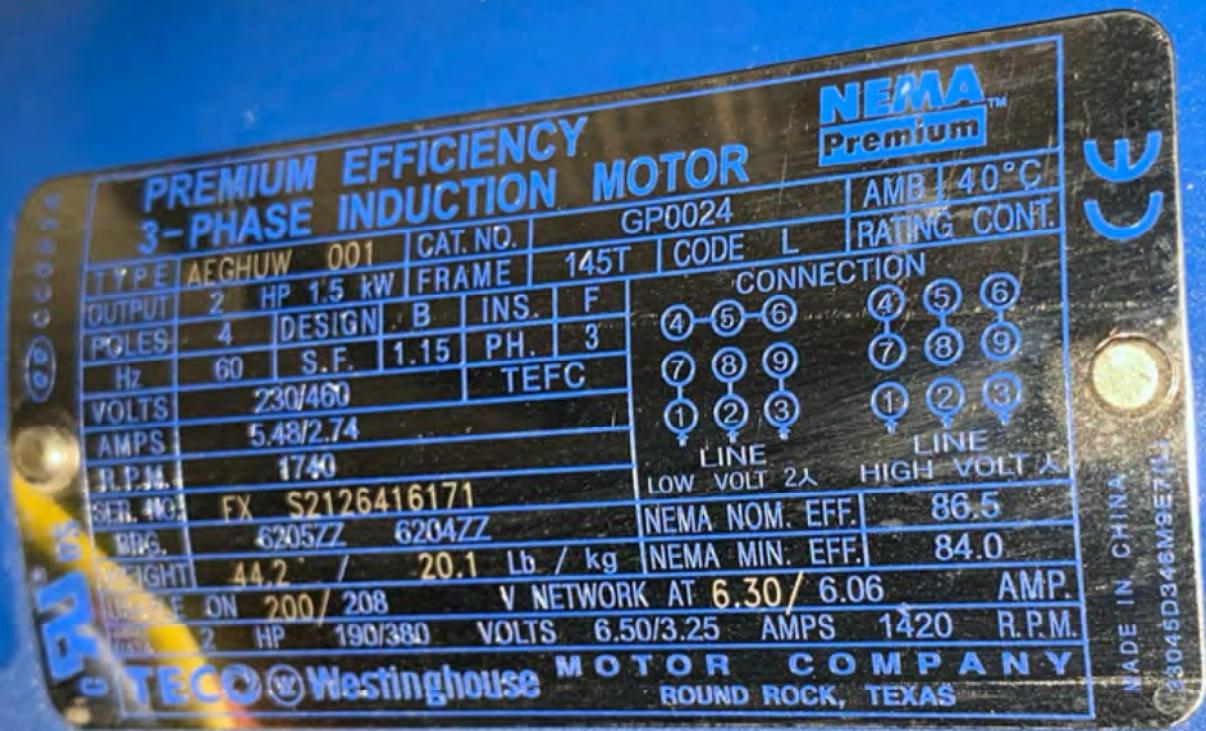
ERV3 Top Motor 460V

7/29/2024 ERV3 - Found unit running with grinding sounds. Shut off unit and lock out power. Open unit and pull belts. Unit needs two new belts (A38 belts). Check top blower and bottom blower. Bearings are OK. Check top motor, and bottom motor. Both motors have very bad bearings and are grinding when I turn them by hand. Both motors need to be replaced. Check dampers, heat recovery cores, and electrical.
 ERV 2 - found unit running and grinding badly. Shut off unit and pull belts off. Needs 2 new belts (A42 and A44 belts). Both motors are grinding badly whe I turn them by hand. Both motors have bad bearings and both motors need to be replaced. Check electrical, controls, dampers, and heat recovery cores.
 ERV 1 - Found unit running and grinding badly. Shut off unit and pull belts. Need 2 new belts (A38 belts). Both motors are grinding badly when turned by hand. Bearings are very bad and motors need to be replaced. Check electrical, dampers, heat recovery cores, and controls.

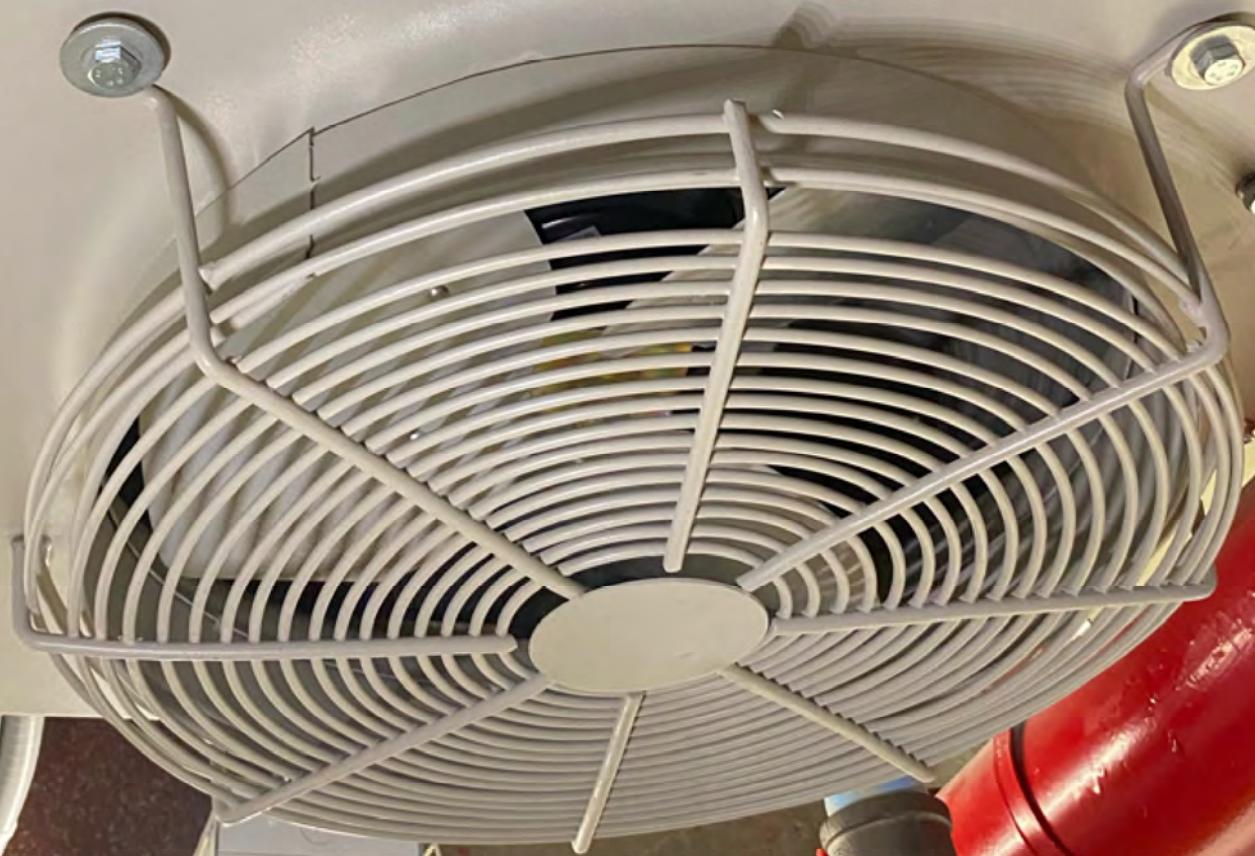
NY070-01
Asset #4605 unit heater#4

7/30/2024 Check and troubleshoot unit heater 3 & 4. They are fan coils. No power to fans. Trace power to temp switch on hot water piping. Switch is set to 100 degrees. When closed, fan turns on. Unit 4 is working ok. Unit 3 has a bad motor starter, not sending power to fan. It needs to be replaced.
