**CERTIFICATION OF WORK
SERVICE CALL.**

FacID: Building: NY030

Vault NY030

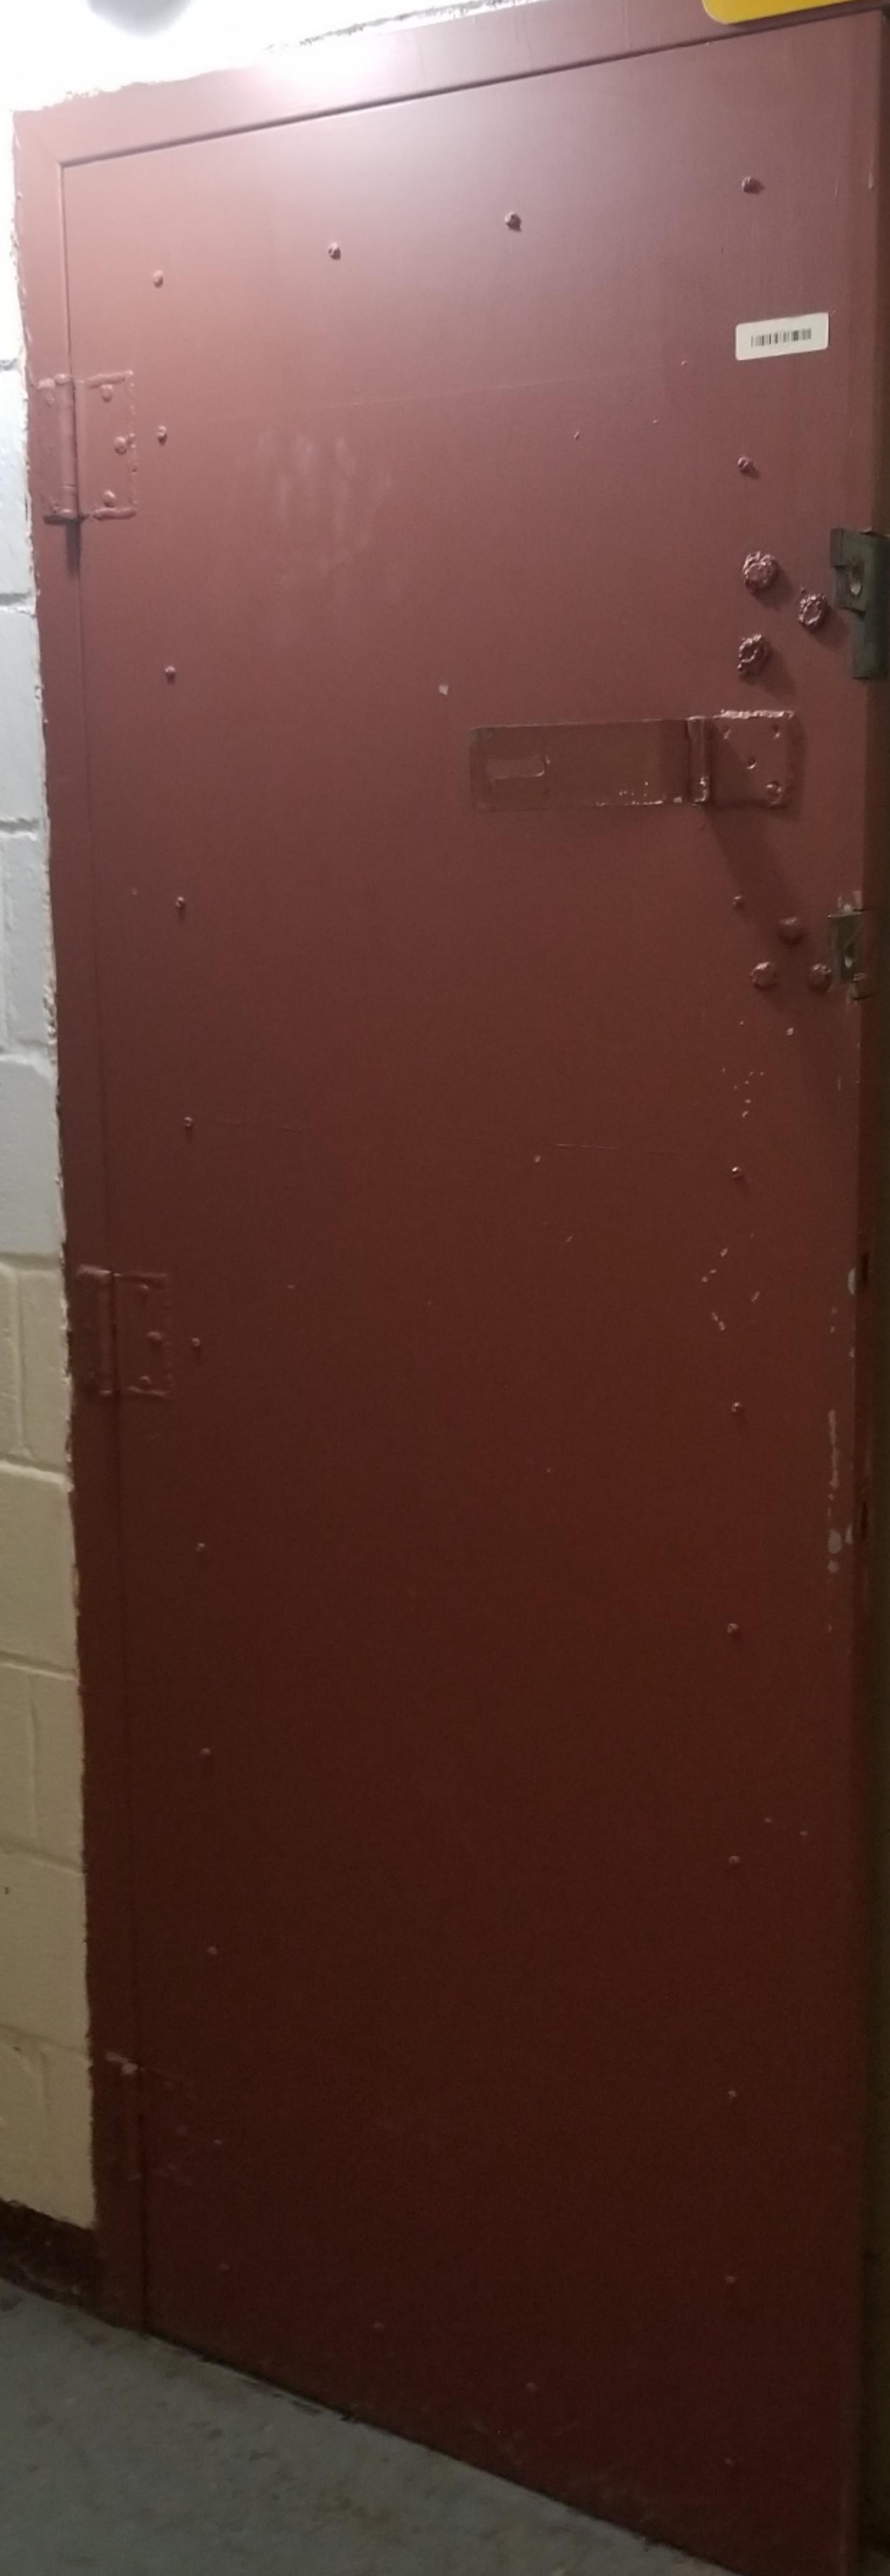
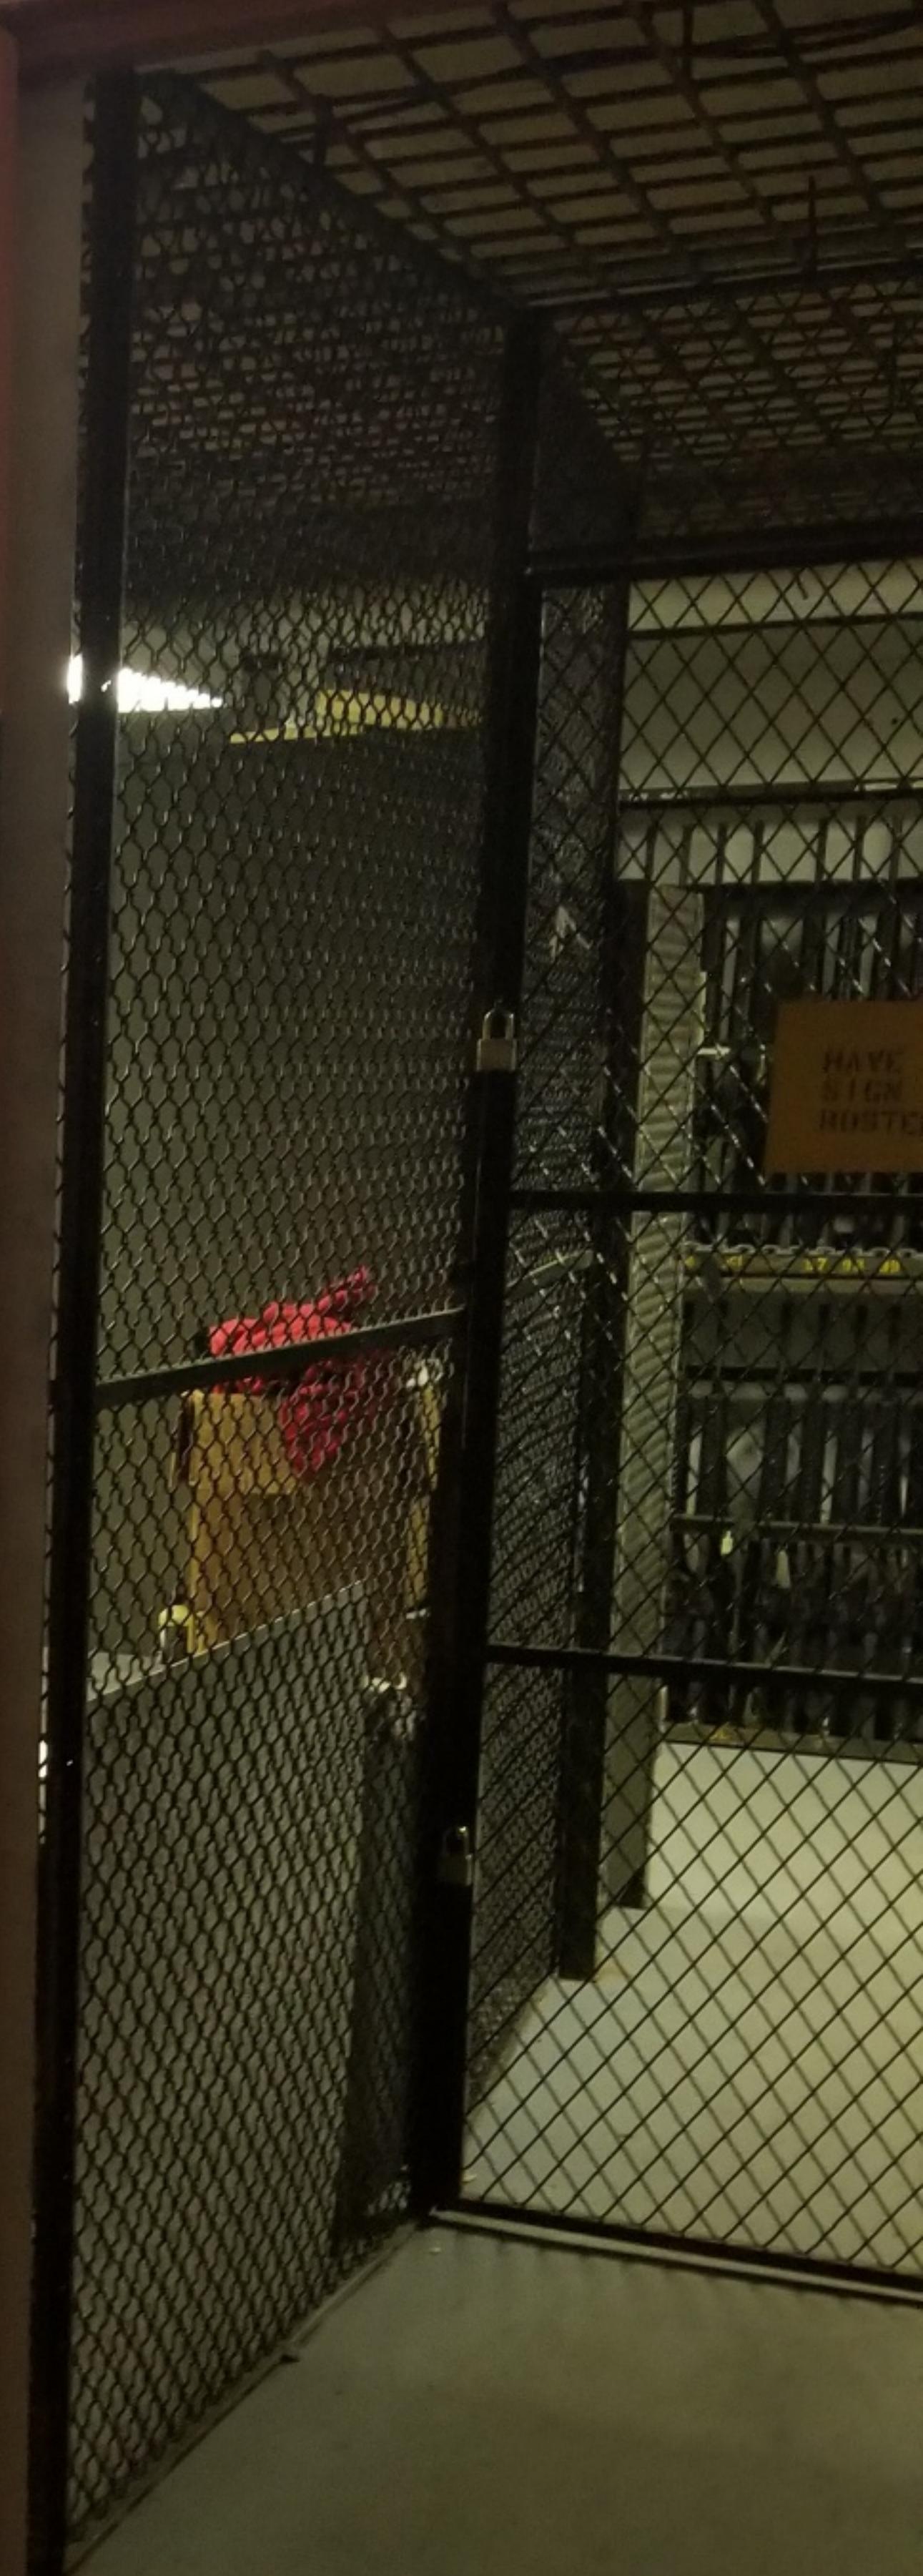
This opening does not meet the requirements as specified in AA-D-600 for an armory vault door. This opening consists of a pair of outswing wooden doors with sheet metal screwed to them immediately followed by a pair of inswing wooden doors with sheet metal screwed to them. The locks on these doors do not meet the current requirements laid out in FF-L-2937 for an armory vault nor do they meet the past requirements of UL 768 Group 1 or 1R certifications. While the outer doors are secured with GSA recognized Sargent and Greenleaf padlocks and the inner doors also have multiple locks on them, these doors are a serious security risk and do not come close to meeting any AA-D-600 specification.

With the advent of modern power tools, access to this vault may be gained in 60 seconds or less in its current state. I cannot stress enough how much of a security risk this opening is especially with an exterior door just a few steps away. I would strongly recommend the replacement of this vault door as soon as physically possible in order to comply with the standards set out in AA-D-600.
