CERTIFICATION OF WORK SERVICE CALL

Tustin Energy Solutions, LLC Preventative Maintenance Report

USAFRC Baltimore BAS Status Report REV1

May 2019

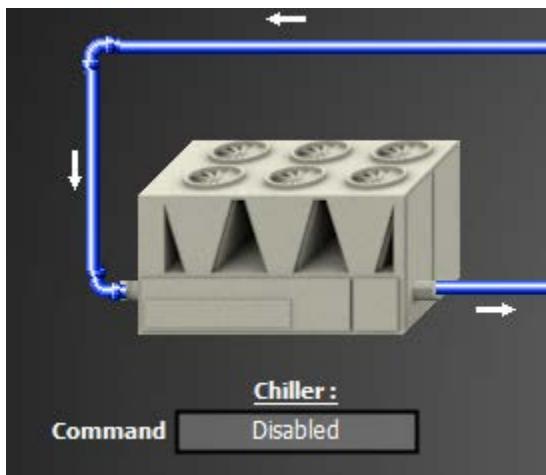
1. Chiller controls are incomplete. It appears that a BACnet connection to the chiller was planned but not connected. Wires are pulled from the chiller control panel out to the chiller but left unterminated.
2. Chiller package (including chilled water pumps) run standalone. The chiller is currently enabled/disabled by the switch at the chiller control panel and will run continuously if nobody attends to it. The BAS system shows a chiller command point which does not work:

There is no work completed at this time. It is recommended at a minimum that the chiller enable point and pump status points are completed. This includes wiring, hardware, software and graphics. Control logic is already present to enable/disable the chiller based on chilled water valve demand. Chilled water supply temperature reset should be considered as an energy saving strategy.

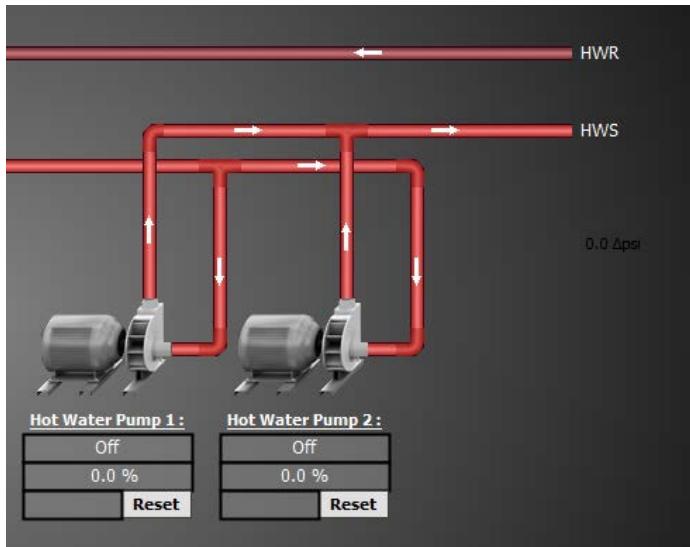
5. Boiler hot water pumps are VFD controlled to maintain system differential pressure setpoint:

The system is also equipped with a hot water bypass valve which is not shown on the graphic. Differential pressure setpoint is also not shown on the graphic. Differential pressure reads very low and as a result pumps are continually ramped to 100 percent. System differential pressure control and hardware devices should be checked for proper operation.

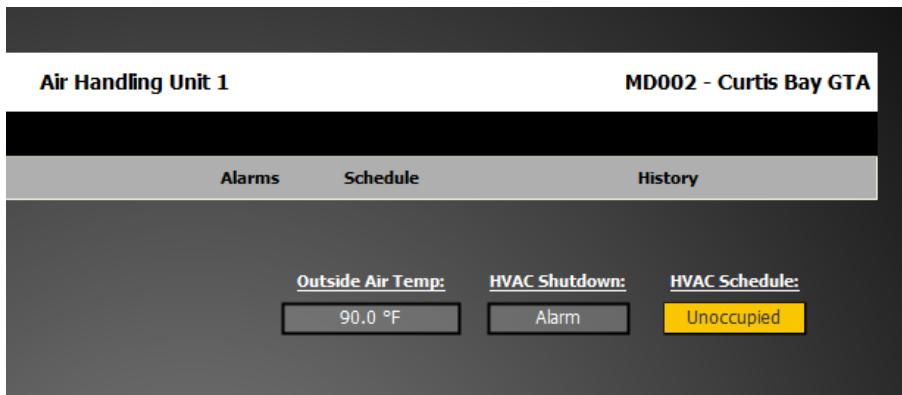
- Unit is scheduled from the graphical interface:

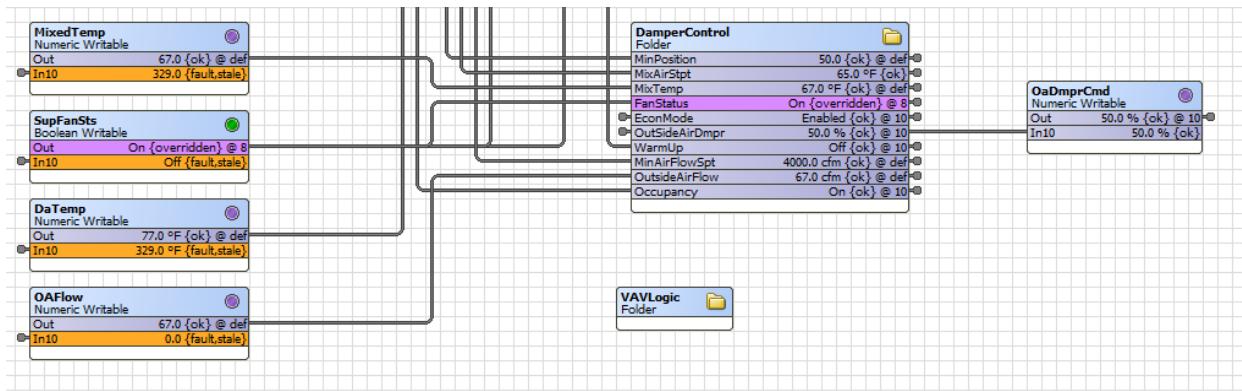
- Supply air fan status remains off when the fan is commanded to run. VFD will remain at minimum speed unless this point is overridden on. The fan proving device needs adjustment or replaced to correct this deficiency.
- Existing AHU mixed air damper control takes outside air airflow into control logic. There is no airflow station installed. This portion of software and mixed air damper control should be corrected:

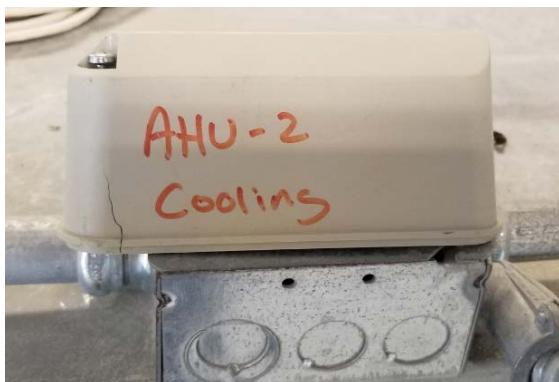
1. AHU-2 cooling valve actuator has failed and needs to be replaced:

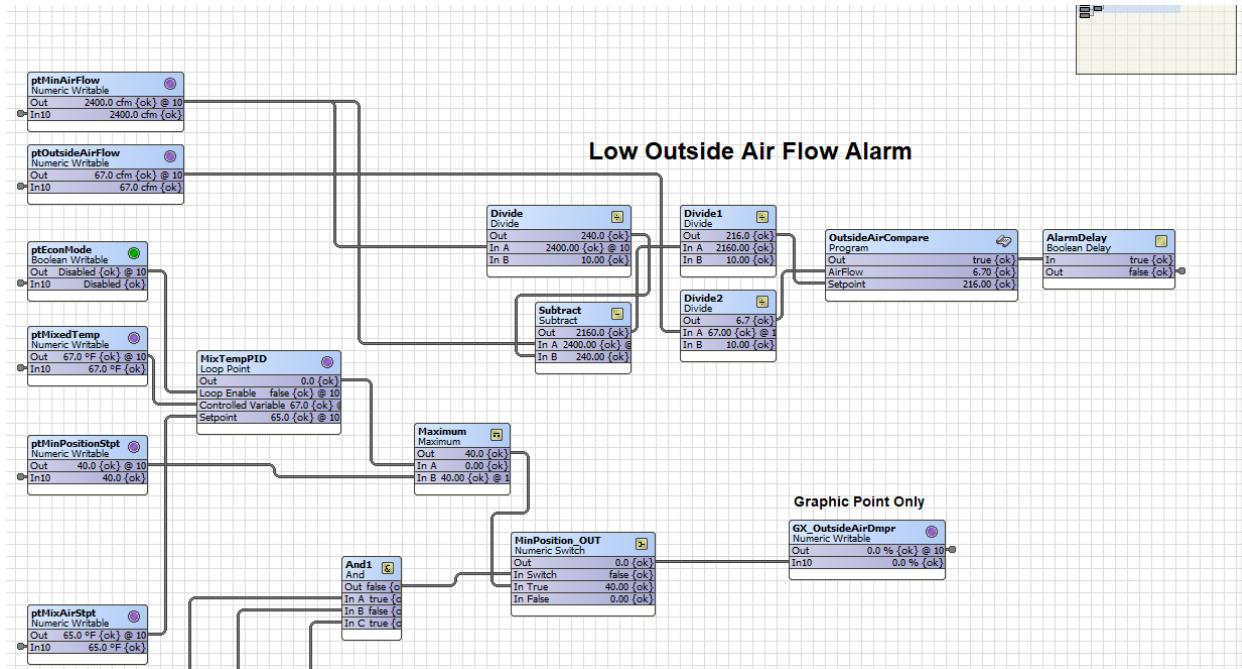
2. There is no airflow station installed. This portion of software should be corrected:

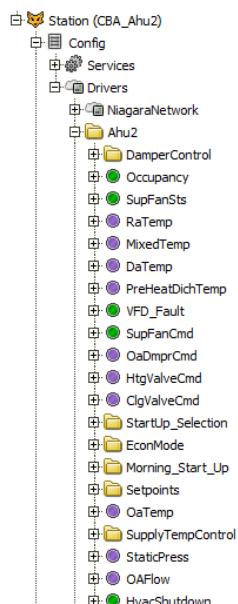
5. Points for Static Pressure and VFD Fault are found in the point database. This is a constant volume AHU:

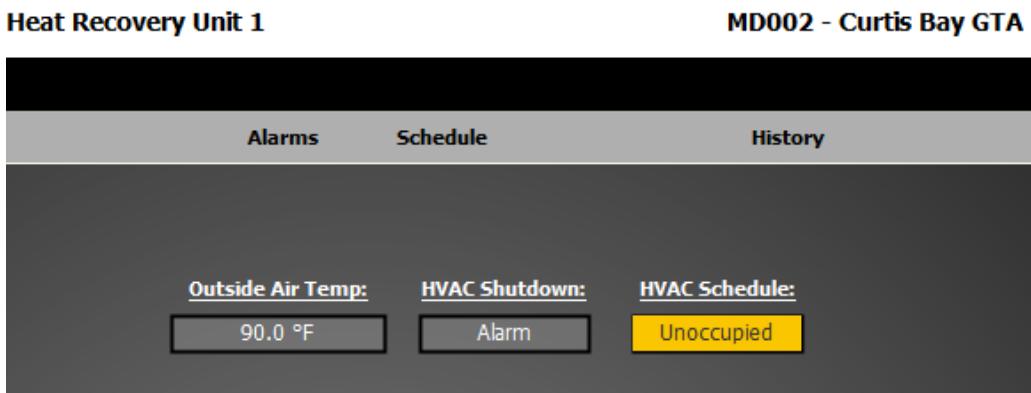
1. Unit is scheduled from the graphical interface:

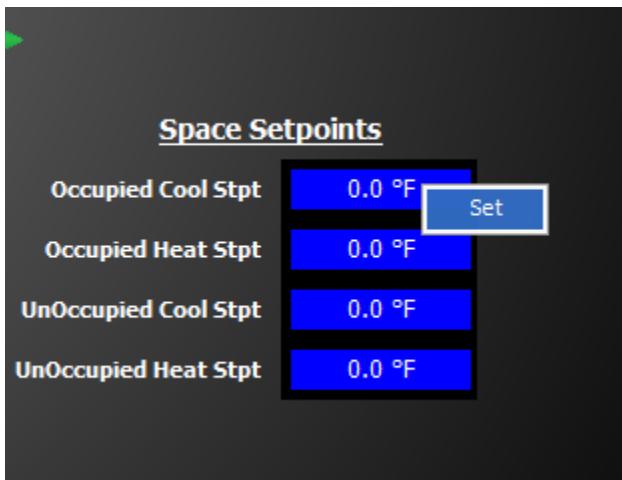
2. Modified all VAV and CAV graphics to allow changeable space temperature and CO2 setpoints:

Change the setpoint by right clicking in the blue box.
