## Additional Funding Request **Invoice**

## Invoice

Service Address
MD002 - Curtis Bay 700 E Ordnance Road Baltimore, MD 21226

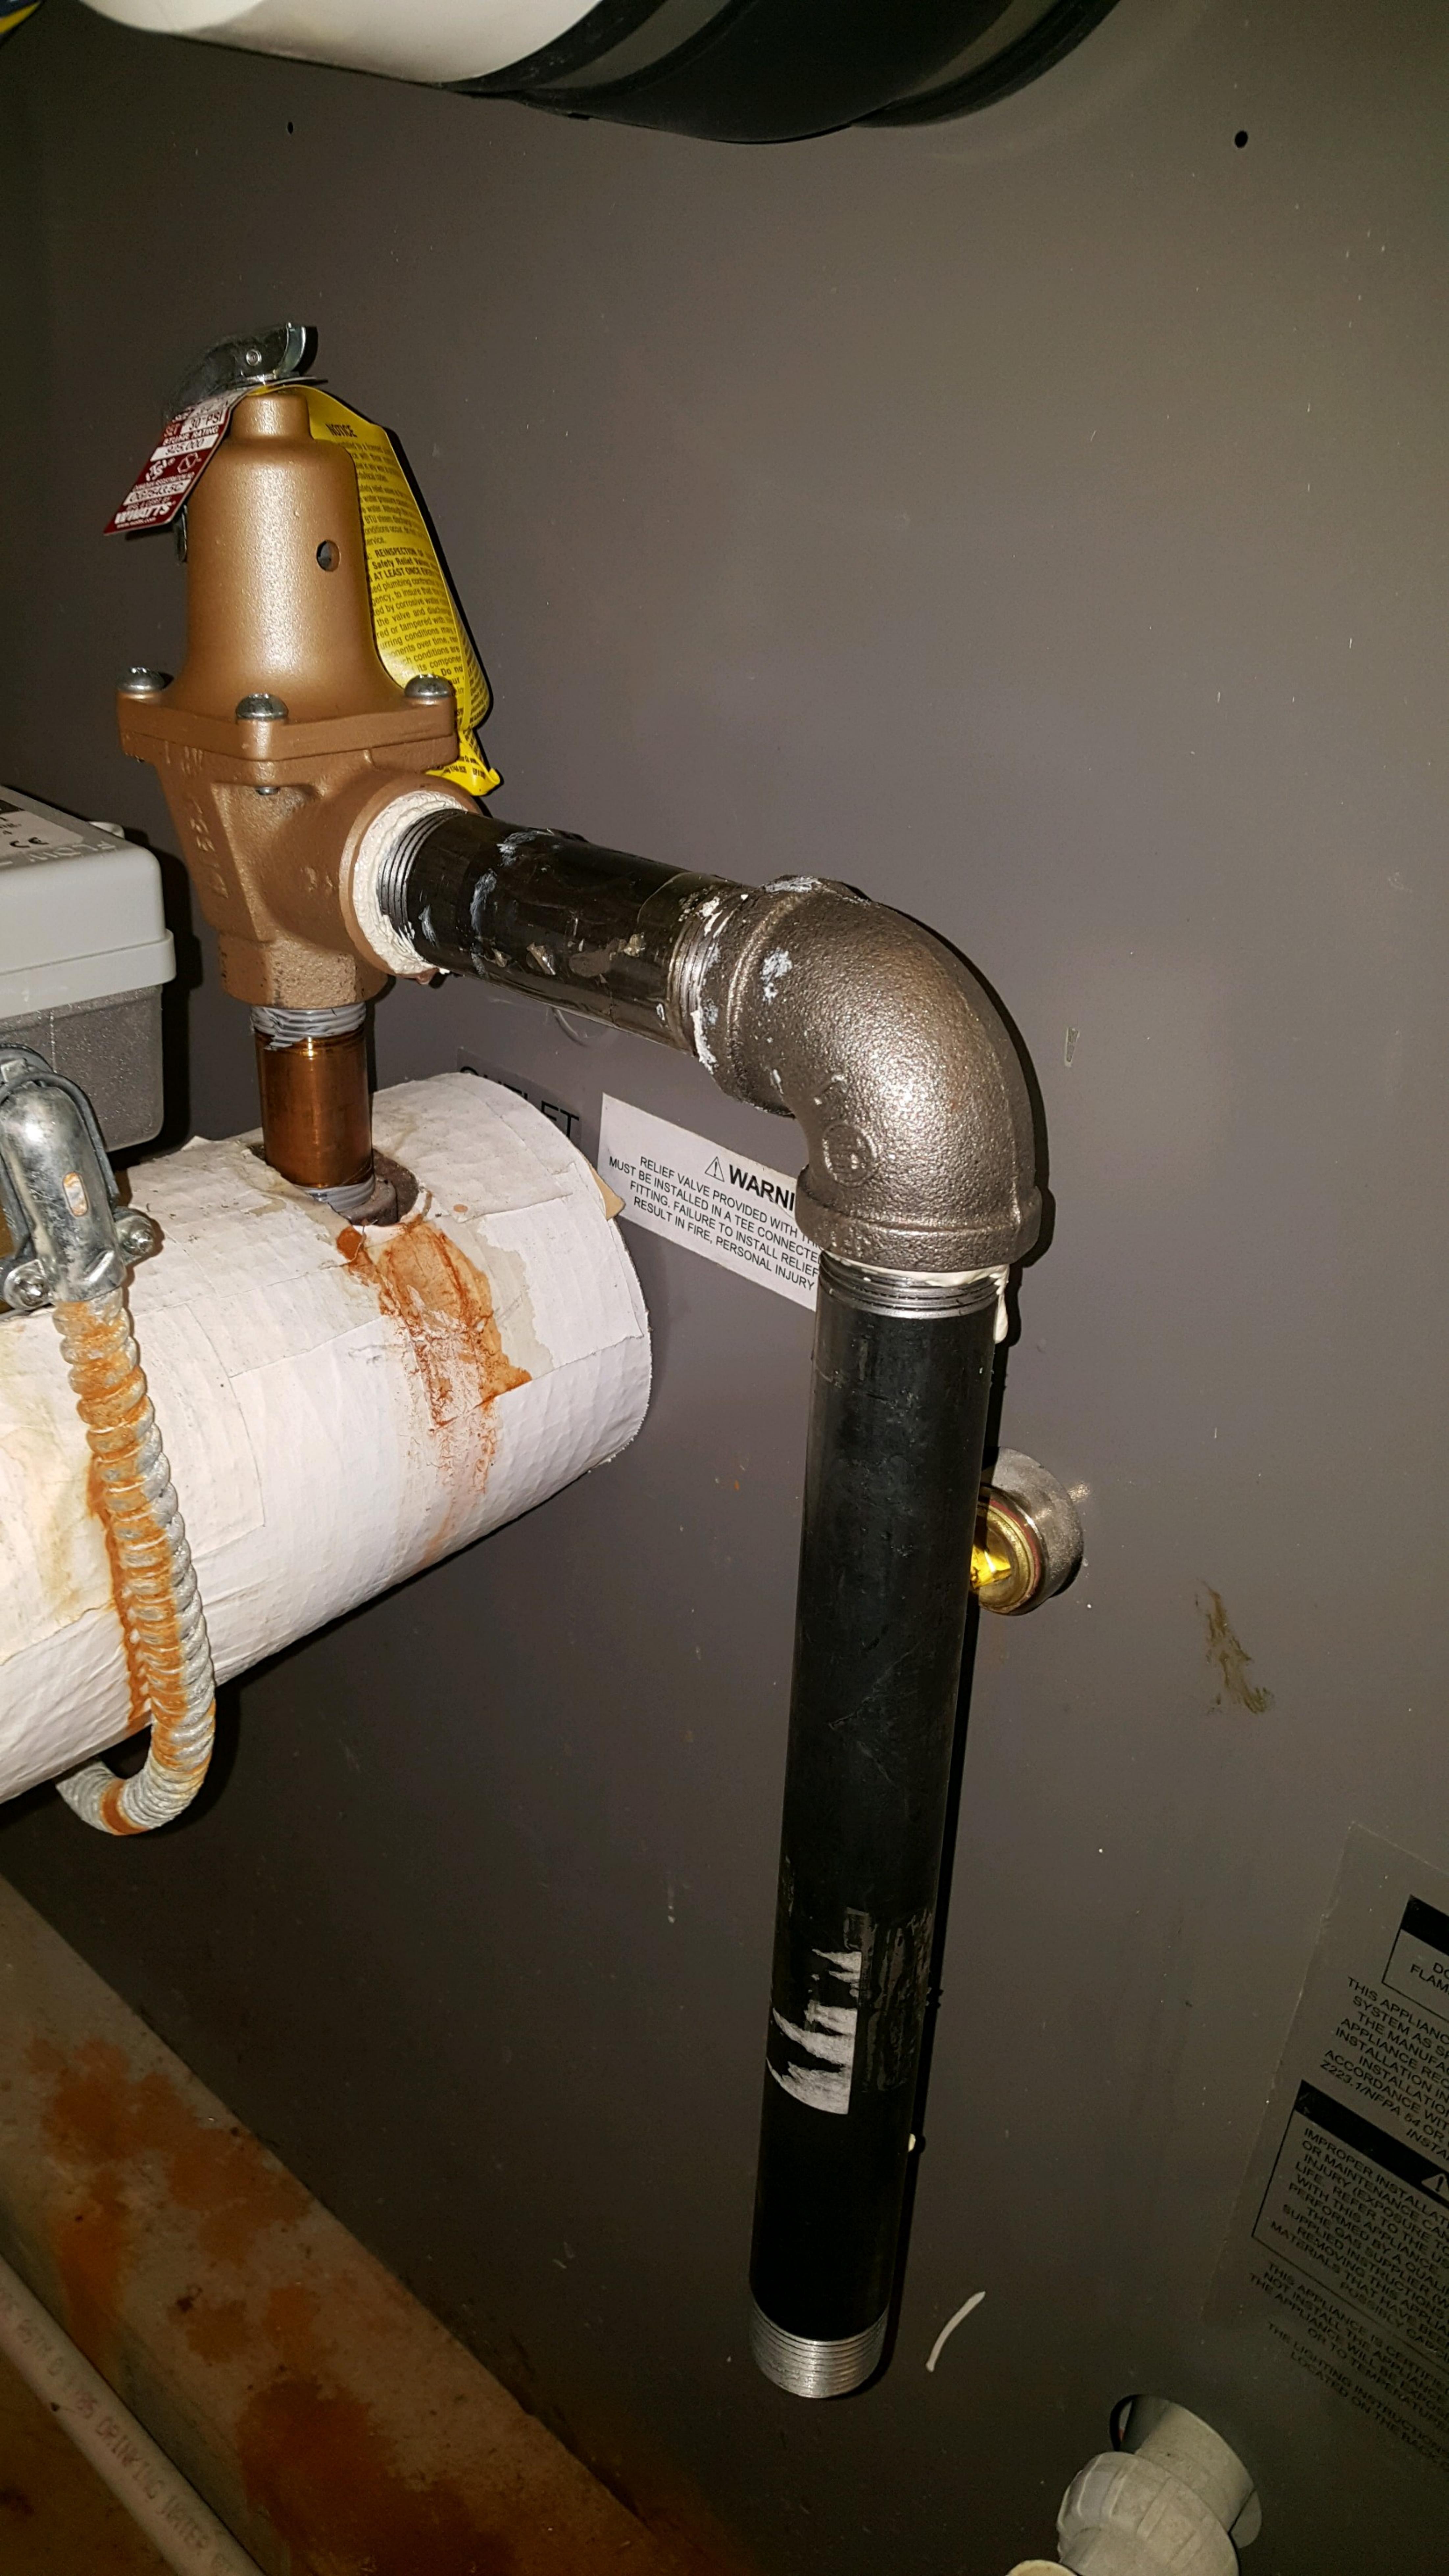
<b>MD002</b>	<b>CSS# 16335 WO# 6469 Asset# 1801</b>																			
Description of Repairs	Labor and materials to bring safety relief valve outlet up to code. Code violation was found during annual boiler inspection.																			
Diagnosis: Initial Work Order	ASME BPVC HG-701.6 (a) requires discharge piping the same size as the valve outlet. The outlet on the safety relief valve on this this boiler has been reduced for the discharge piping.																			
Diagnostic Fee	\$0																			
Additional Labor Cost to Perform Repairs	<p>\$ 400</p> <p>S&amp;S Labor \$100/hr x 3 Trip Charge \$100</p>																			
Additional Material Cost to Perform Repairs	<p>\$16.94</p>

RELIEF VALVE  
SIZE 3/4 IN  
SET 30 PSI  
BTU/H. RATING  
925,000  
CANADIAN REGISTRATION NO  
OG7543.5C  
WATTS

Item	Description	Qty	Rate	Amount
HVAC Labor	Pipe on relief valve is smaller than port: Assessed job and went to supply house to get material needed. Returned and removed smaller diameter relief pipe and replaced with same size of pipe as the relief port fitting. Work complete.	3	100.00	300.00
Materials	12"x1" Nipple	1	9.45	9.45
Materials	4"x1" Nipple	1	3.39	3.39
Materials	90	1	4.10	4.10
HVAC Travel		1	100.00	100.00
**Tax is included in total invoice amount**

1. found wrong size pipe leaving Relief Valve
2. picked up new like size material.
3. Replaced small pipe with correct size pipe of the relief valve.  
w/o 6468 / 16334 Boiler.
