Additional Funding Request

WORK ESTIMATE

Labor and materials to replace exterior wall pack light that was hit by vehicle.

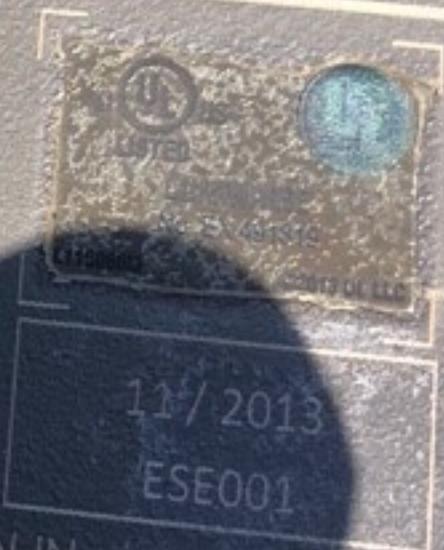
MODEL: FL2F28022 FILE: E340511
INPUT: 120-277V~ 50/60Hz, Max. 0.55A, 60W
THIS PRODUCT MUST BE INSTALLED IN ACCORDANCE
WITH THE APPLICABLE INSTALLATION CODE BY
A PERSON FAMILIAR WITH THE CONSTRUCTION AND
OPERATION OF THE PRODUCT AND THE HAZARDS
INVOLVED. CAUTION - RISK OF SHOCK. DISCONNECT
POWER BEFORE SERVICING. SUITABLE FOR OPERATION IN
AMBIENT NOT EXCEEDING 40°C. SUITABLE FOR WET LOCATION
