Original Description: Repair to small roof leak in the fire panel room of building 0314.

Tidewater
700 E Ordnance Rd.
Curtis Bay MD 21226
CSS 19330 WO 9000 MD002
Tina Lee

ROOFING INSPECTION REPORT

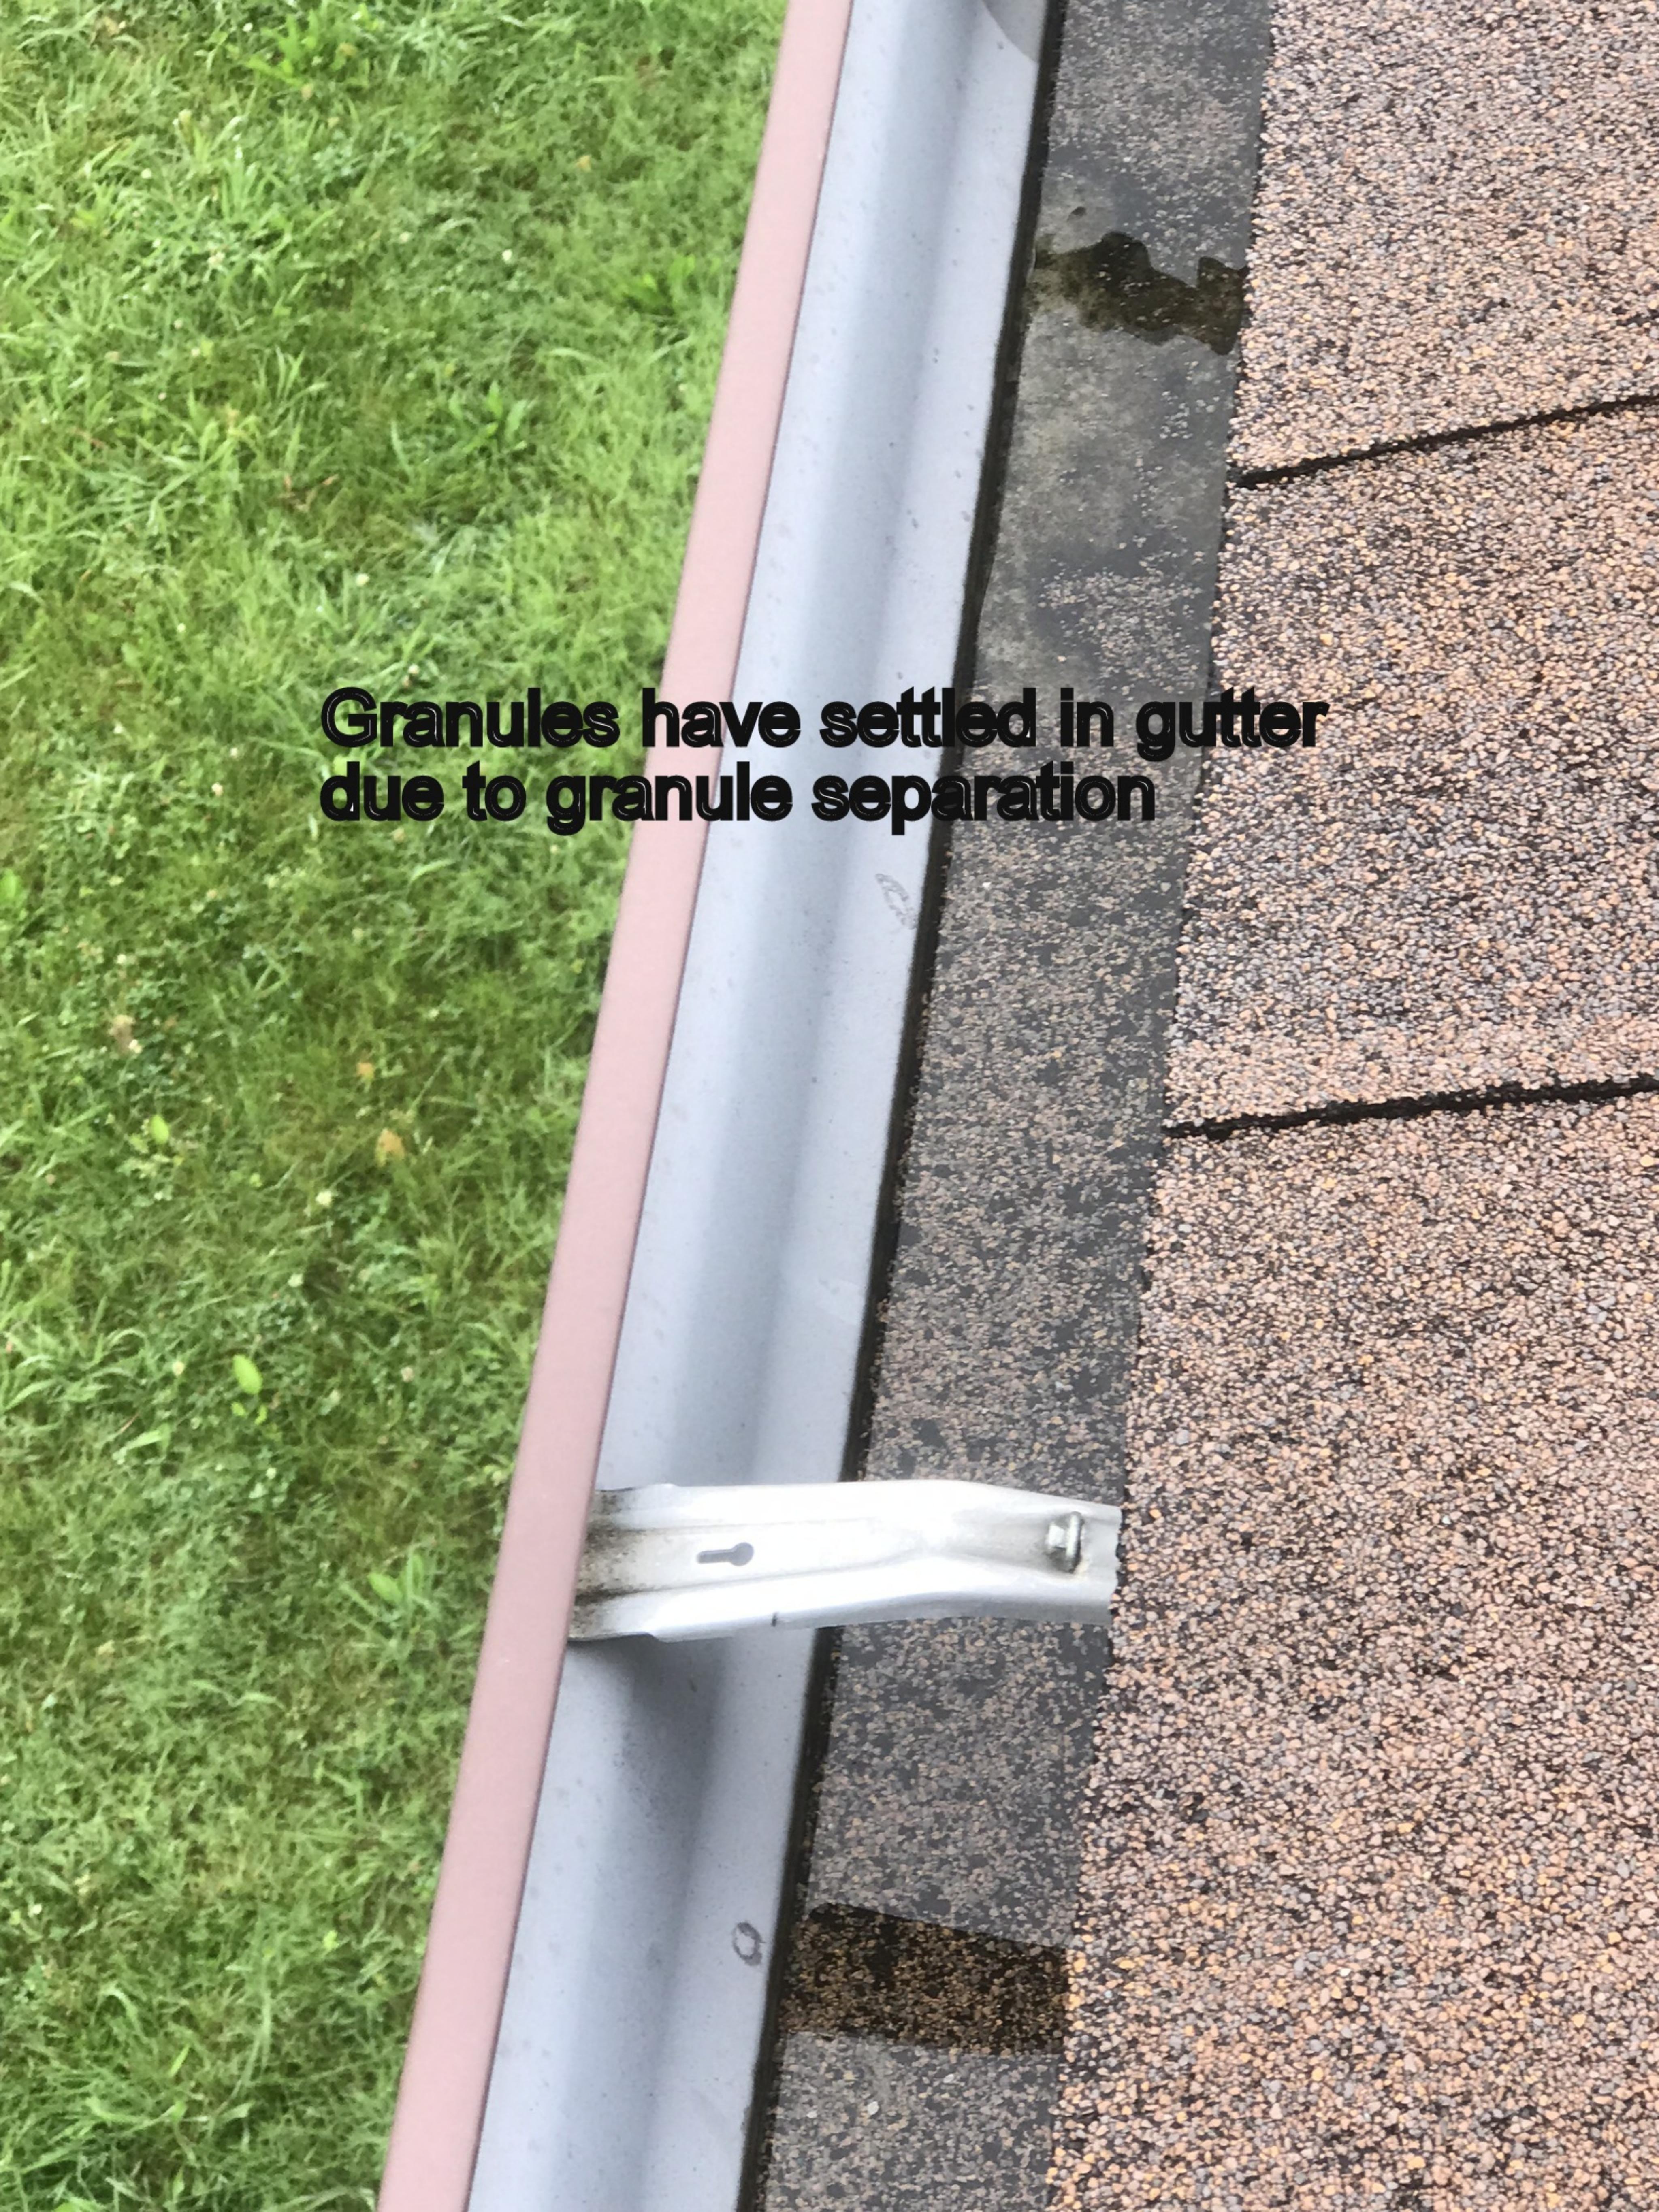
1. There is a large amount of granule separation of shingles due to age of roof.
2. Shingle layout is wrong; there are numerous areas where there is less than 3 1/2 inches between tabs which are areas where water penetrated as tested through nails, commonly called soaked nails.
3. Due to water penetration the seals on shingles have failed throughout roof.
4. There is a quarter inch between shingles throughout roof, so shingles are not abutted properly, allowing water to penetrate and causing seal to fail.
5. After inspection of roof, due to the obvious lack of proper roofing procedures, we cannot repair roof and highly recommend a complete tear off and new roof.

**Granules have settled in gutter
due to granule separation**

A visual hand on external inspection finds the following reasons why we cannot repair the roof and why we highly recommend the entire replacement of the roof.

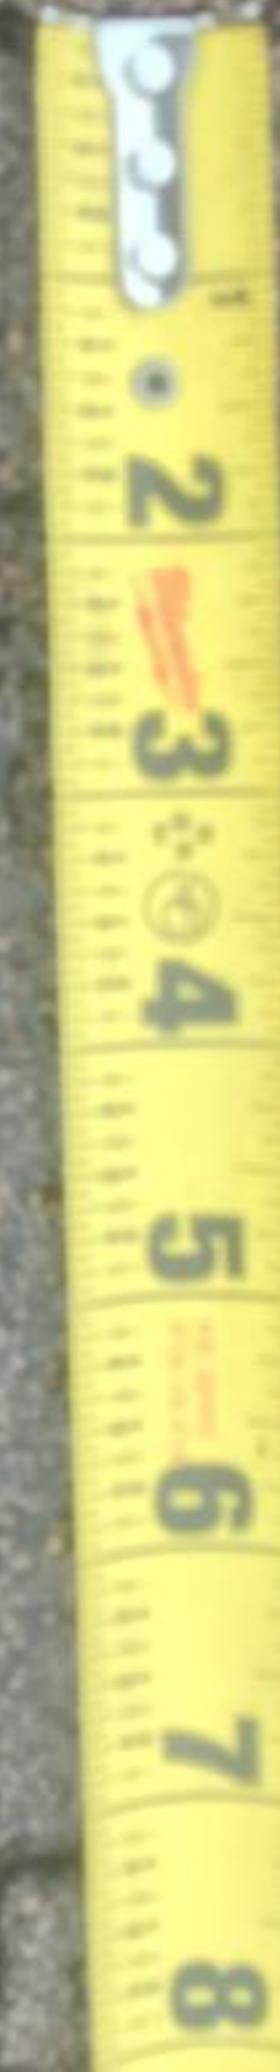
There should be at least 5 1/2 inches between tabs

Seal has failed due to water penetration

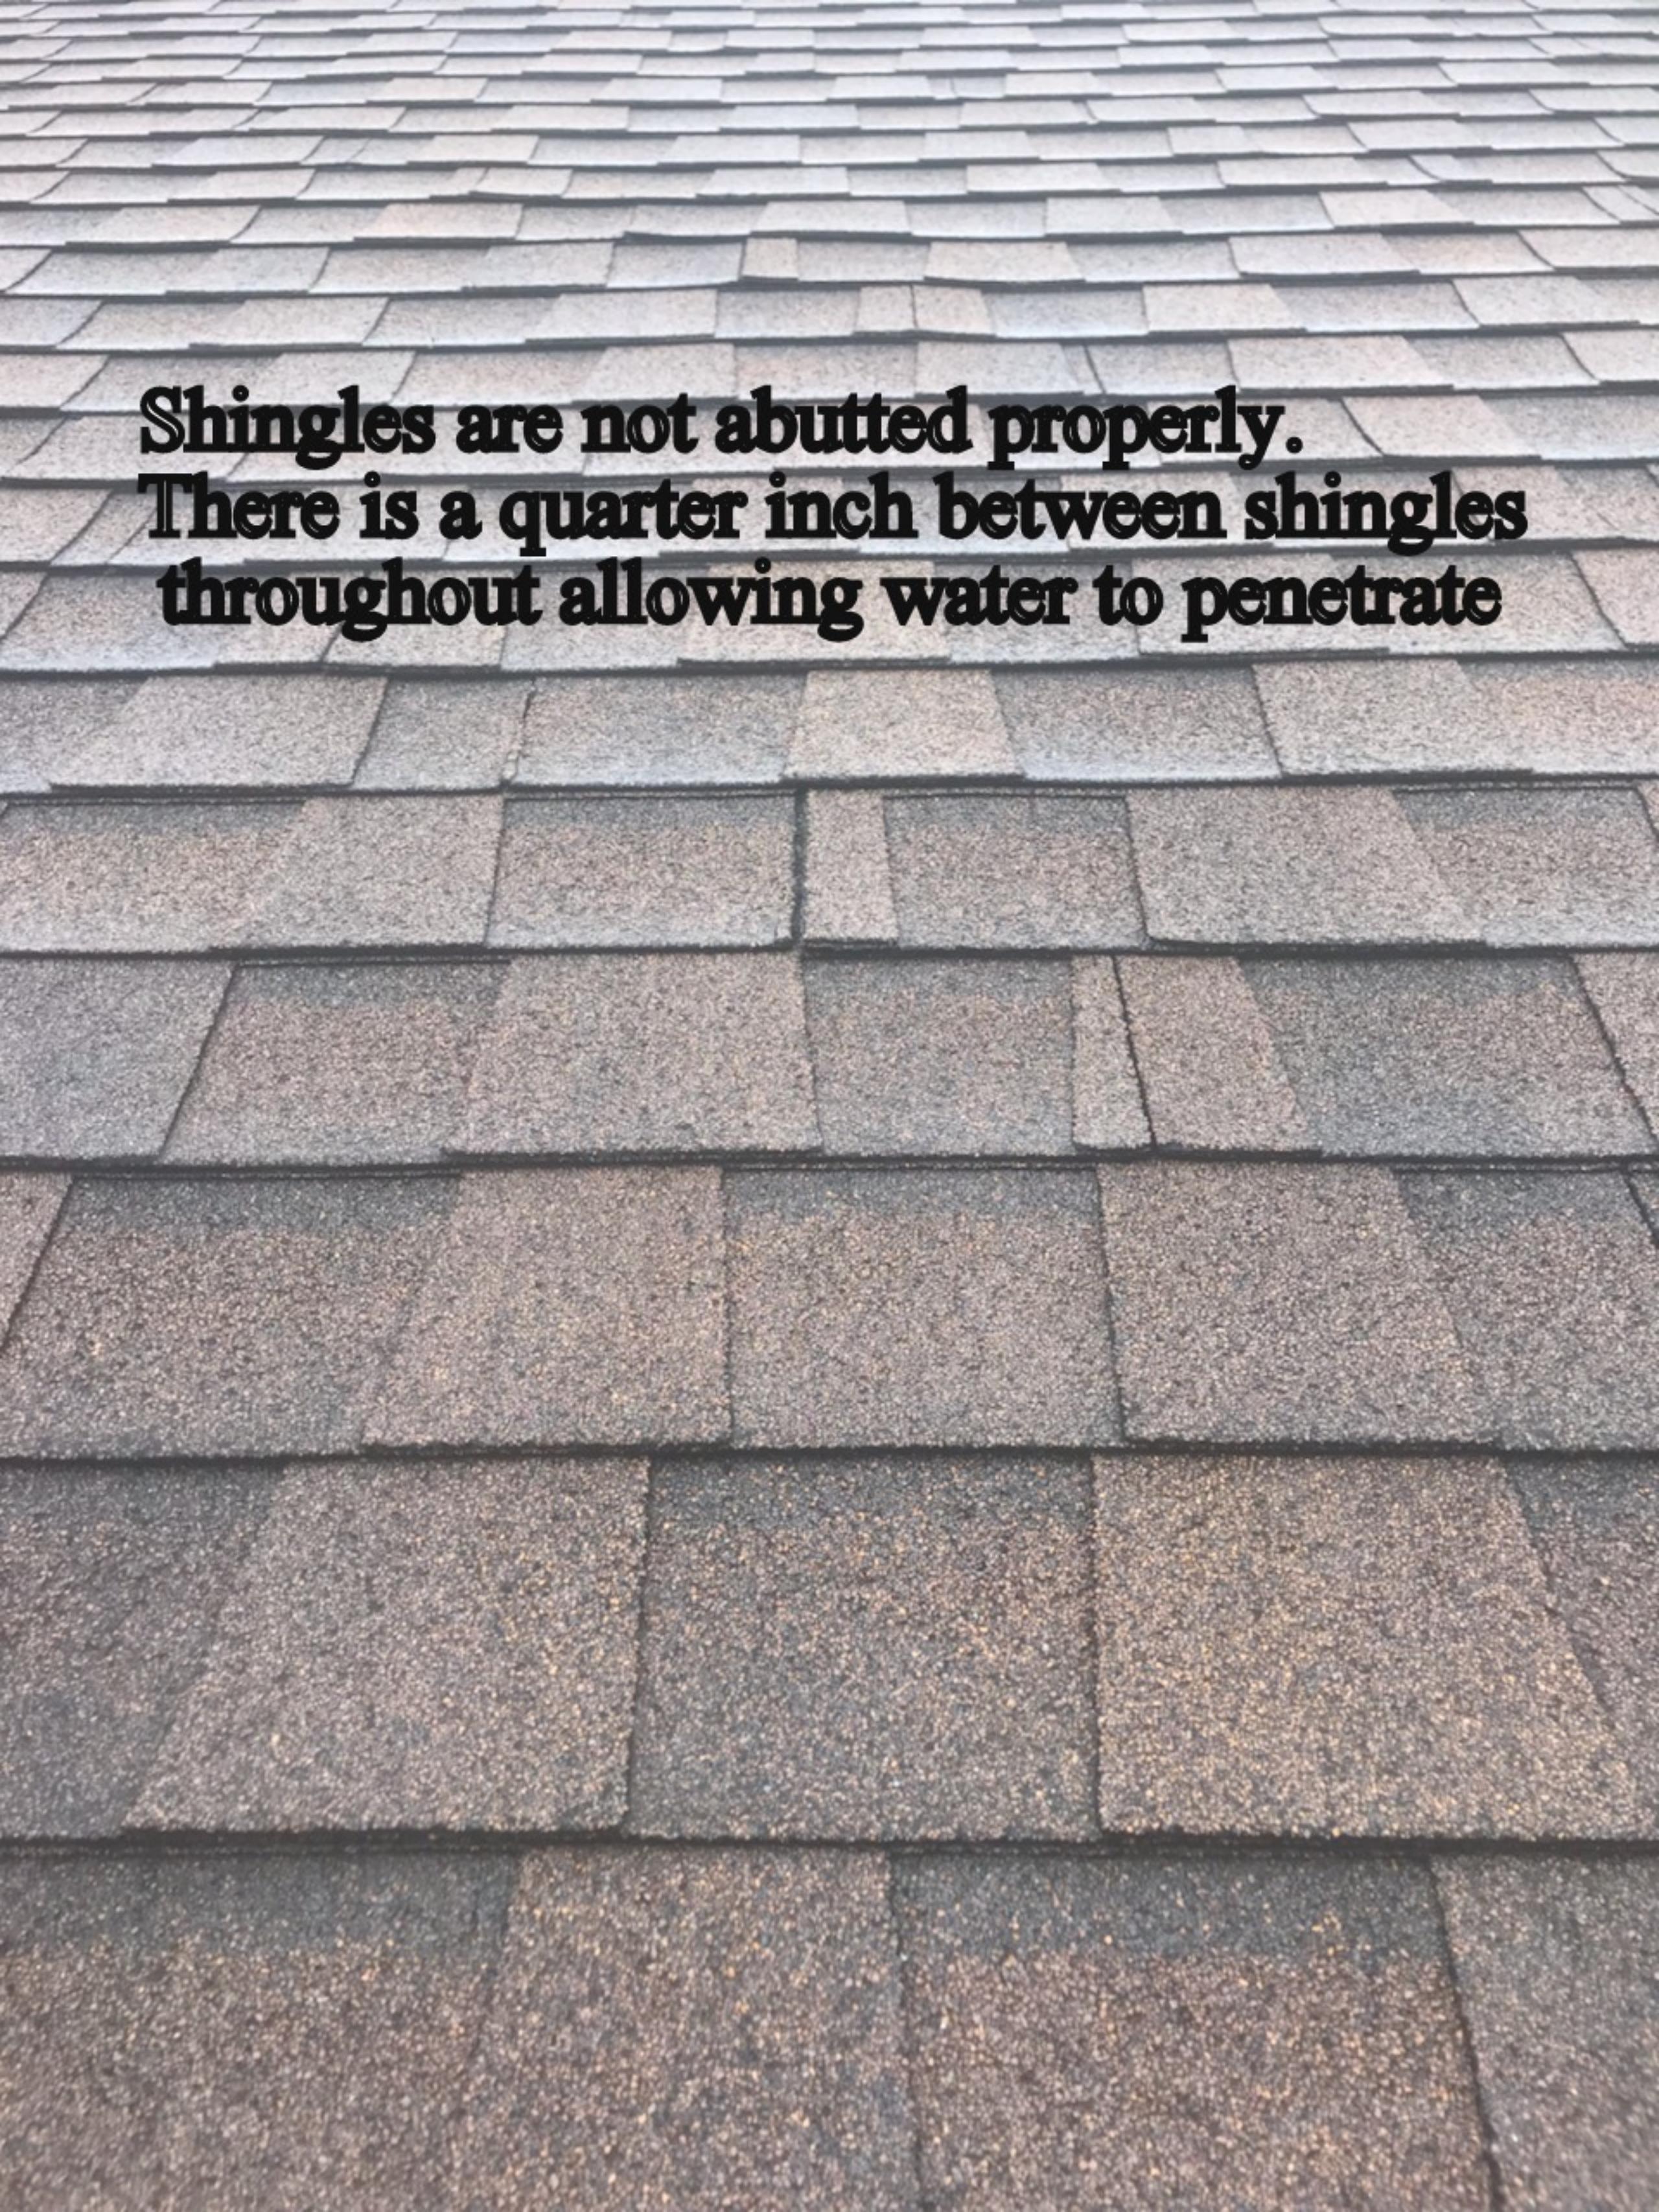
**Shingles are not abutted properly.
There is a quarter inch between shingles
throughout allowing water to penetrate**
