**Location:** MD002

**CSS #:** 19330

**Original Description:** Repair to small leak in the fire panel room of building 0314.

**ROOFING INSPECTION REPORT**

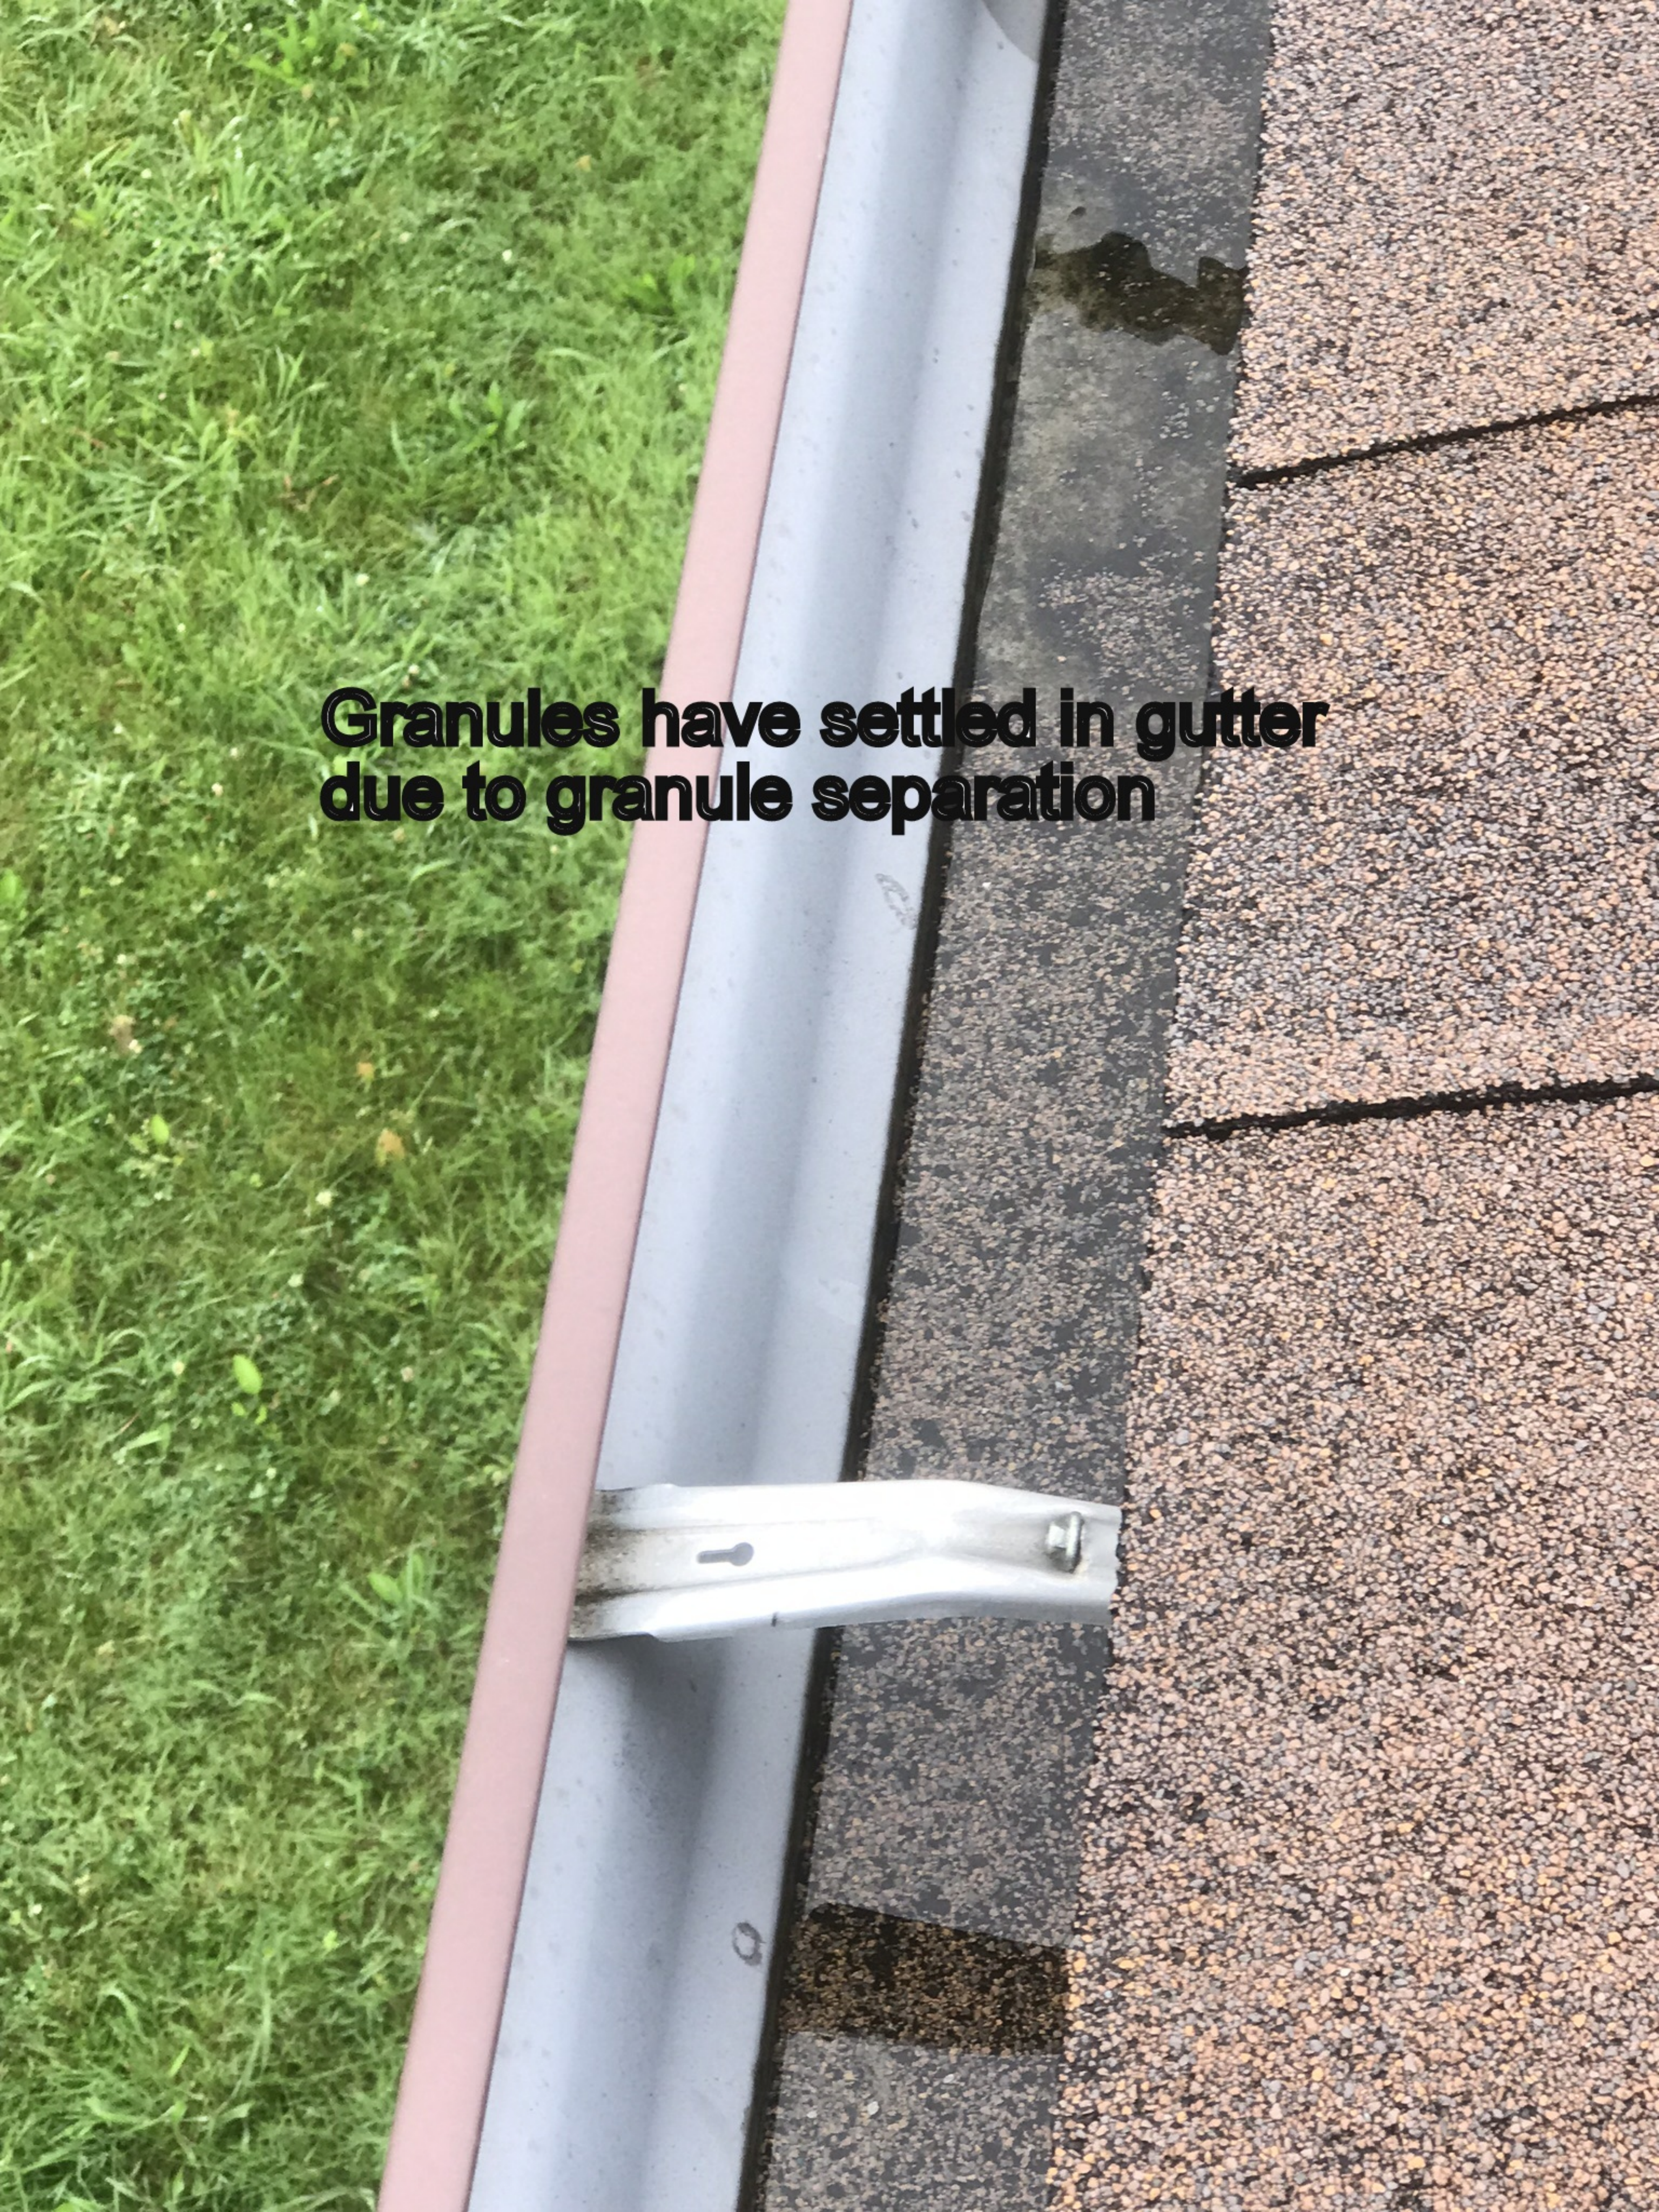
1. There is a large amount of granule separation of shingles due to age of roof.
2. Shingle layout is wrong; there are numerous areas where there is less than 3 ½ inches between tabs which are areas where water penetrated as tested through nails, commonly called soaked nails.
3. Due to water penetration the seals on shingles have failed throughout roof.
4. There is a quarter inch between shingles throughout roof, so shingles are not abutted properly, allowing water to penetrate and causing seal to fail
5. After inspection of roof, due to the obvious lack of proper roofing procedures, we cannot repair roof and highly recommend a complete tear off and new roof.

**Granules have settled in gutter  
due to granule separation**

A visual hand on external inspection finds the following reasons why we cannot repair the roof and why we highly recommend the entire replacement of the roof.

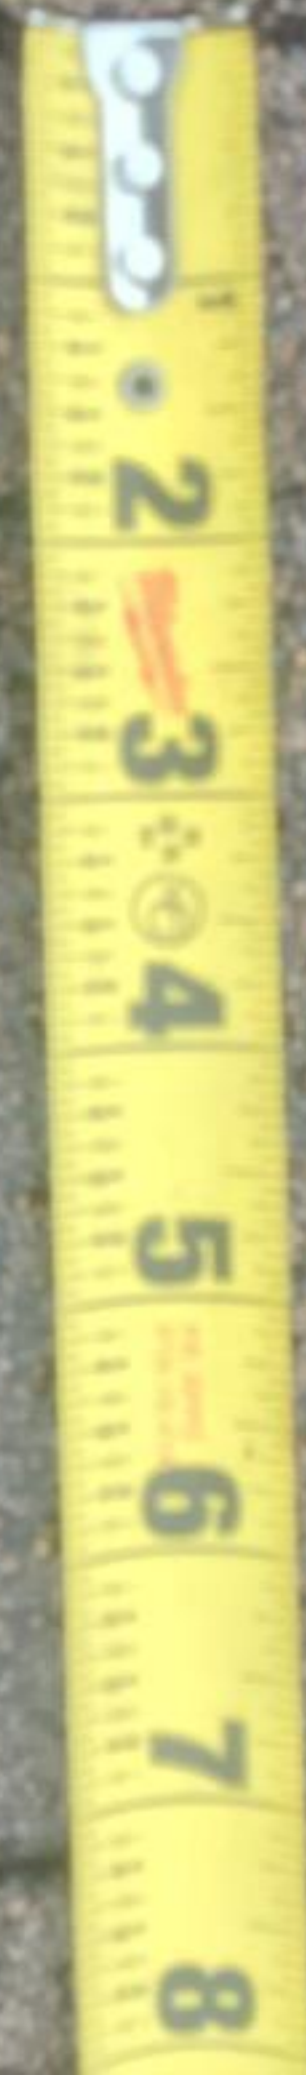
**There should be at least 5 1/2 inches between tabs**

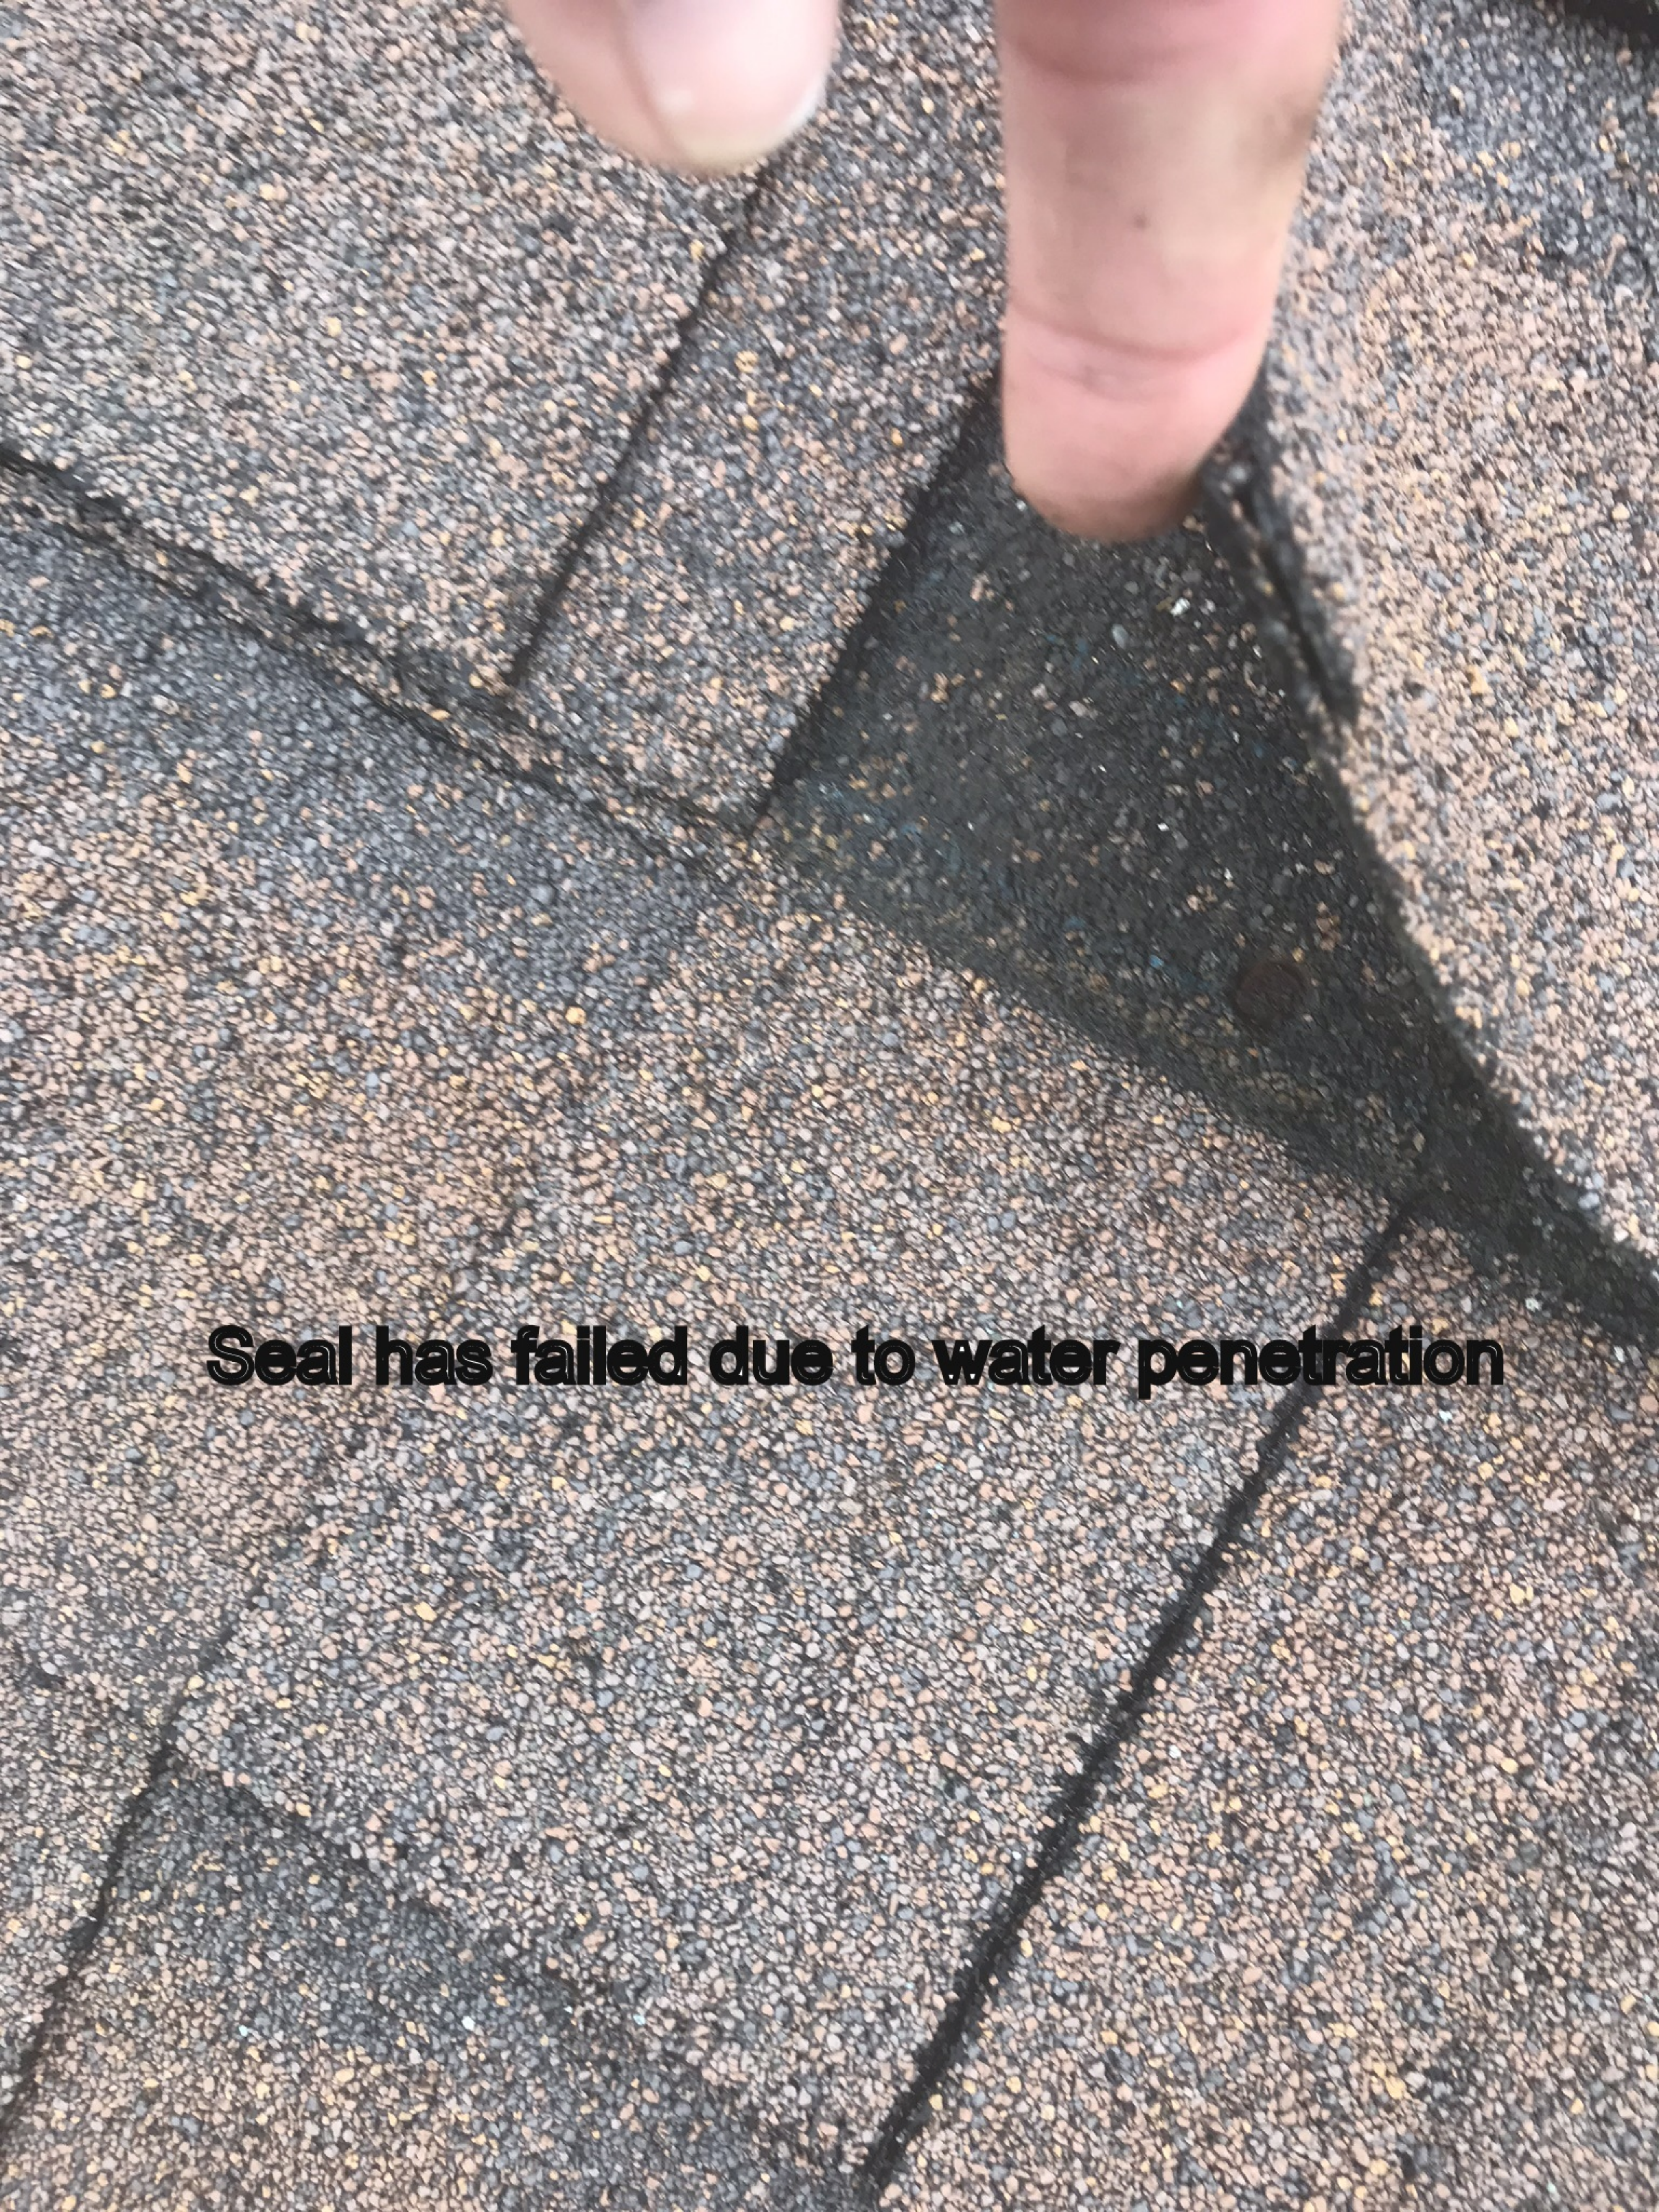
There should be at least 5 1/2 inches  
between tabs

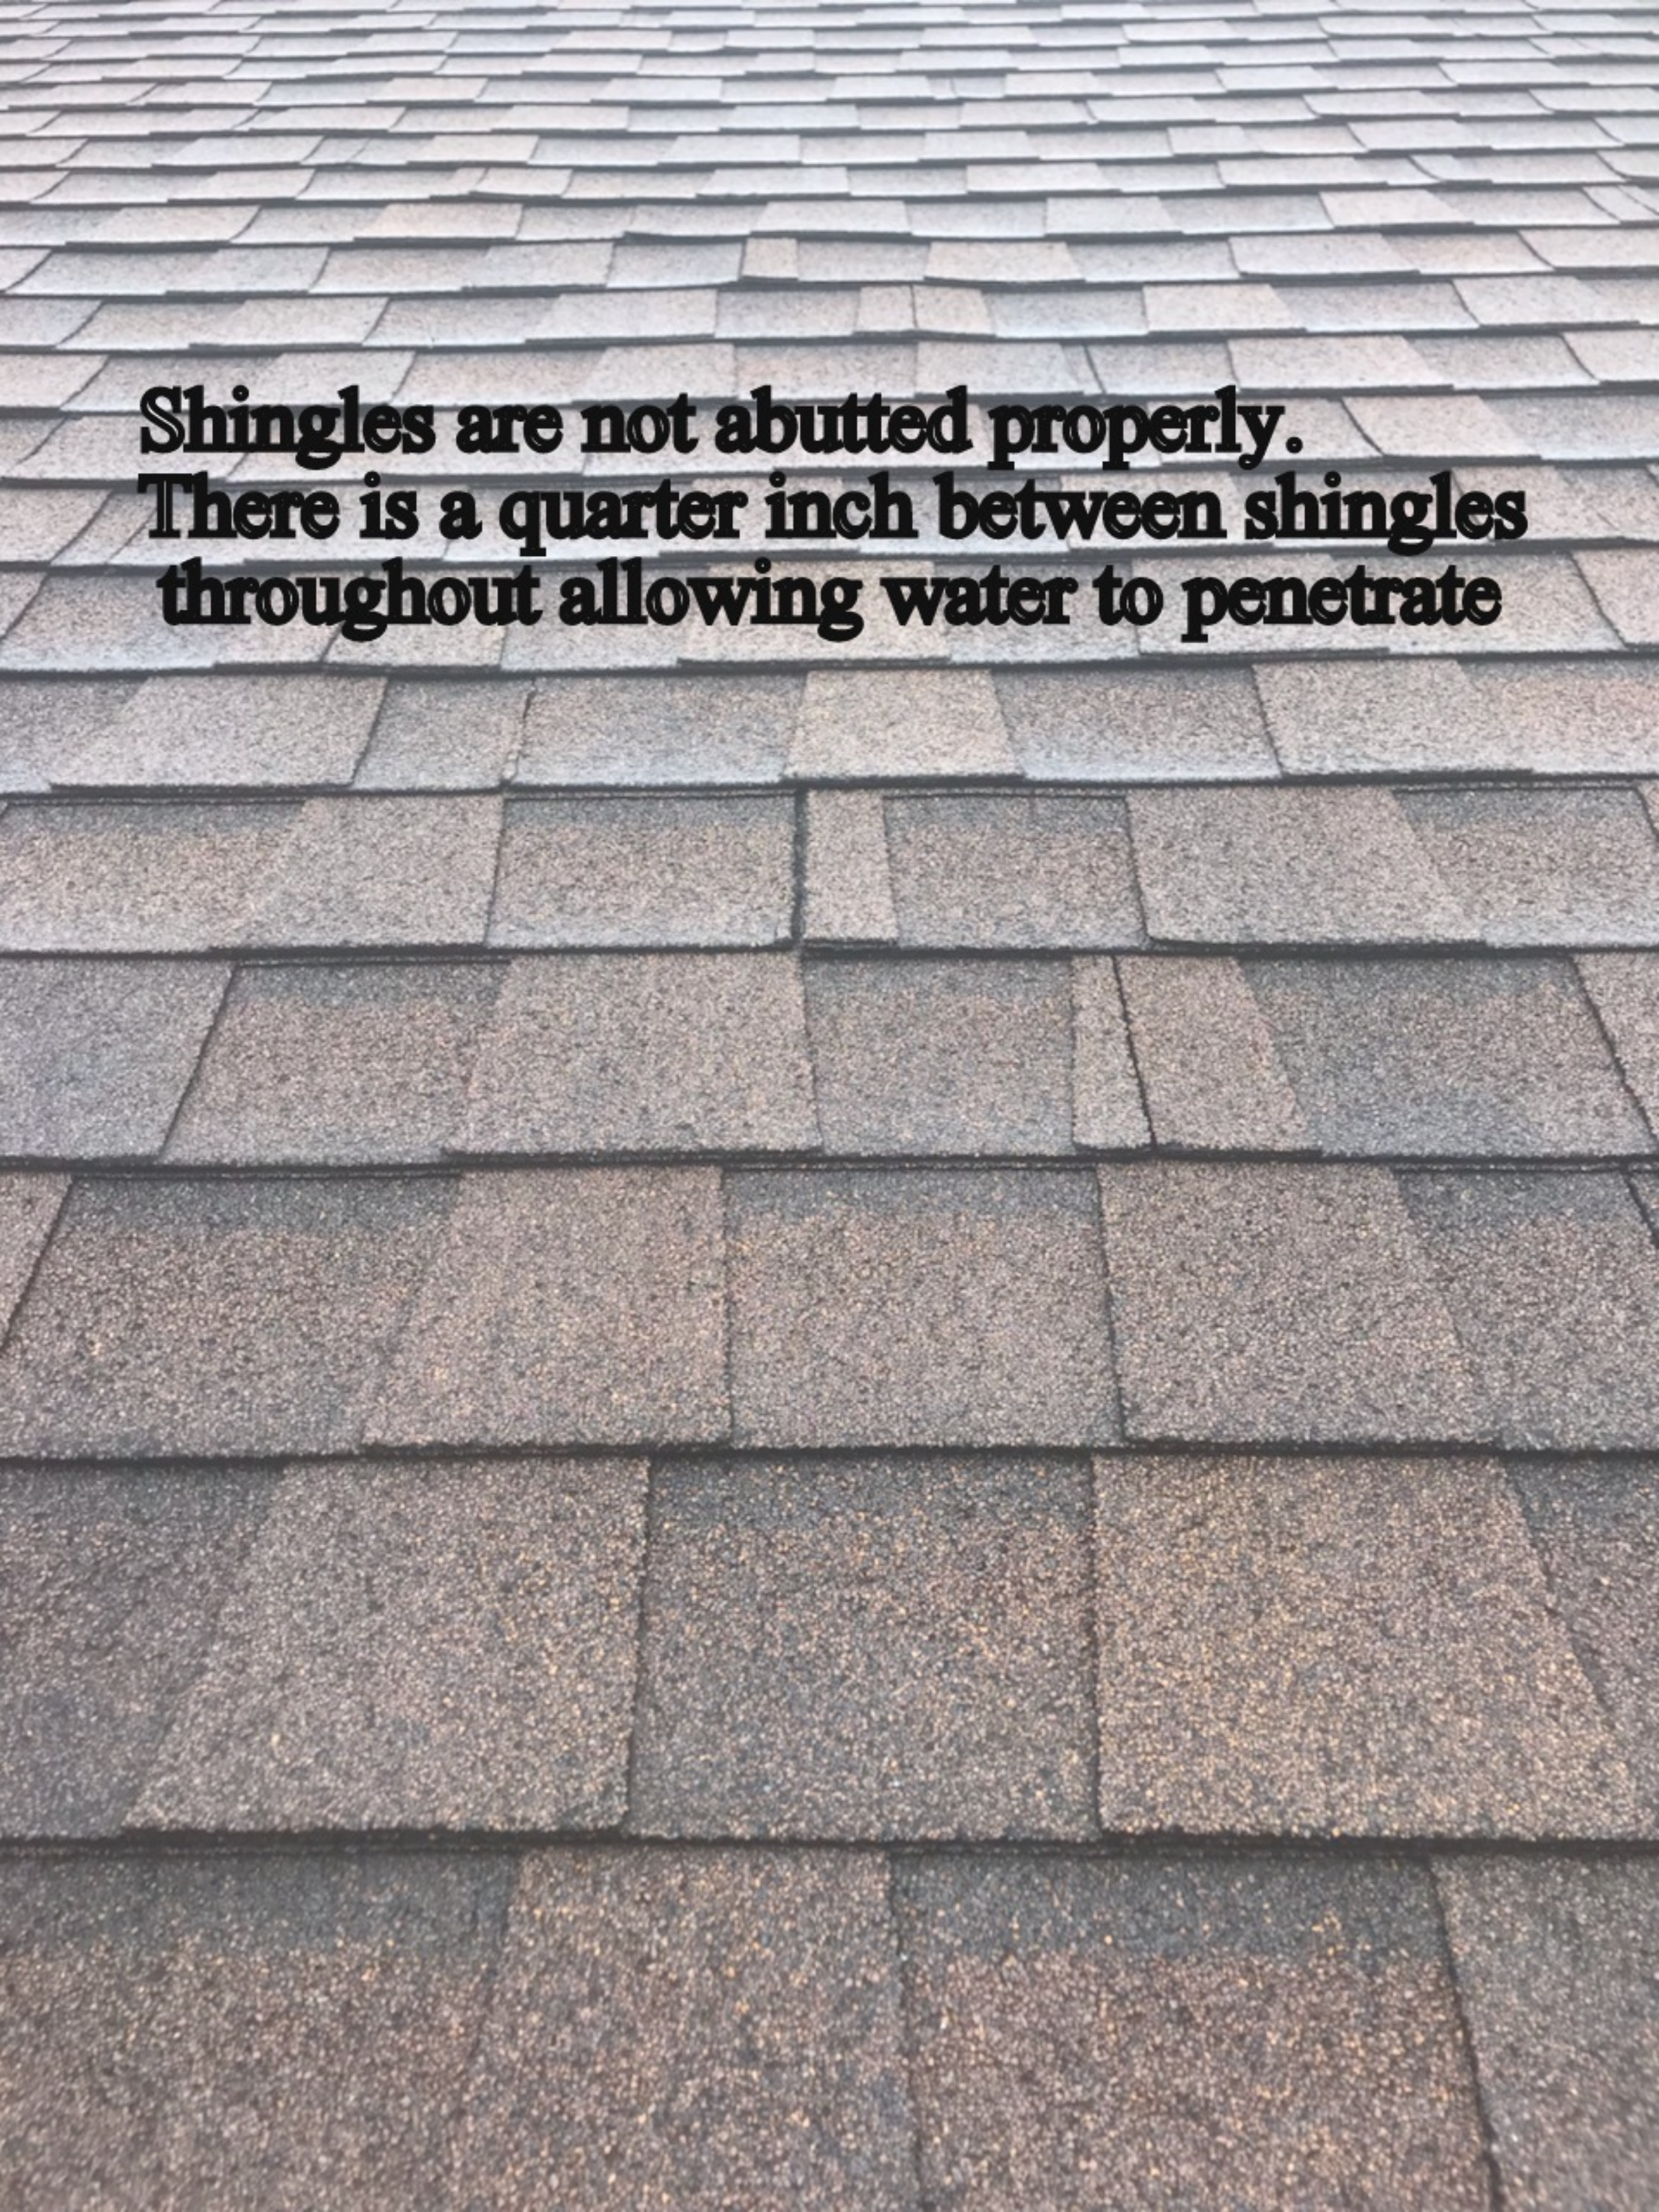
**Seal has failed due to water penetration**
