Additional Funding Request

VA006	CSS# 23672 WO# 11748 Asset# NA				
Description of Repairs	Labor and materials to repair leaking hot water supply pump. Shut down boilers, shut off water, drain water from boilers and pump. Remove booster pump, clean and install new gaskets/seals. Re assemble and open water valve to test for leaks. Return system to full ops, and check for leaks again, when seals are under pressure.				
Diagnosis: Initial Work Order	The hot water heating system is losing water and locking out the boilers				
Diagnostic Fee	\$240				
Additional Labor Cost to Perform Repairs	\$480 TW Labor 6 hours @ \$ 80				
Additional Material Cost to Perform Repairs	\$29.30				
	Flange Gasket 4DZP2	1	\$29.30		\$29.30
Total Cost of Repair	\$829.30

WORK ESTIMATE

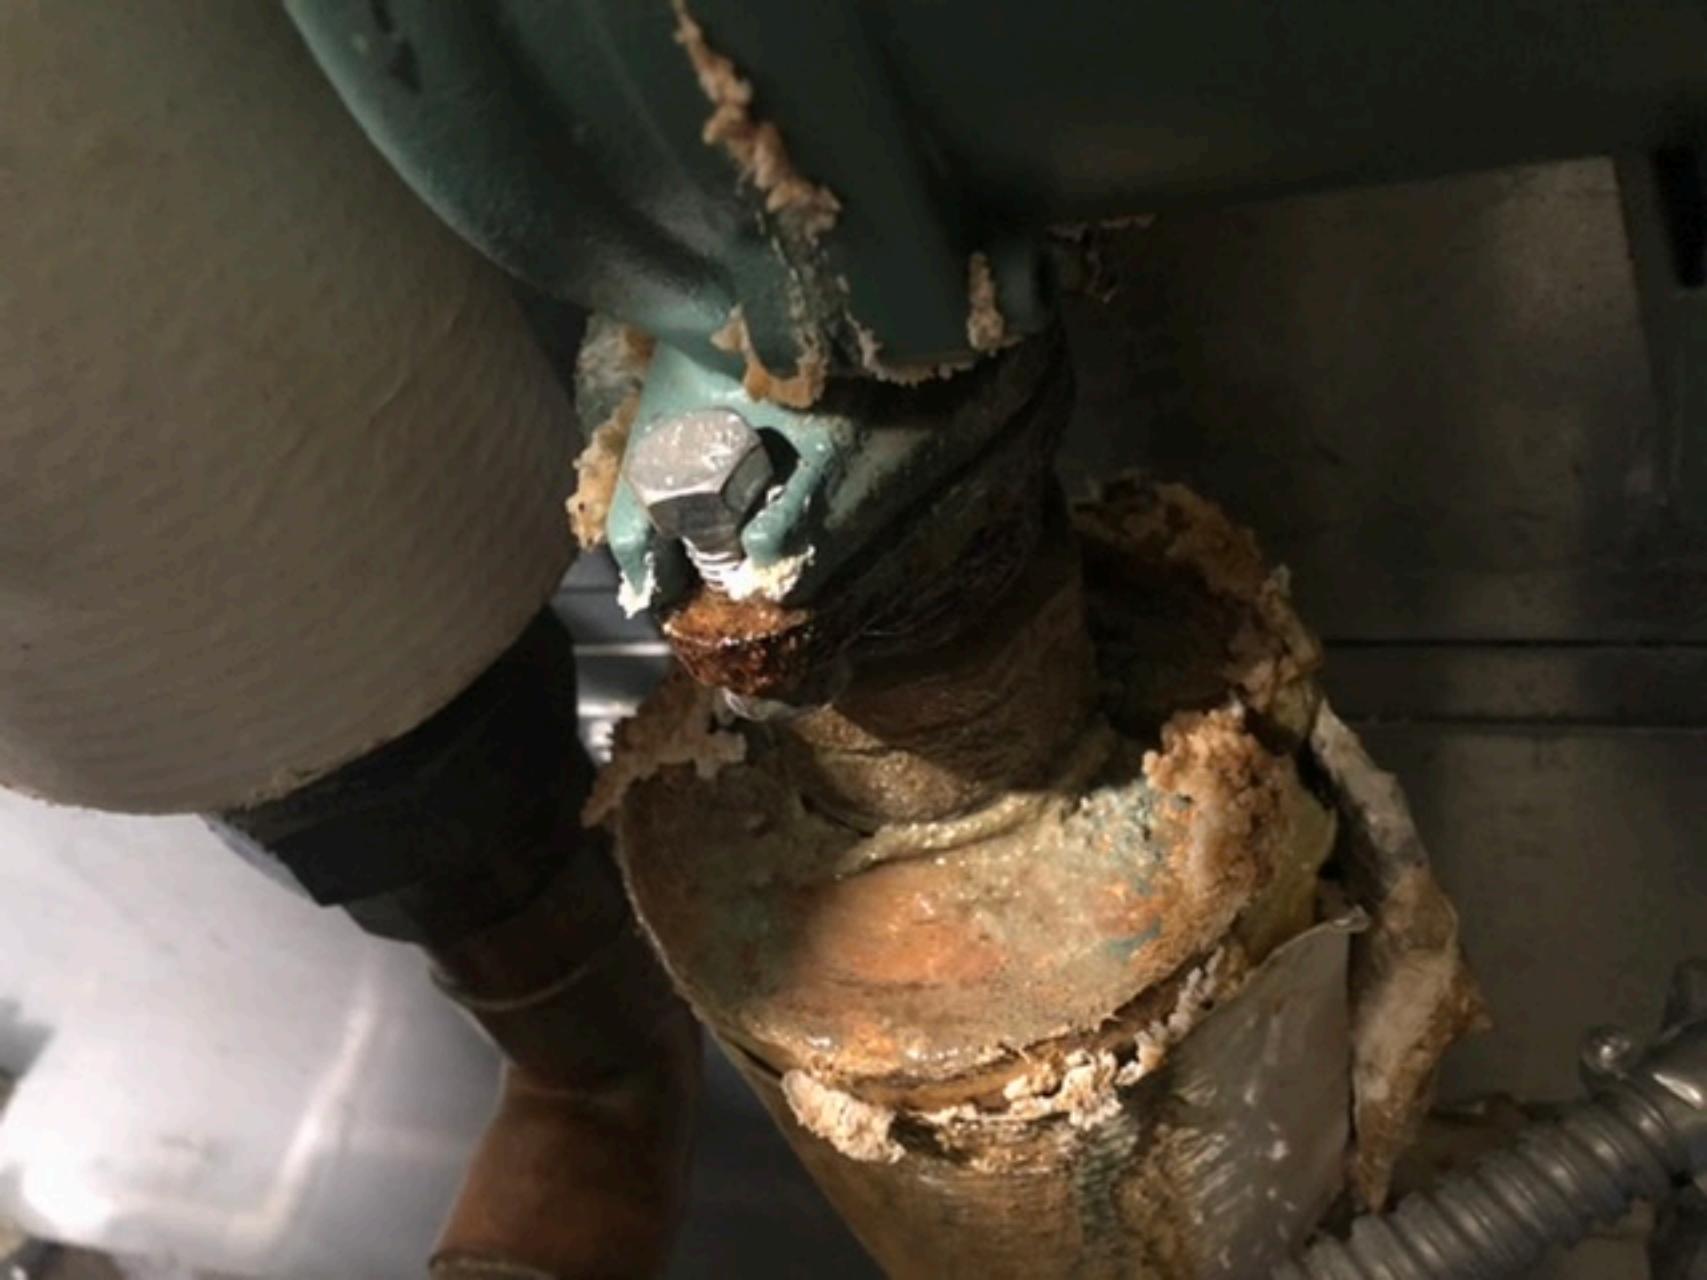
Labor and materials to repair leaking hot water supply pump. Shut down boilers, shut off water, drain water from boilers and pump. Remove booster pump, clean and install new gaskets/seals. Re assemble and open water valve to test for leaks. Return system to full ops, and check for leaks again, when seals are under pressure.
