Additional Funding Request

VA049	CSS# 23919 WO# 11785 Asset# NA				
Description of Repairs	Labor and Materials to disassemble, clean flange, replace gaskets, and re assemble leaking pump.				
Diagnosis: Initial Work Order	Water pump in mechanical room is leaking. Slow steady leak. Forming puddle on floor				
Diagnostic Fee	\$240				
Additional Labor Cost to Perform Repairs	\$480 TW Labor 6 hours @ \$ 80				
Additional Material Cost to Perform Repairs	\$199.21				
	Rebuild Seal kit Bell and Gossett - 6HKZ3 (includes tax)	1	\$199.21		\$199.21
Total Cost of Repair	\$919.21

WORK ESTIMATE

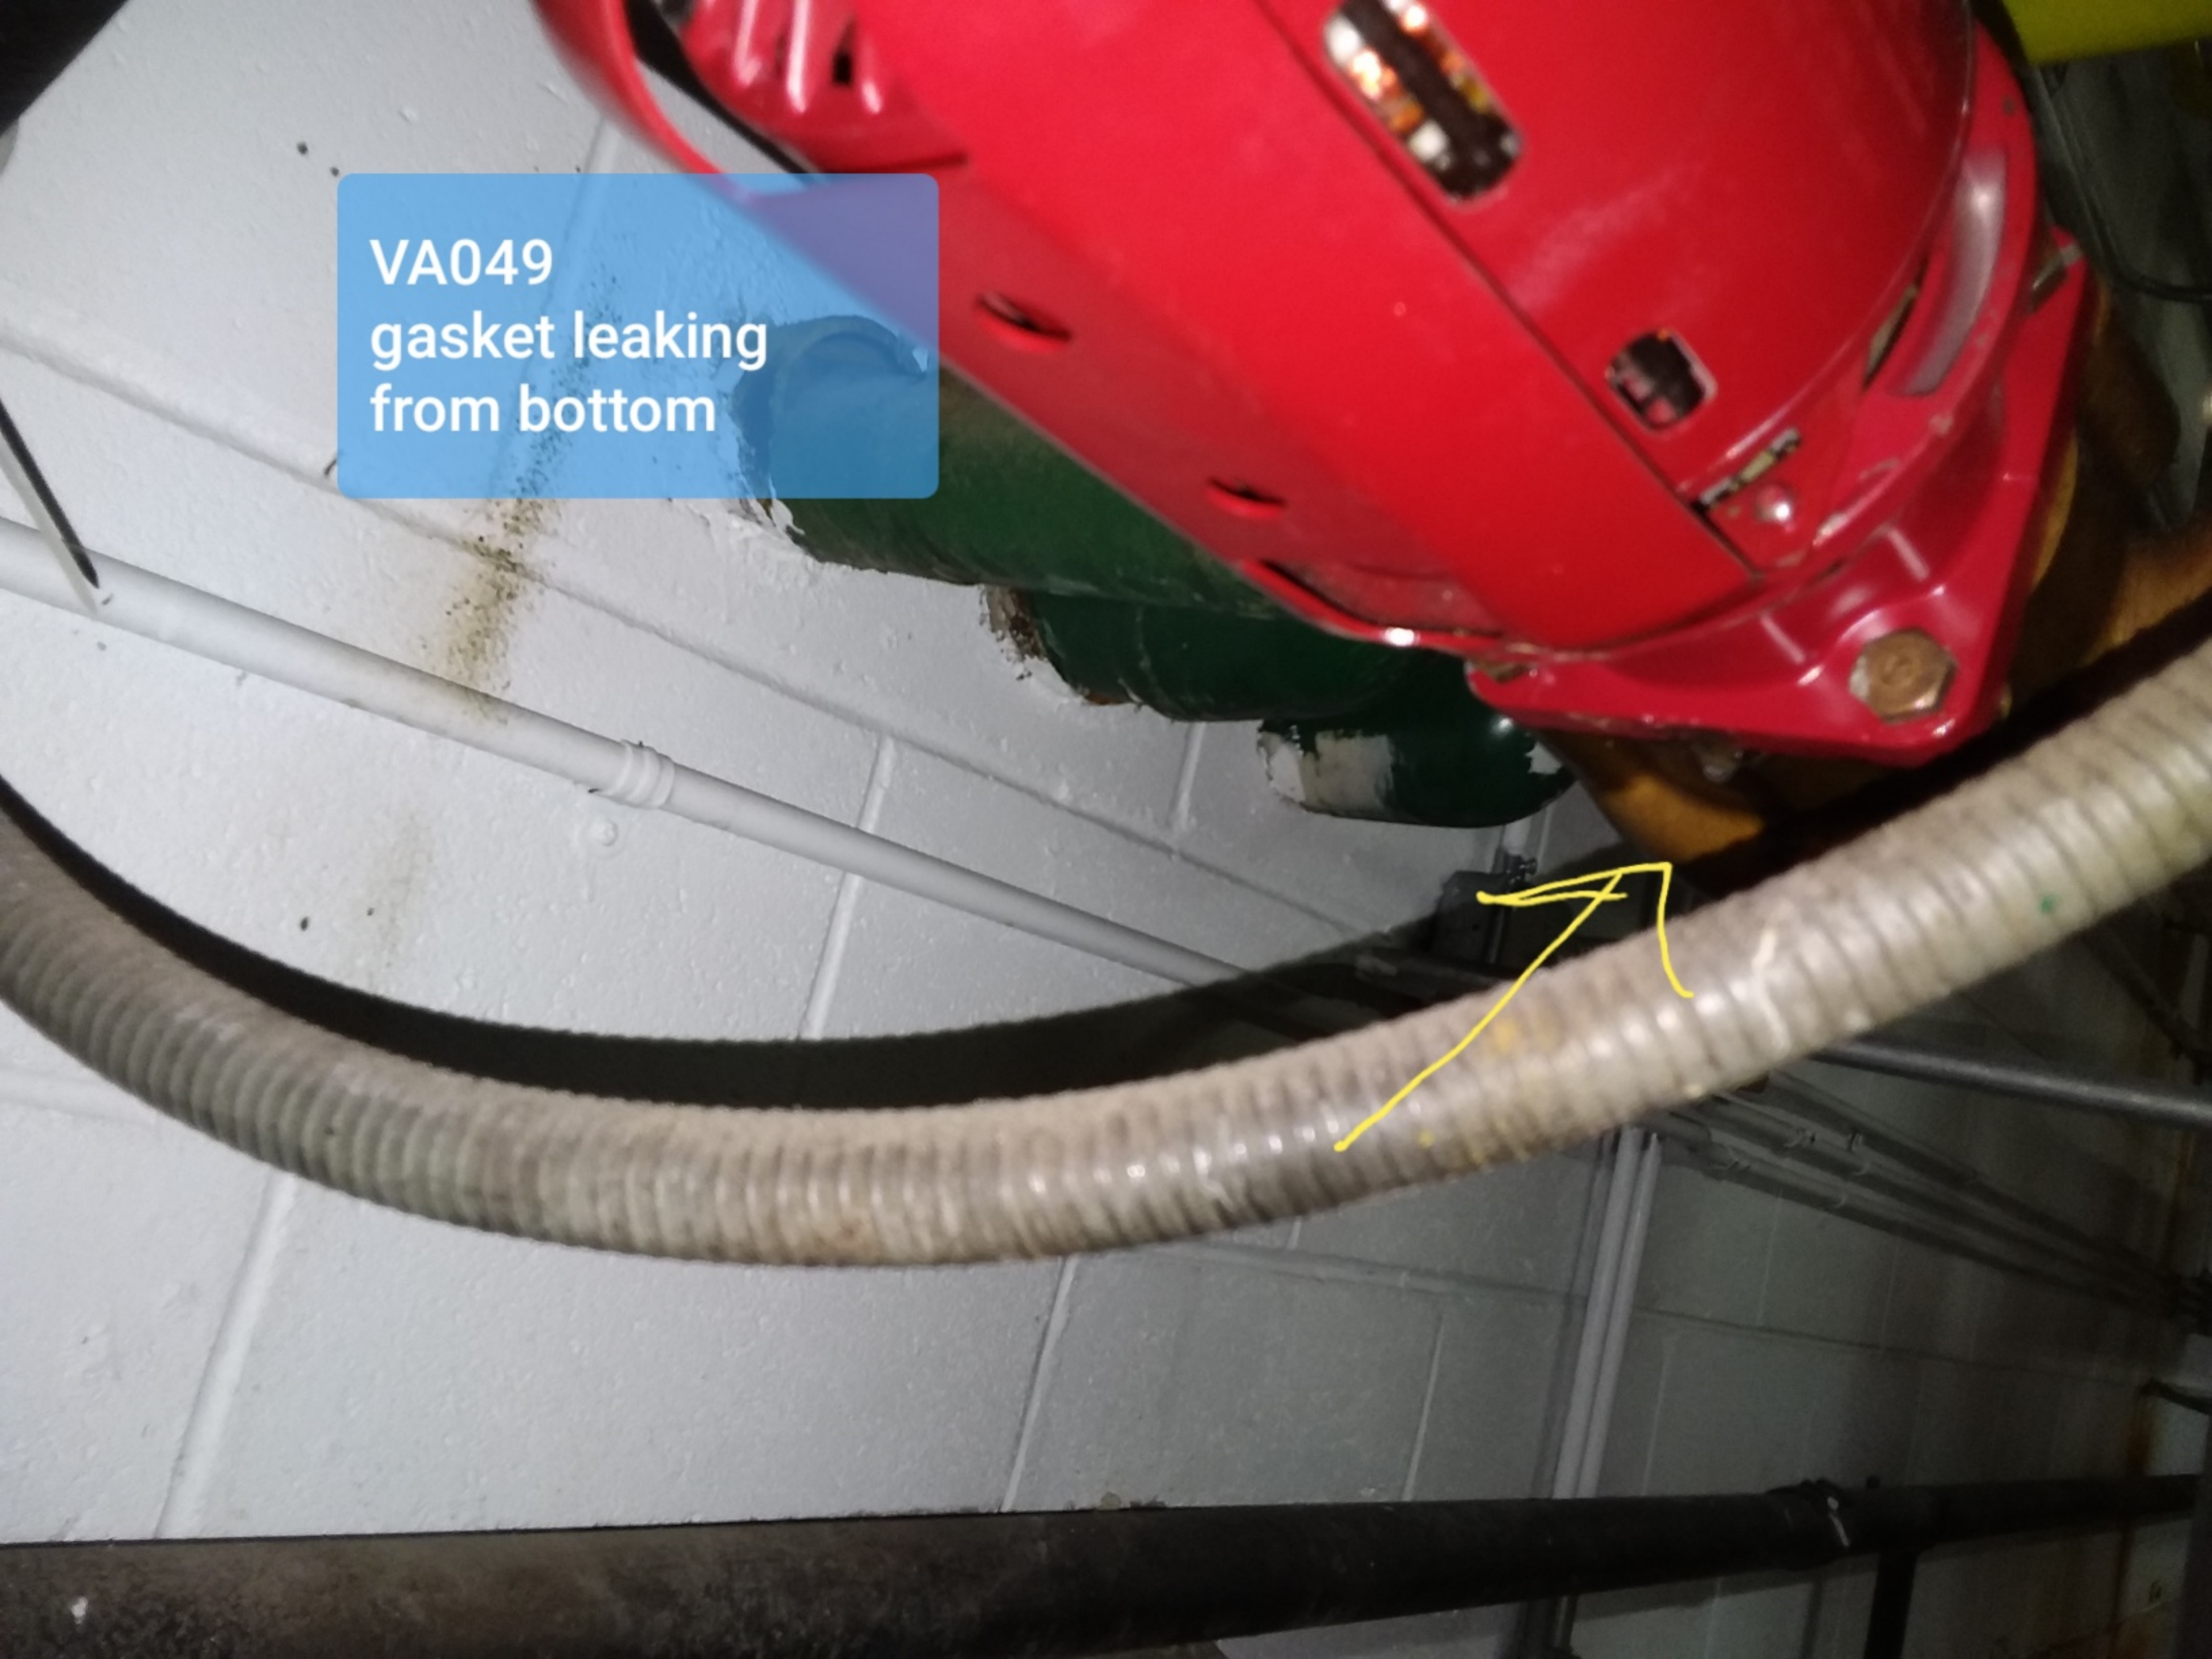
VA049
gasket leaking
from bottom

Labor and Materials to disassemble, clean flange, replace gaskets, and re assemble leaking pump.
