Additional Funding Request

WORK ESTIMATE

Company Name:	Tidewater, Inc.	Facility ID:	VA049
Contractor POC:	Adam Colopy		
Telephone No:	740-819-6207	Building/Location; (e.g., Classroom/Room #)	Mech Room
E-Mail Address:	adam.colopy@tideh2o.net		
Assigned Technician(s):	Richard Walker

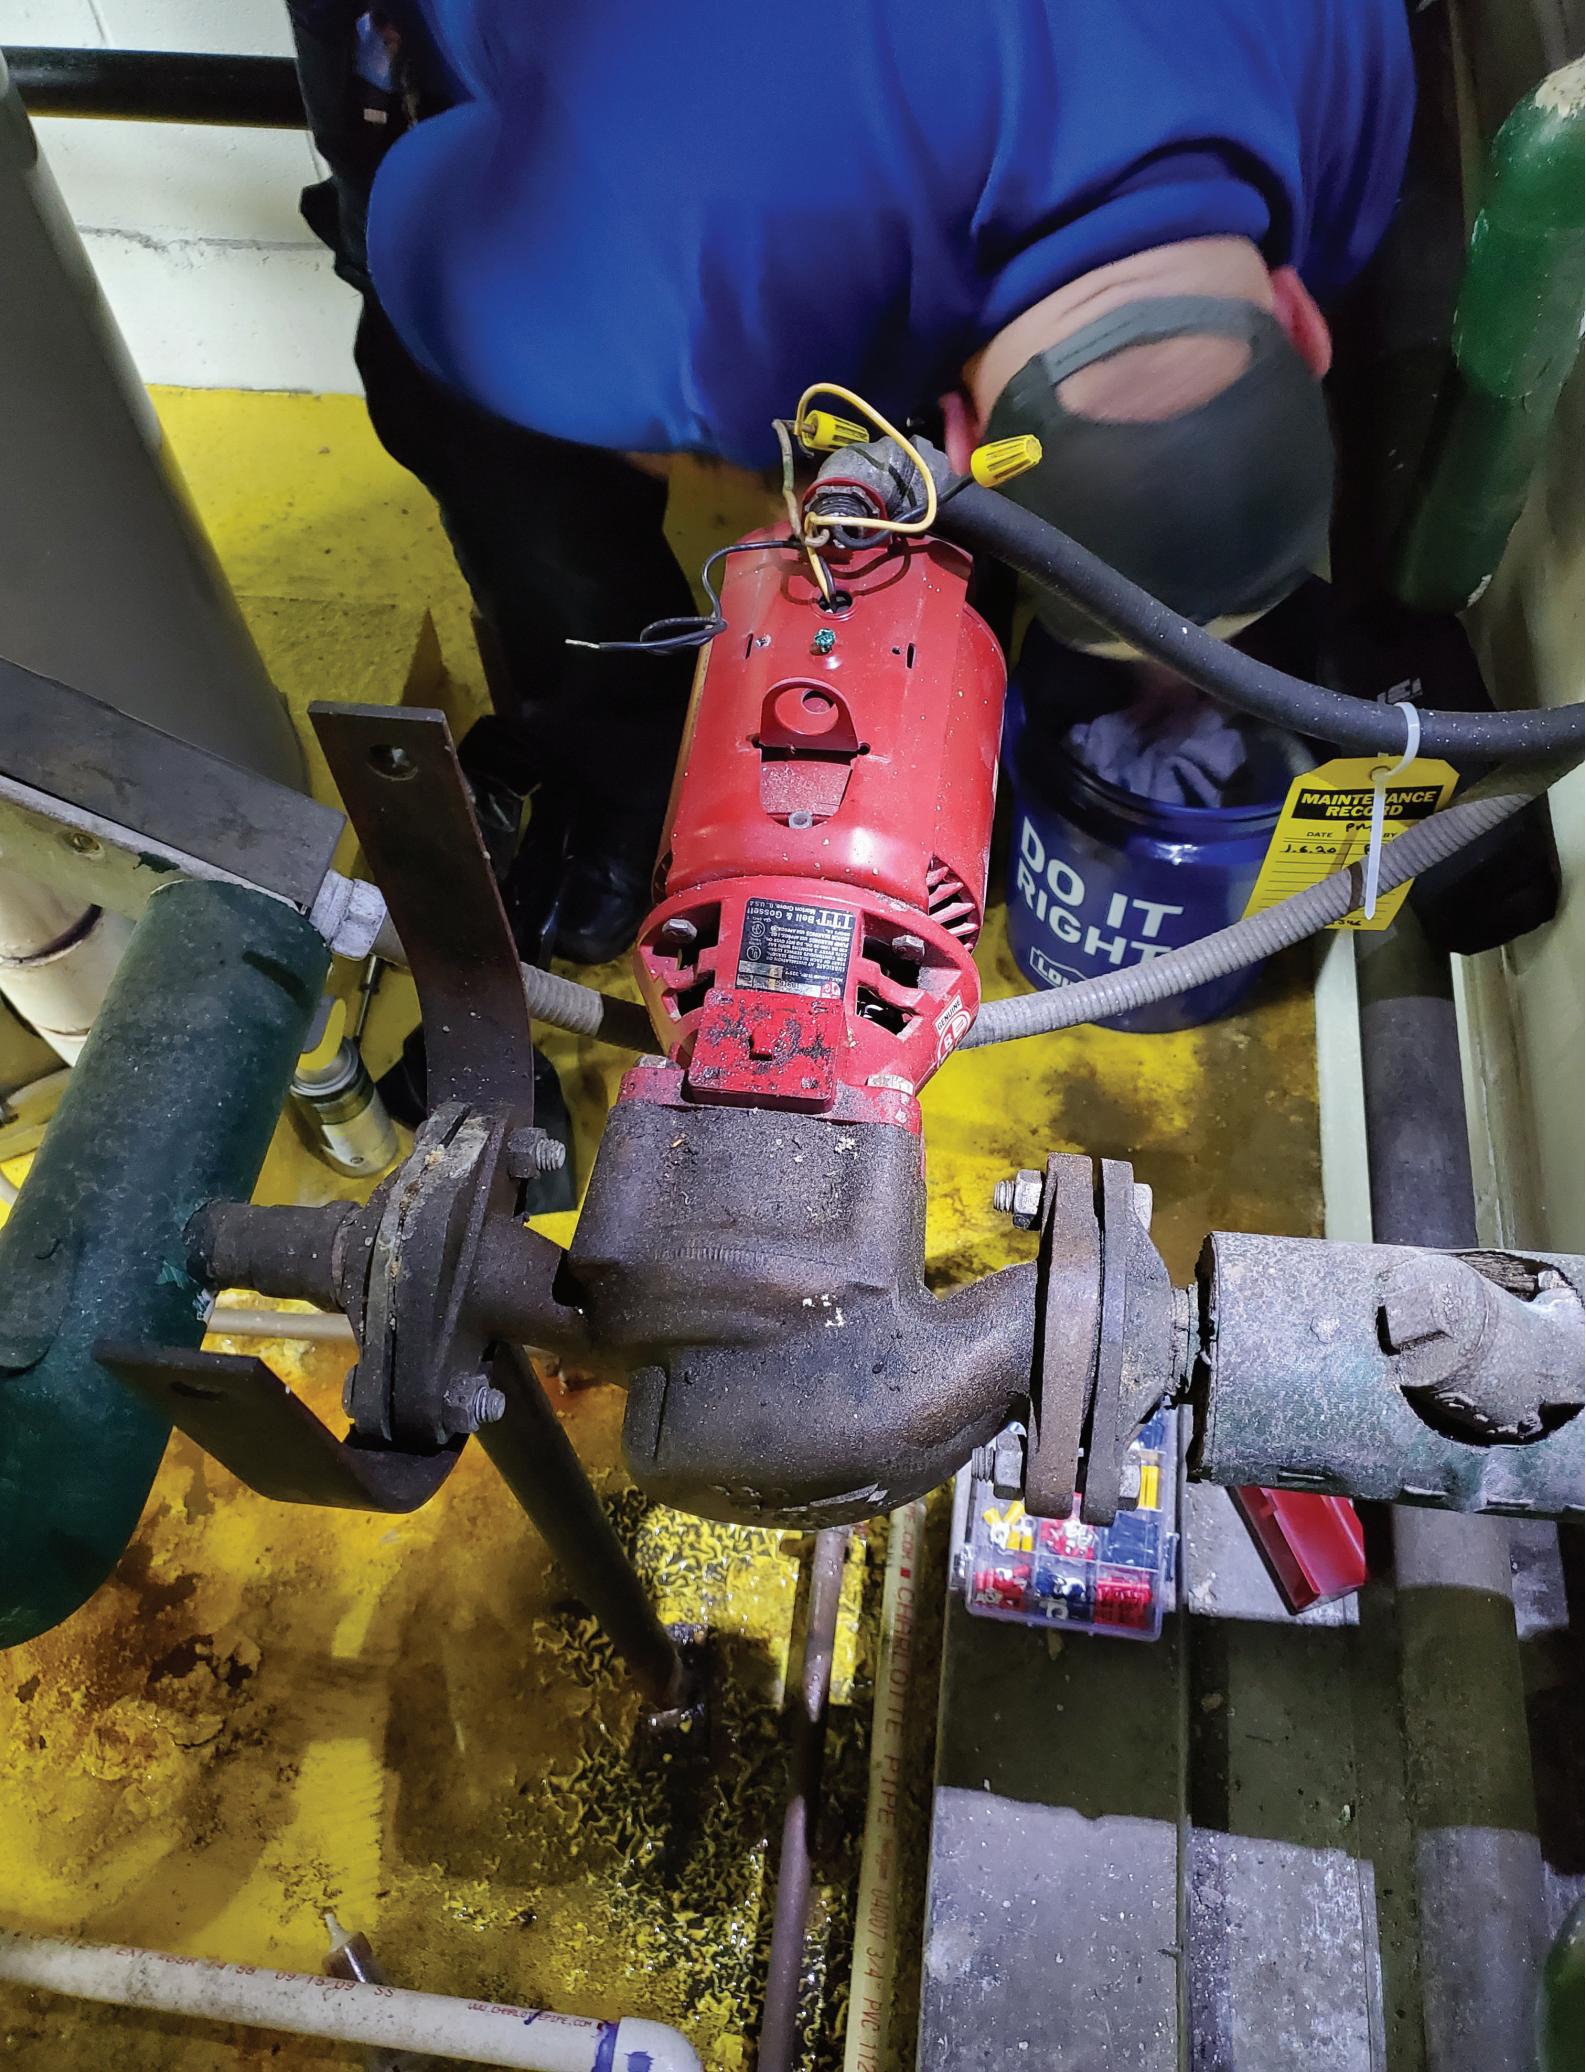
VA049
gasket leaking
from bottom

Labor and Materials to disassemble, clean flange, replace gaskets, and re assemble leaking pump.

***Update - Arrived on site to perform work. Found that one of the isolation valves that is needed to isolate the pump does not hold. Additional funds are needed to now shut off main water valve to building and replace the isolation valve in addition to the original scope.
