Additional Funding Request

VA050	CSS# 24781 WO# 12163 Asset# 1464								
Description of Repairs	LoCurrent will replace the damaged fence post. Repairs will include hand digging out the old fence post and repouring of concrete base and installation of the new fence post and tying everything together.								
Diagnosis: Initial Work Order	The gate is not working properly getting stuck open and once reset it works for a short period of time and then stays open again.								
Diagnostic Fee	\$ 400 TWI Labor \$80/hr x 5								
Additional Labor Cost to Perform Repairs	\$ 1,200 Labor \$75/hr x 16 (2men)								
Additional Cost	\$ 270 <table border="1" style="width: 100%; border-collapse: collapse;"> <tr> <td style="width: 40%;">Fence Post</td> <td style="width: 15%;">1</td> <td style="width: 20%;">\$120.00</td> <td style="width: 25%;">\$120.00</td> </tr> <tr> <td>Concrete</td> <td>1</td> <td>\$150.00</td> <td>\$150.00</td> </tr> </table>	Fence Post	1	\$120.00	\$120.00	Concrete	1	\$150.00	\$150.00
Fence Post	1	\$120.00	\$120.00						
Concrete	1	\$150.00	\$150.00						
Total Cost of Repair	\$ 1,870.00

Strathmore Fence Post Repair

From: Richard Walker <richard.walker@tideh2o.net>
Sent:

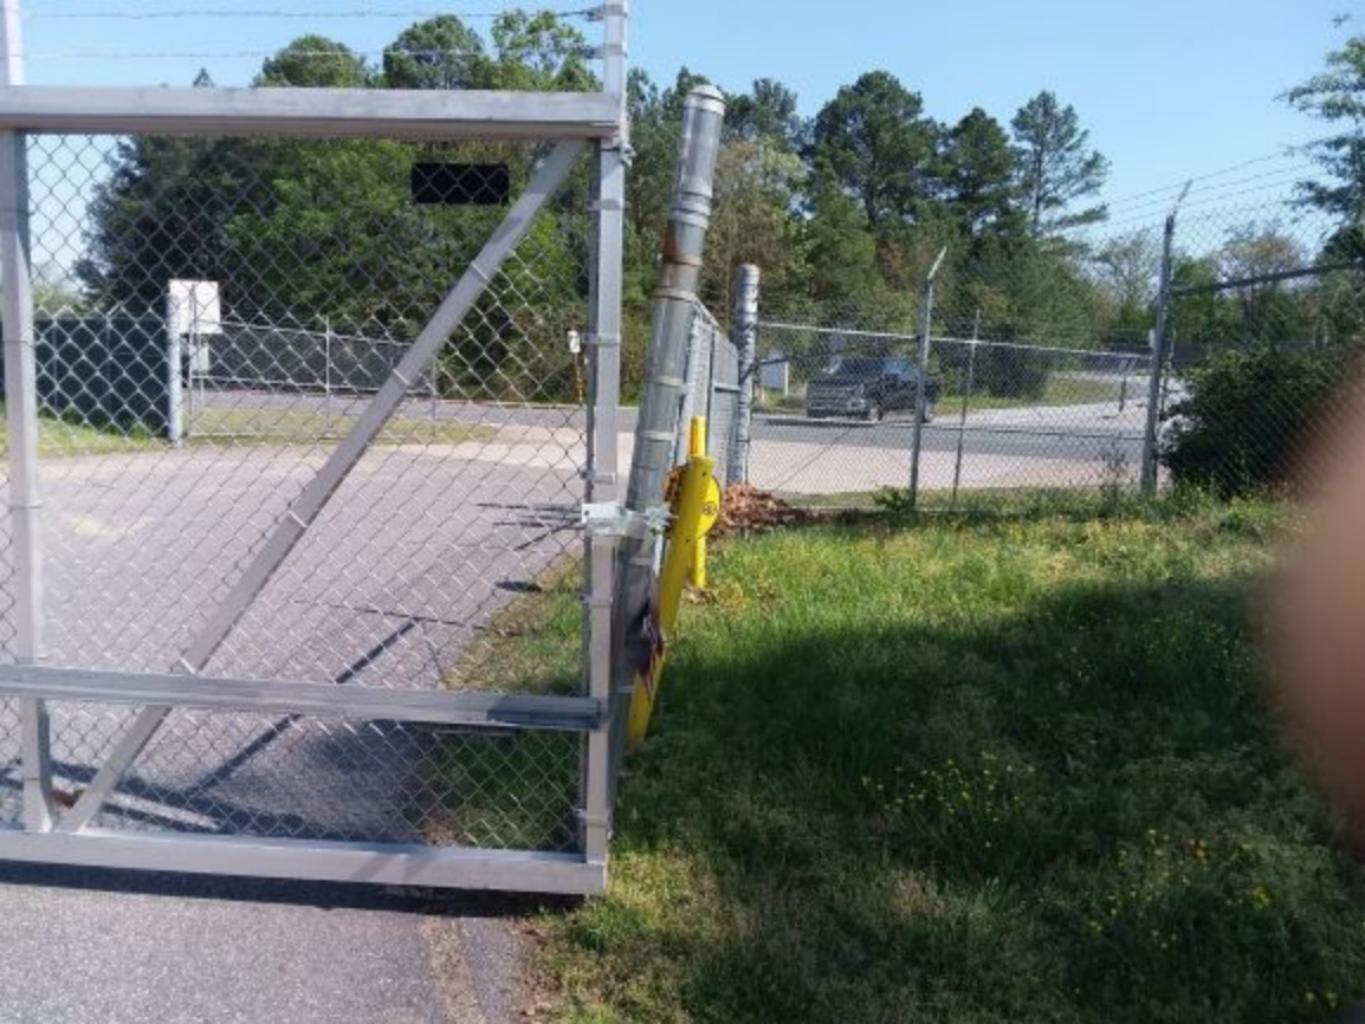
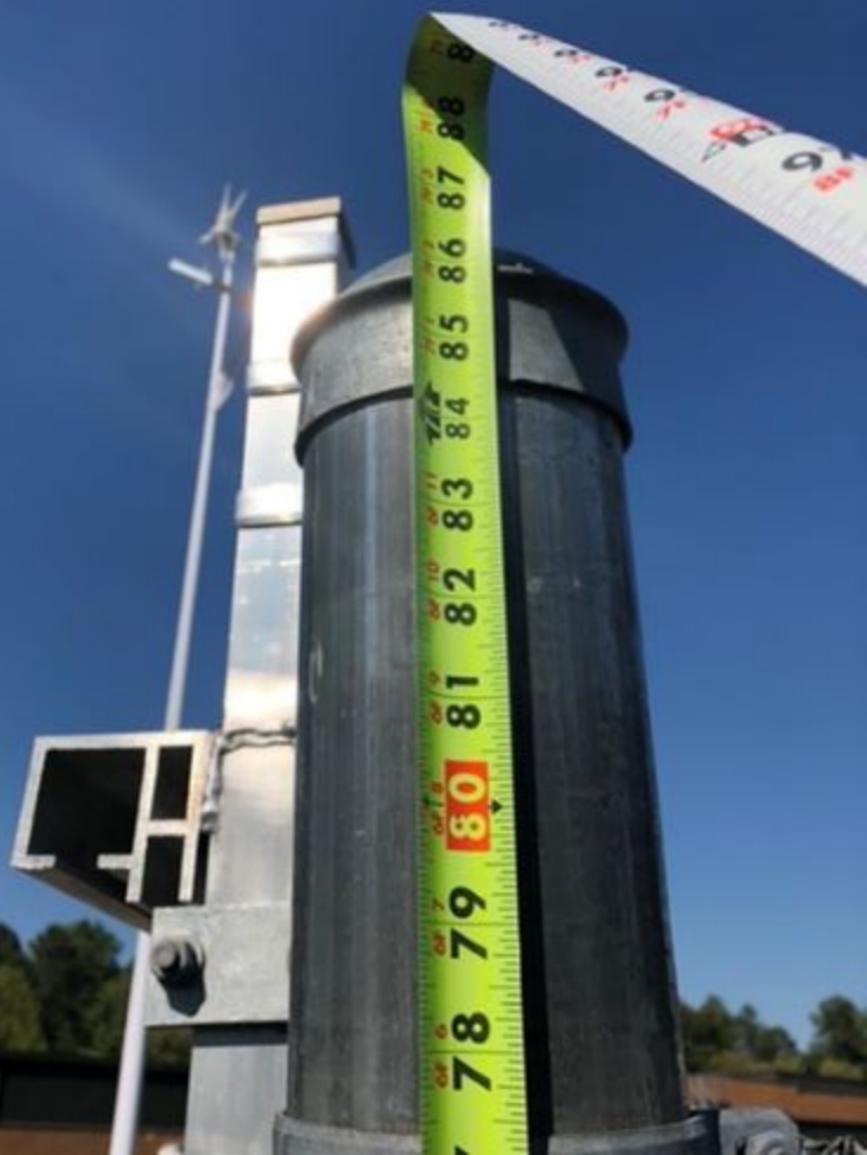
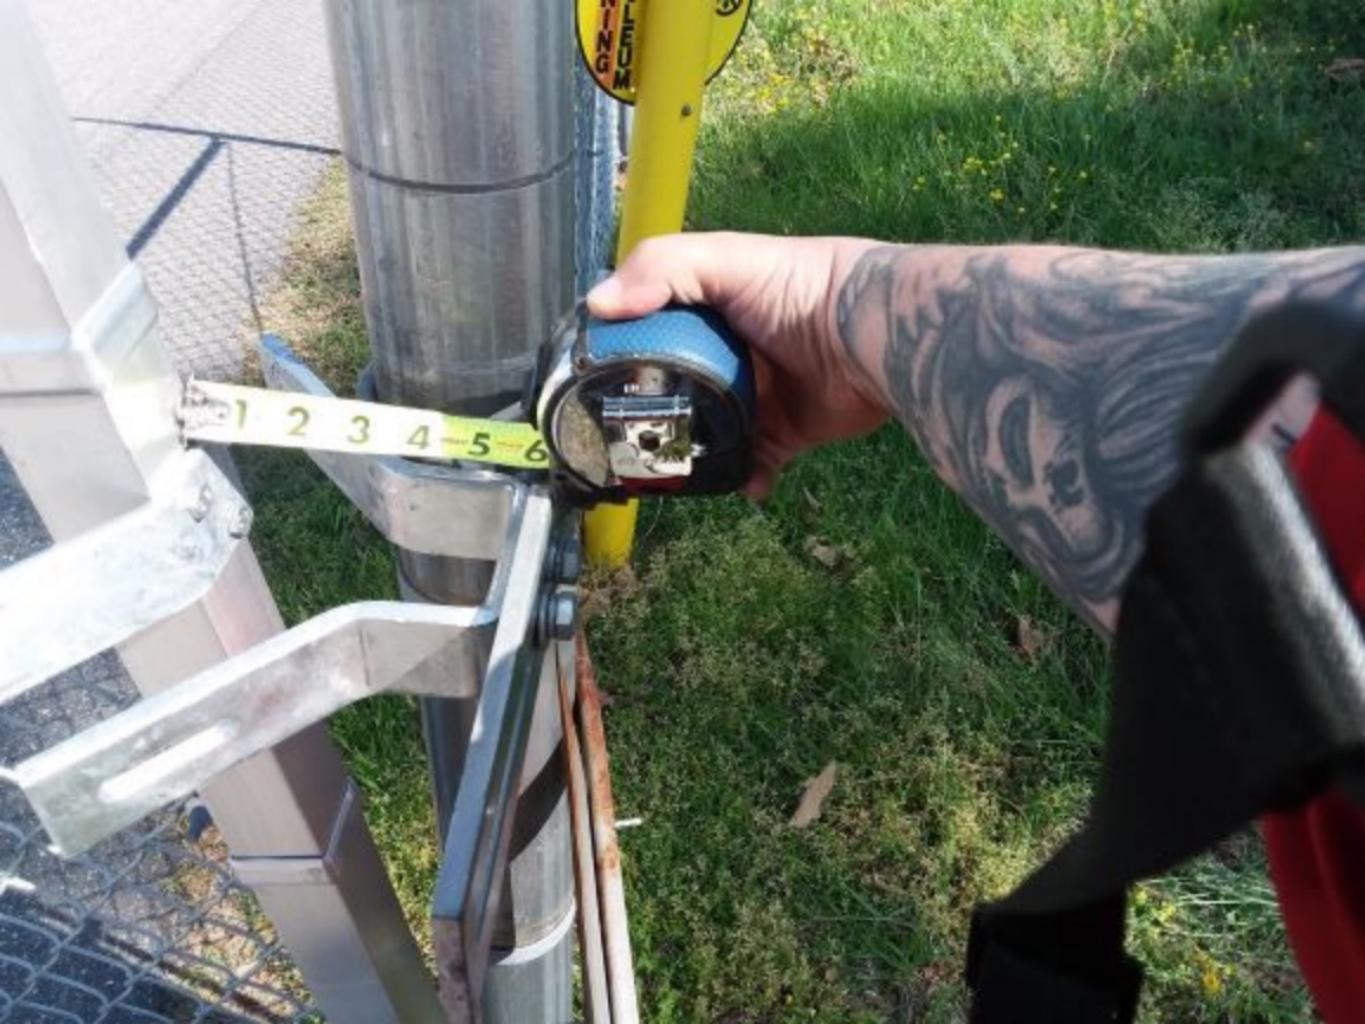
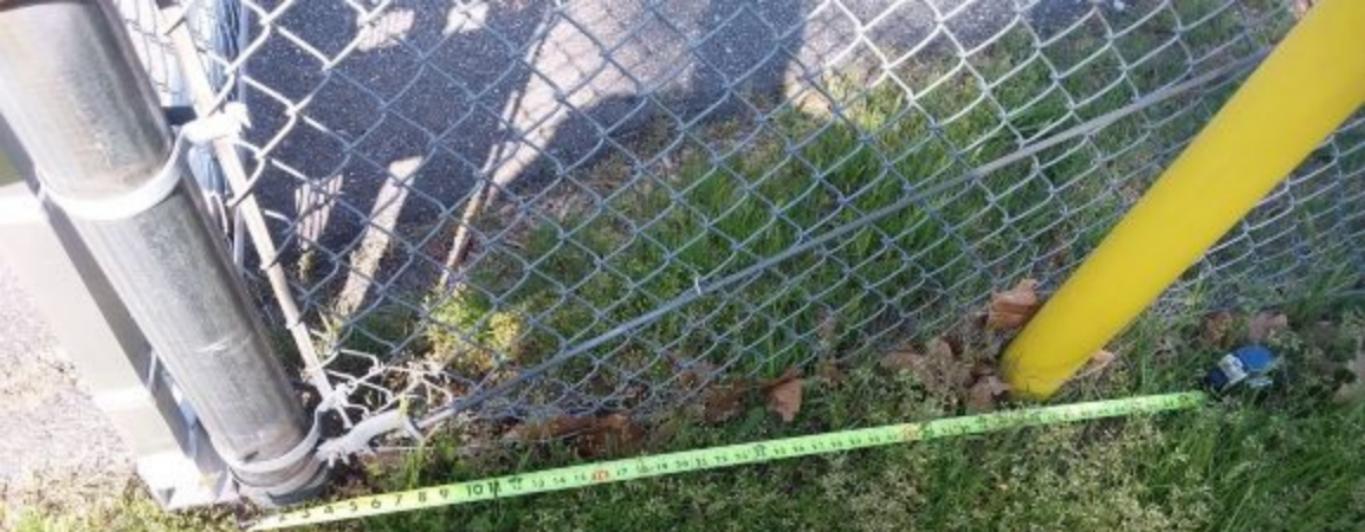
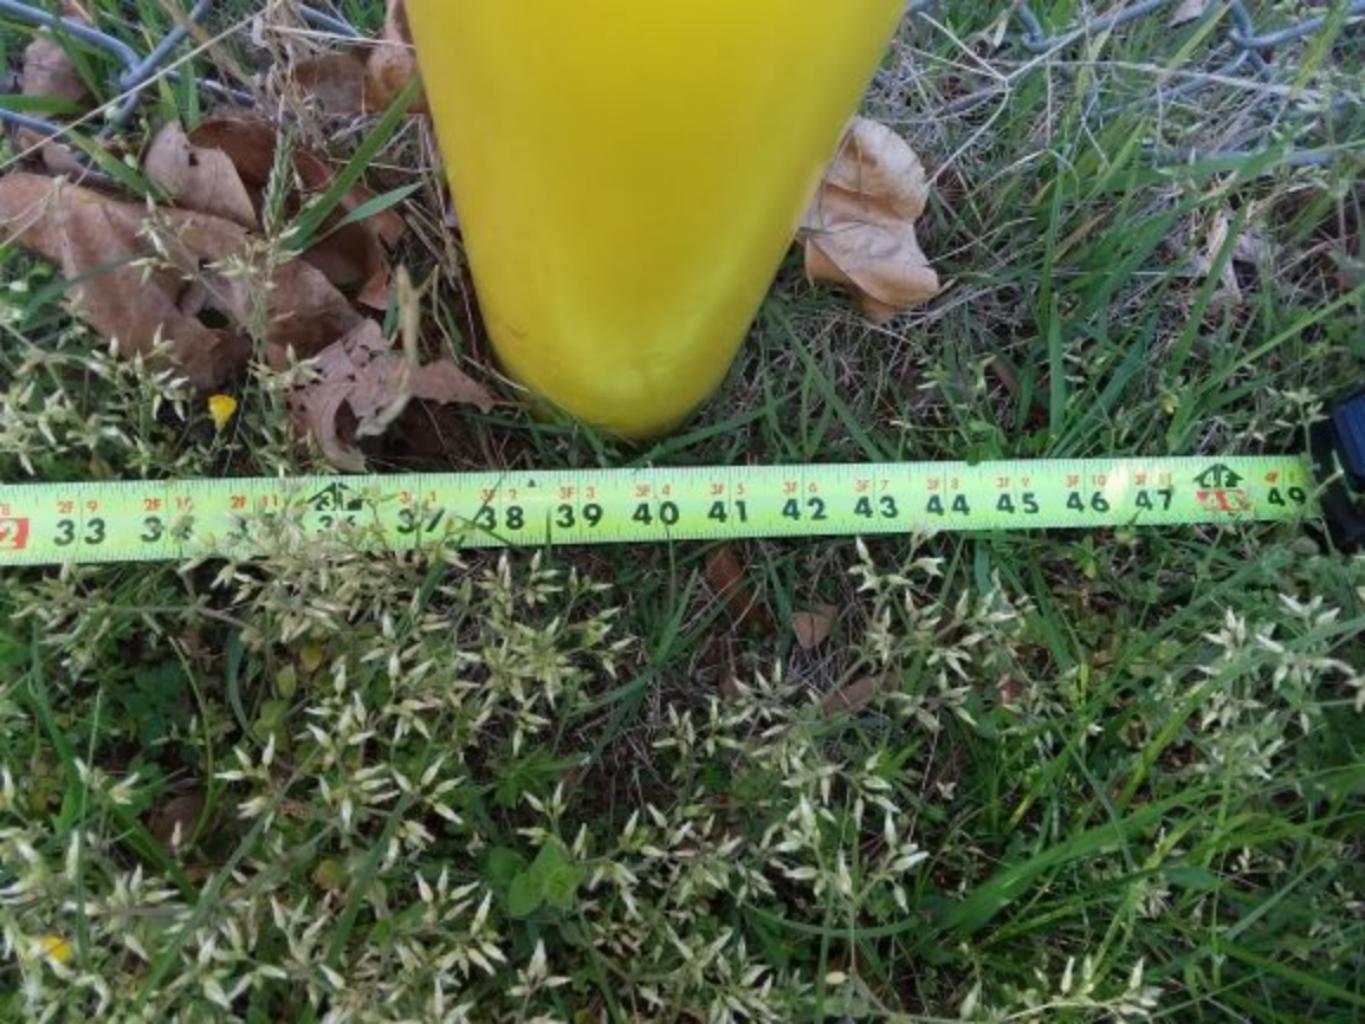
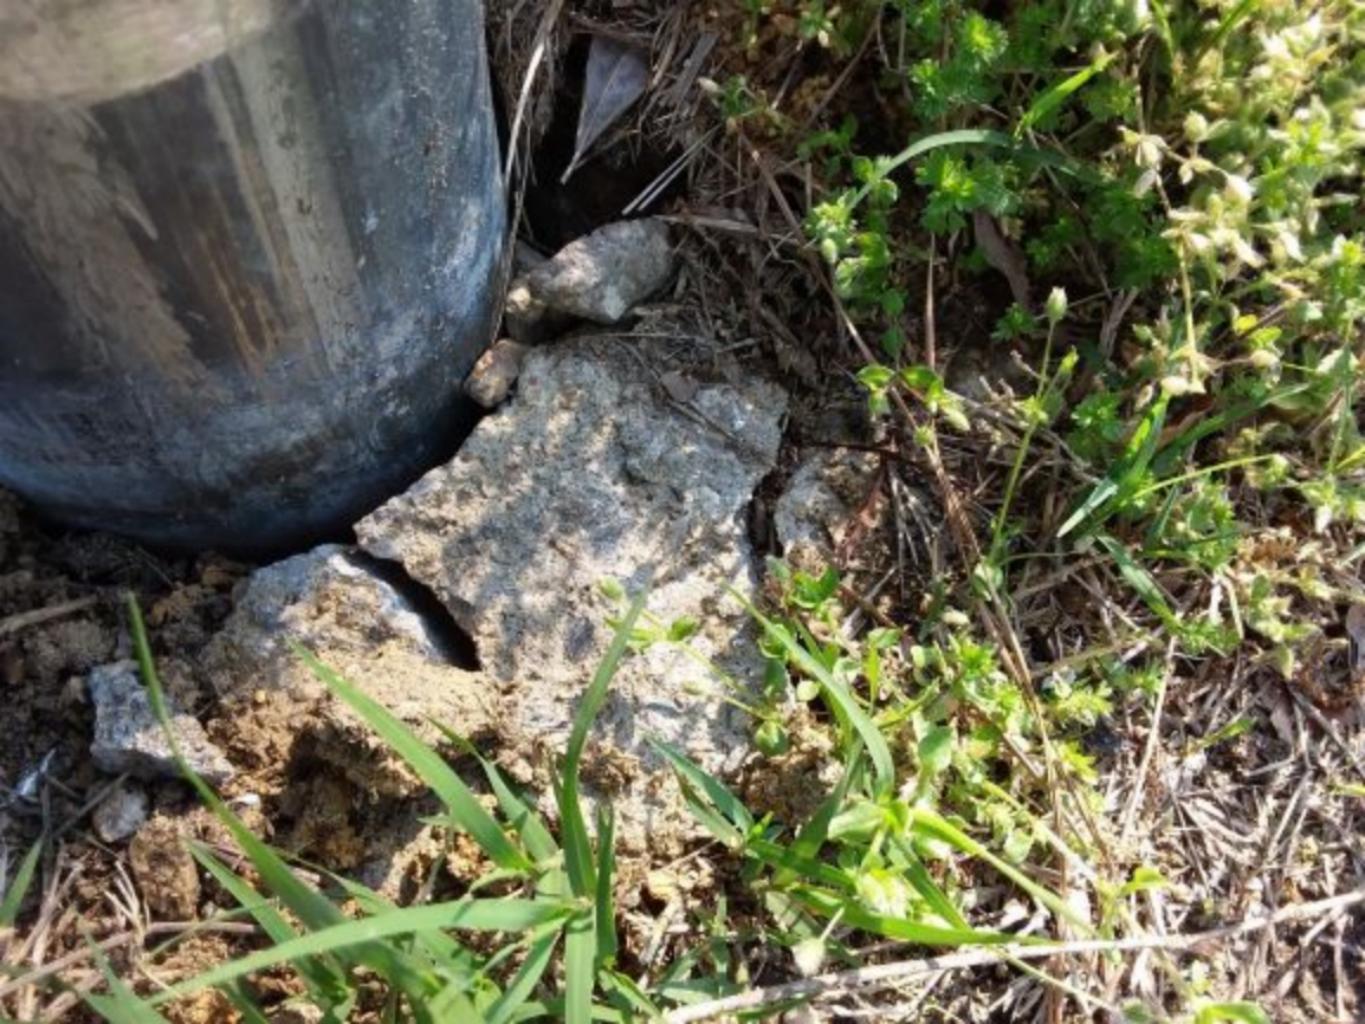
After checking operating status I believe primary gate malfunction is due to the ribbon attached from the LCD readout to the obstruction section of the board within the gate operation board.

Additional issue with the gate is closed contact point at gate is bent. Reflecting point is adjusted to enable gate to be used.

Concrete at foot of pole is cracked, and Gas utility lines are marked at gate.

Upon measurements found pole is bent 5.5 inches from base, in backwards direction.

Gate is operating currently, and periodically will fault out and remain open until communicating response is functioning. Then gate will automatically close.

As per your request, LoCurrent Systems is pleased to provide a quotation to repair/replace the damaged Fence Post at the Strathmore Facility. Repairs will include hand digging out old Fence Post, repouring of concrete base, installation of new fence post and tying everything together.
