Additional Funding Request **Invoice**

VA049	CSS# 25096 WO# 12184 Asset# NA
Description of Repairs	<p>Tech: CHARLES GRESHAM, Date: 5/14/20 1:08 PM - I arrived on site and met with Mark Anderson. He showed me the two security lights near the vault that we're out and a 2x4 LED emergency flat panel in the loading dock hallway that he said flickers when the light switch is turned off. I opened up the security lights at the vault and found that they had bad bulbs. I then turned off the lights to the hall and could not cause the 2x4 to recreate the problem. The push to test button stayed green and the light never flickered. I turned the lights on and off several times and it worked fine. I open the light and checked for loose connections and found one of the neutrals joints a little loose. This may have been the cause of the problem. The joint was not extremely loose and could have settled into place causing the light to work. I tightened all joints and insured proper operation of the light. I went and sourced new bulbs for the security vault lights and returned to site and installed them. All three lights are working as designed.</p>

SERVICE INVOICE: 468951

CERTIFICATION OF WORK SERV

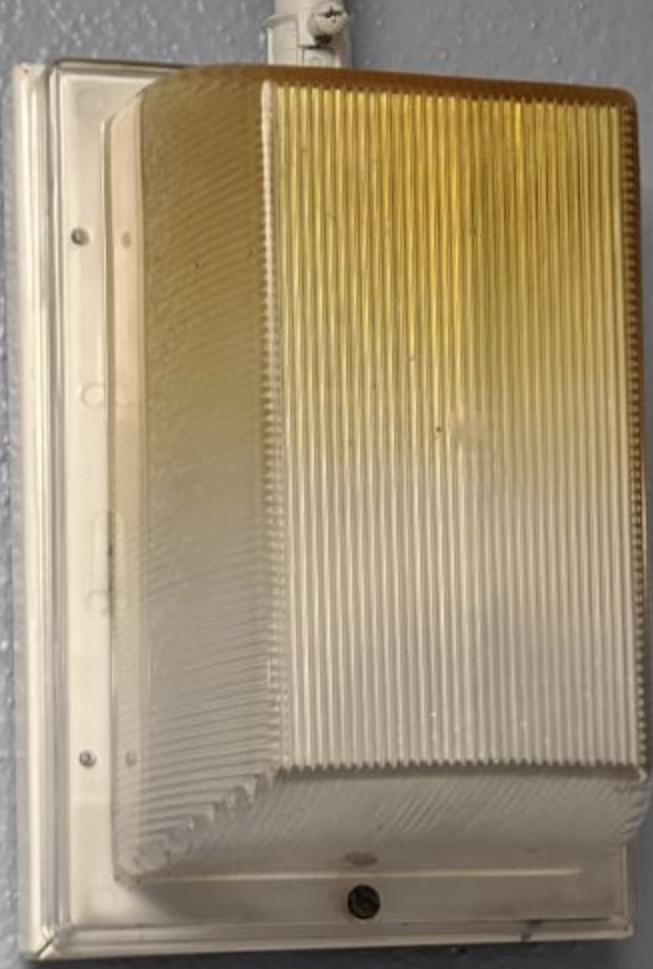
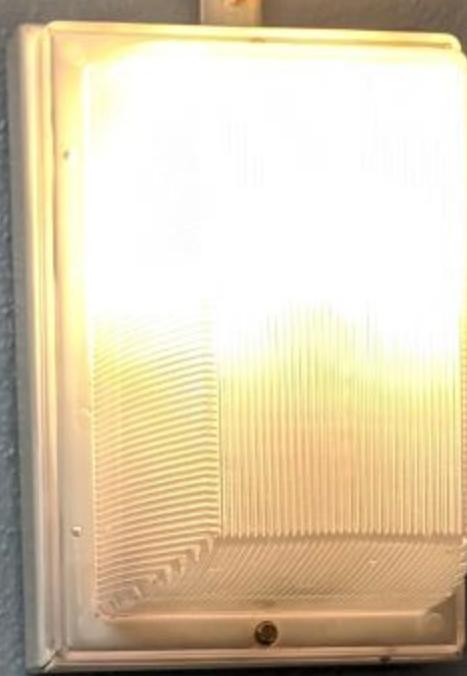
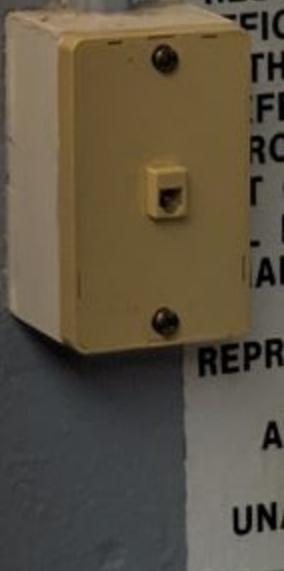
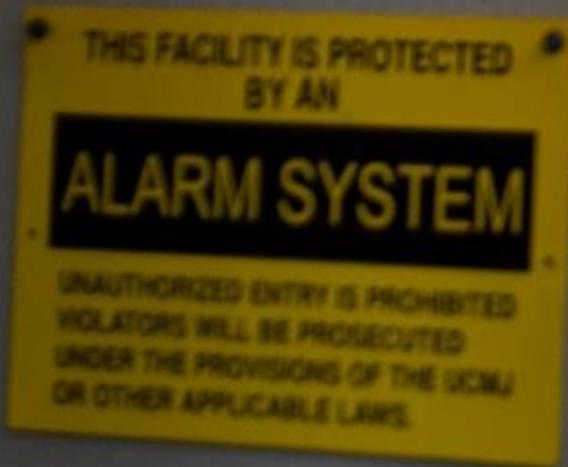
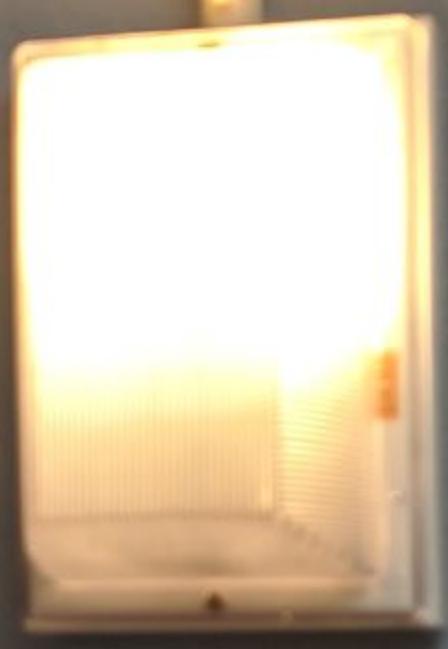
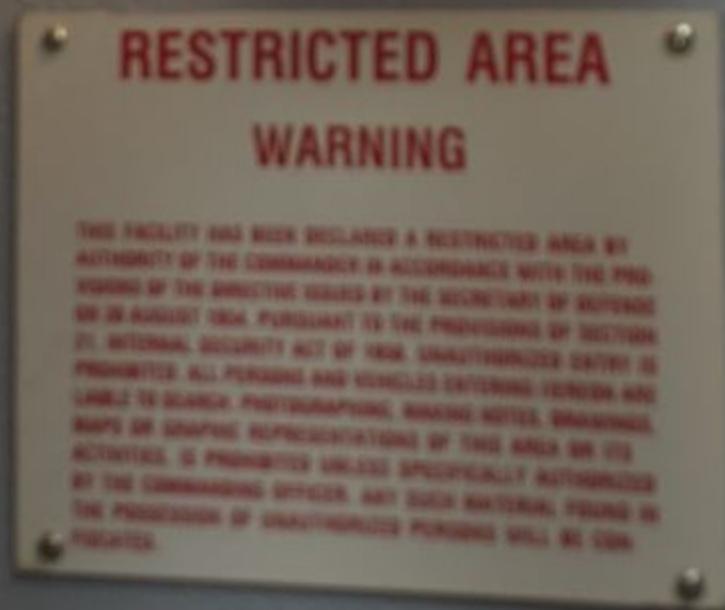
I opened up the security lights at the vault and found that they had bad bulbs. I then turned off the lights to the hall and could not cause the 2x4 to recreate the problem. The push to test button stayed green and the light never flickered. I turned the lights on and off several times and it worked fine.

I open the light and checked for loose connections and found one of the neutrals joints a little loose. This may have been the cause of the problem. The joint was not extremely loose and could have settled into place causing the light to work. I tightened all joints and insured proper operation of the light.

I went and sourced new bulbs for the security vault lights and returned to site and installed them. All three lights are working as designed.
