## Additional Funding Request

<b>VA049</b>	<b>CSS# 25661 WO# 11458 Asset# 2335</b>
Description of Repairs	Labor and materials to replace bad ignitor on Trane Package unit.
Diagnosis: Initial Work Order	Trane package unit needs new ignitor and ignition module.
Diagnostic Fee	\$160
Additional Labor Cost to Perform Repairs	\$480 TW Labor 6 hours @ \$ 80
Additional Material Cost to Perform Repairs	\$210.42  See attached Detail.
PM CREDIT	<b>(<span style="color: red;">\$250</span>)</b>
Total Cost of Repair	\$600.42

# WORK ESTIMATE

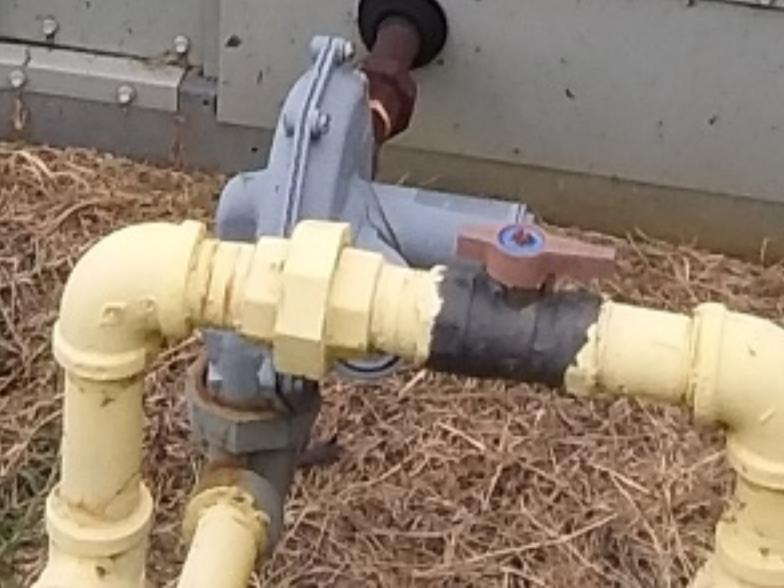
Labor and materials to replace bad ignitor on Trane Package unit.
