Additional Funding Request

MD024	CSS# 26446 WO# 13973 Asset# NA							
Description of Repairs	Labor and material to replace door closer to exterior door, across from latrine in building 1003.							
Diagnosis: Initial Work Order	Repair door closure, exterior door across from latrines, bldg 1003.							
Diagnostic Fee	\$ 160 Labor \$80/hr x 2							
Additional Labor Cost to Perform Repairs	\$ 160 Labor \$80/hr x 2							
Additional Material Cost to Perform Repairs	\$ 320 <table border="1" style="width: 100%; border-collapse: collapse; margin-top: 5px;"> <tr> <td style="width: 50%;">Part</td> <td style="width: 10%; text-align: center;">1</td> <td style="width: 20%; text-align: right;">209.69</td> <td style="width: 20%; text-align: right;">209.69</td> </tr> </table>				Part	1	209.69	209.69
Part	1	209.69	209.69					
Total Cost of Repair	\$ 529.69

WORK ESTIMATE

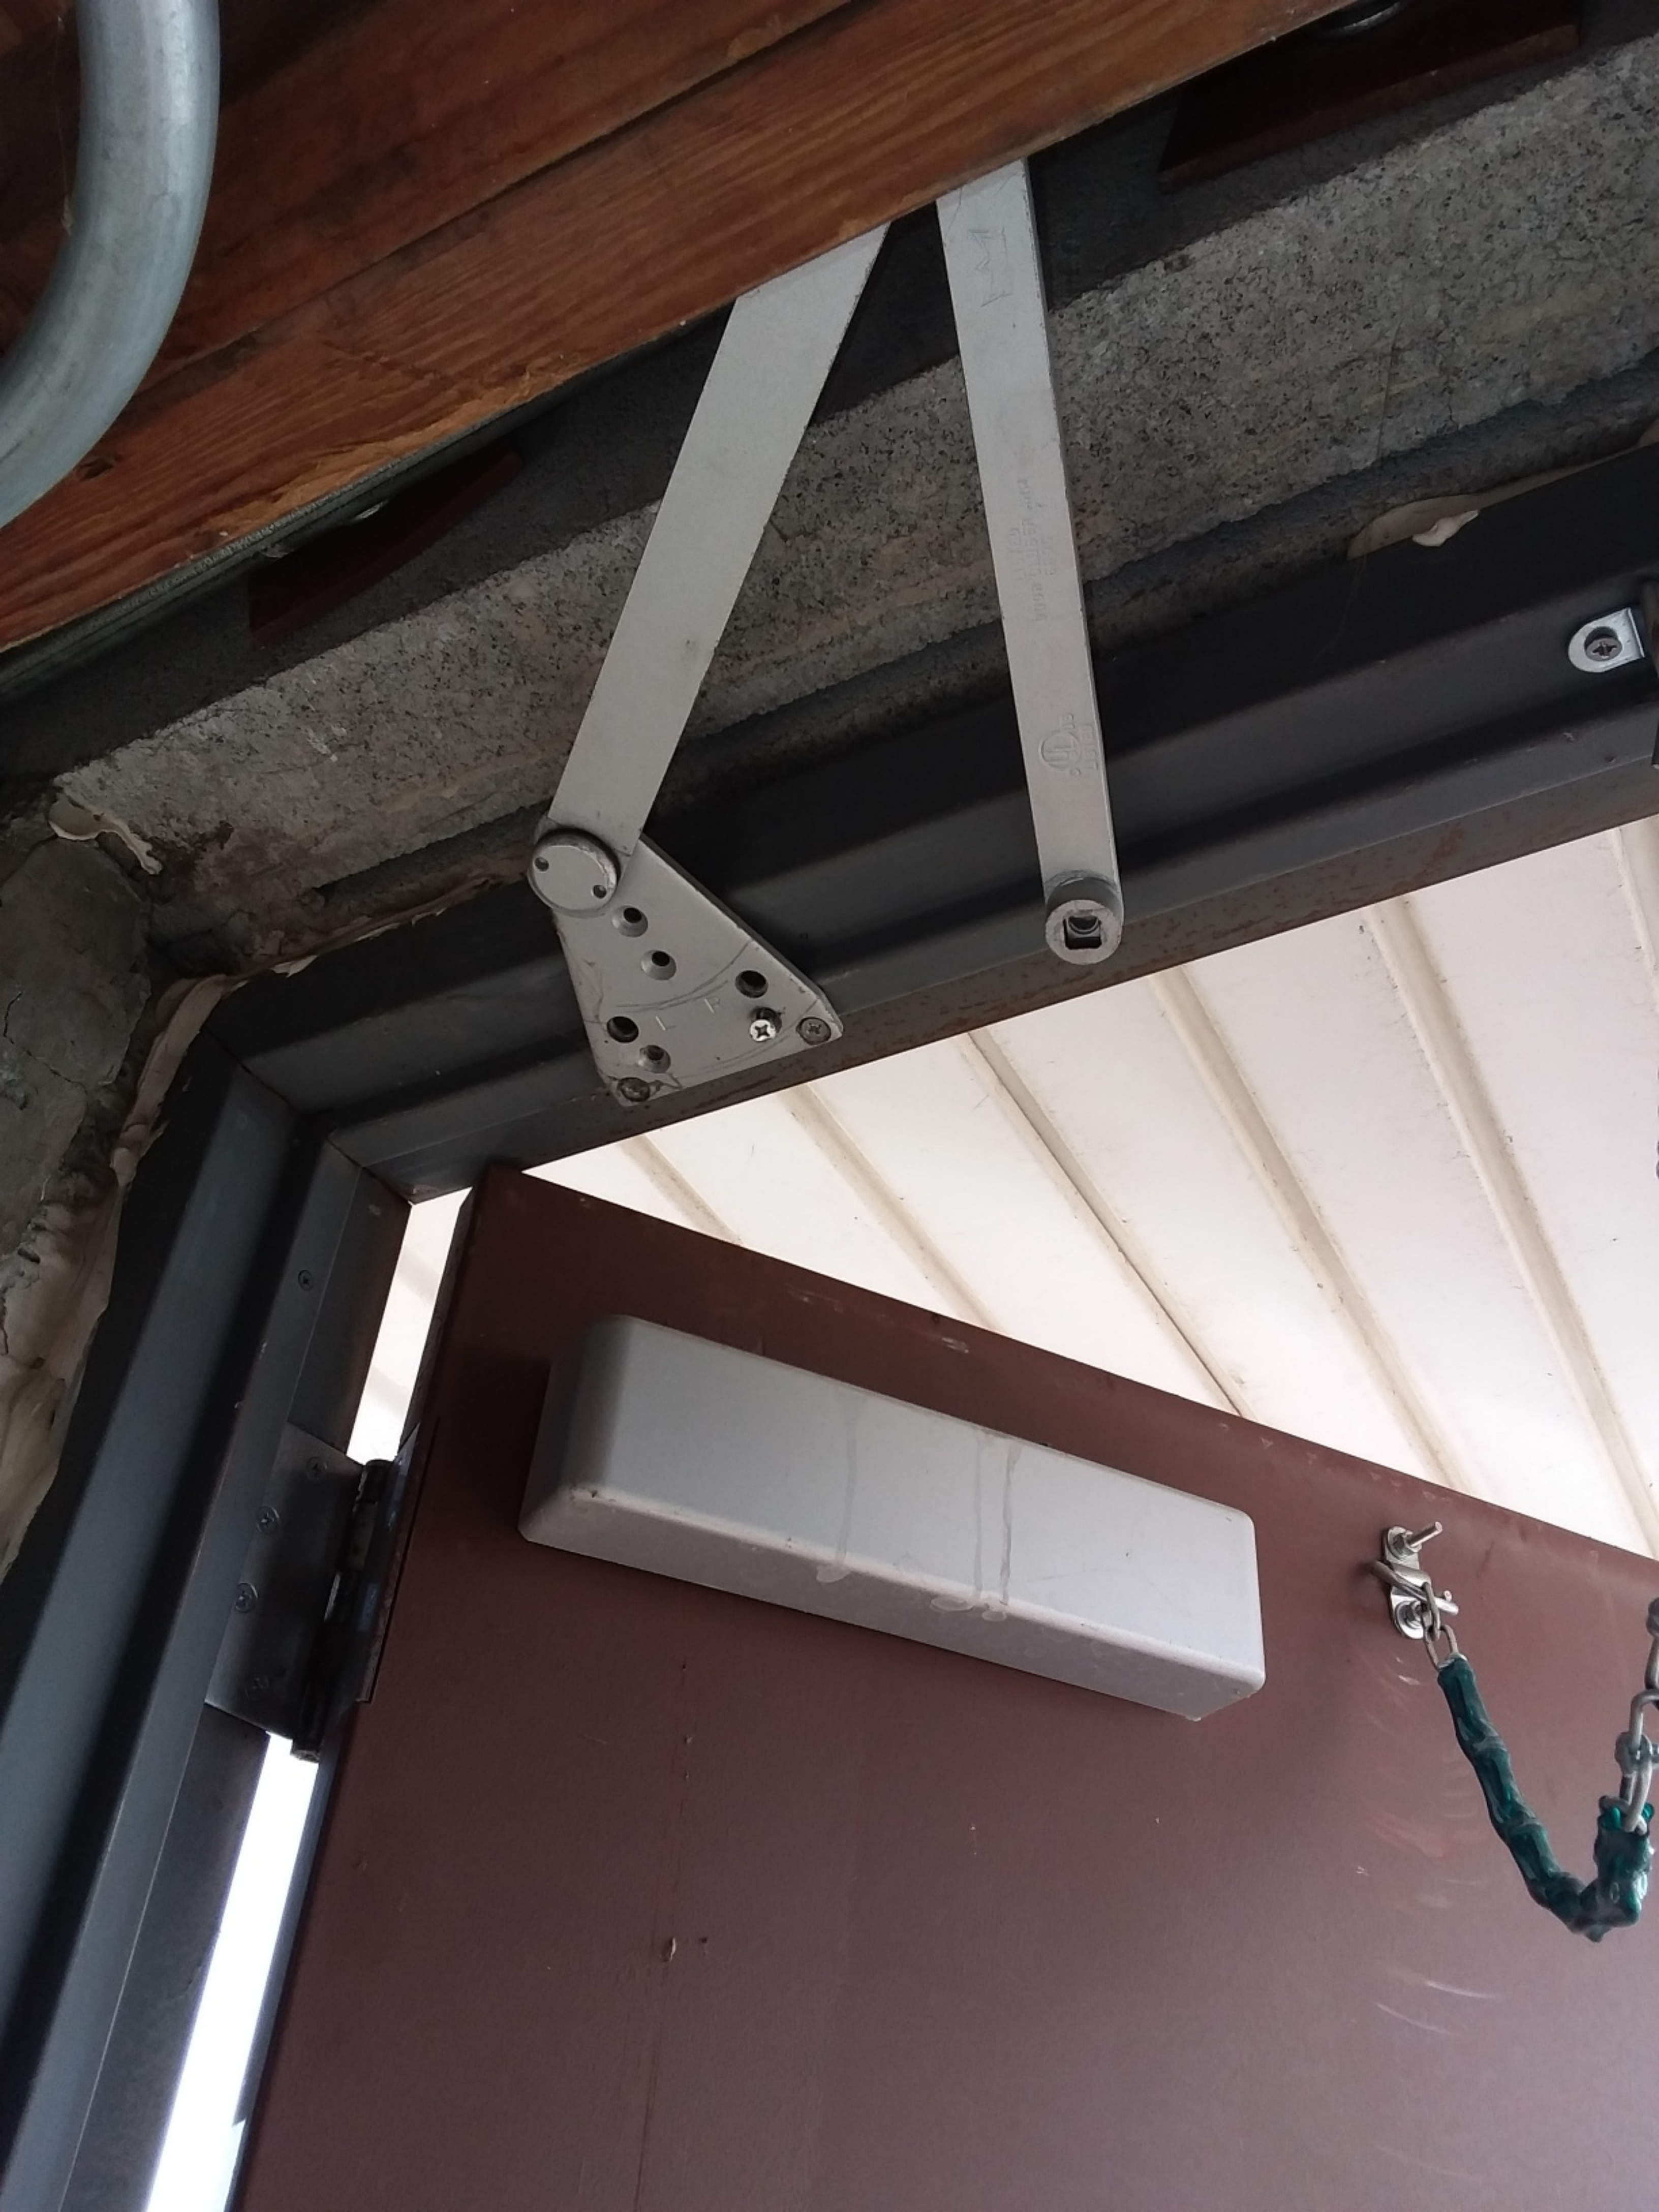
Replace door closer to exterior door, across from latrines in building 1003.
