## Additional Funding Request

<b>VA048</b>	<b>CSS# 28061 WO# 13328 Asset# NA</b>							
Description of Repairs	Labor and materials to replace leaking ¼ in saddle valve on hot water supply line.							
Diagnosis: Initial Work Order	Water is leaking from the roof or pipes above the cage in the AMSA bay area to the floor.							
Diagnostic Fee	<p>\$ 240</p> <p>Labor \$80/hr x 3</p>							
Additional Labor Cost to Perform Repairs	<p>\$ 640</p> <p>Labor \$80/hr x 8</p>							
Additional Material Cost to Perform Repairs	<p>\$ 70.06</p> <table border="1" style="width: 100%; border-collapse: collapse;"> <tr> <td style="width: 40%;">Parts (see detail in quote)</td> <td style="width: 10%; text-align: center;">1</td> <td style="width: 20%; text-align: center;">70.06</td> <td style="width: 30%; text-align: center;">70.06</td> </tr> </table>				Parts (see detail in quote)	1	70.06	70.06
Parts (see detail in quote)	1	70.06	70.06					
Total Cost of Repair	\$ 950.06

# WORK ESTIMATE

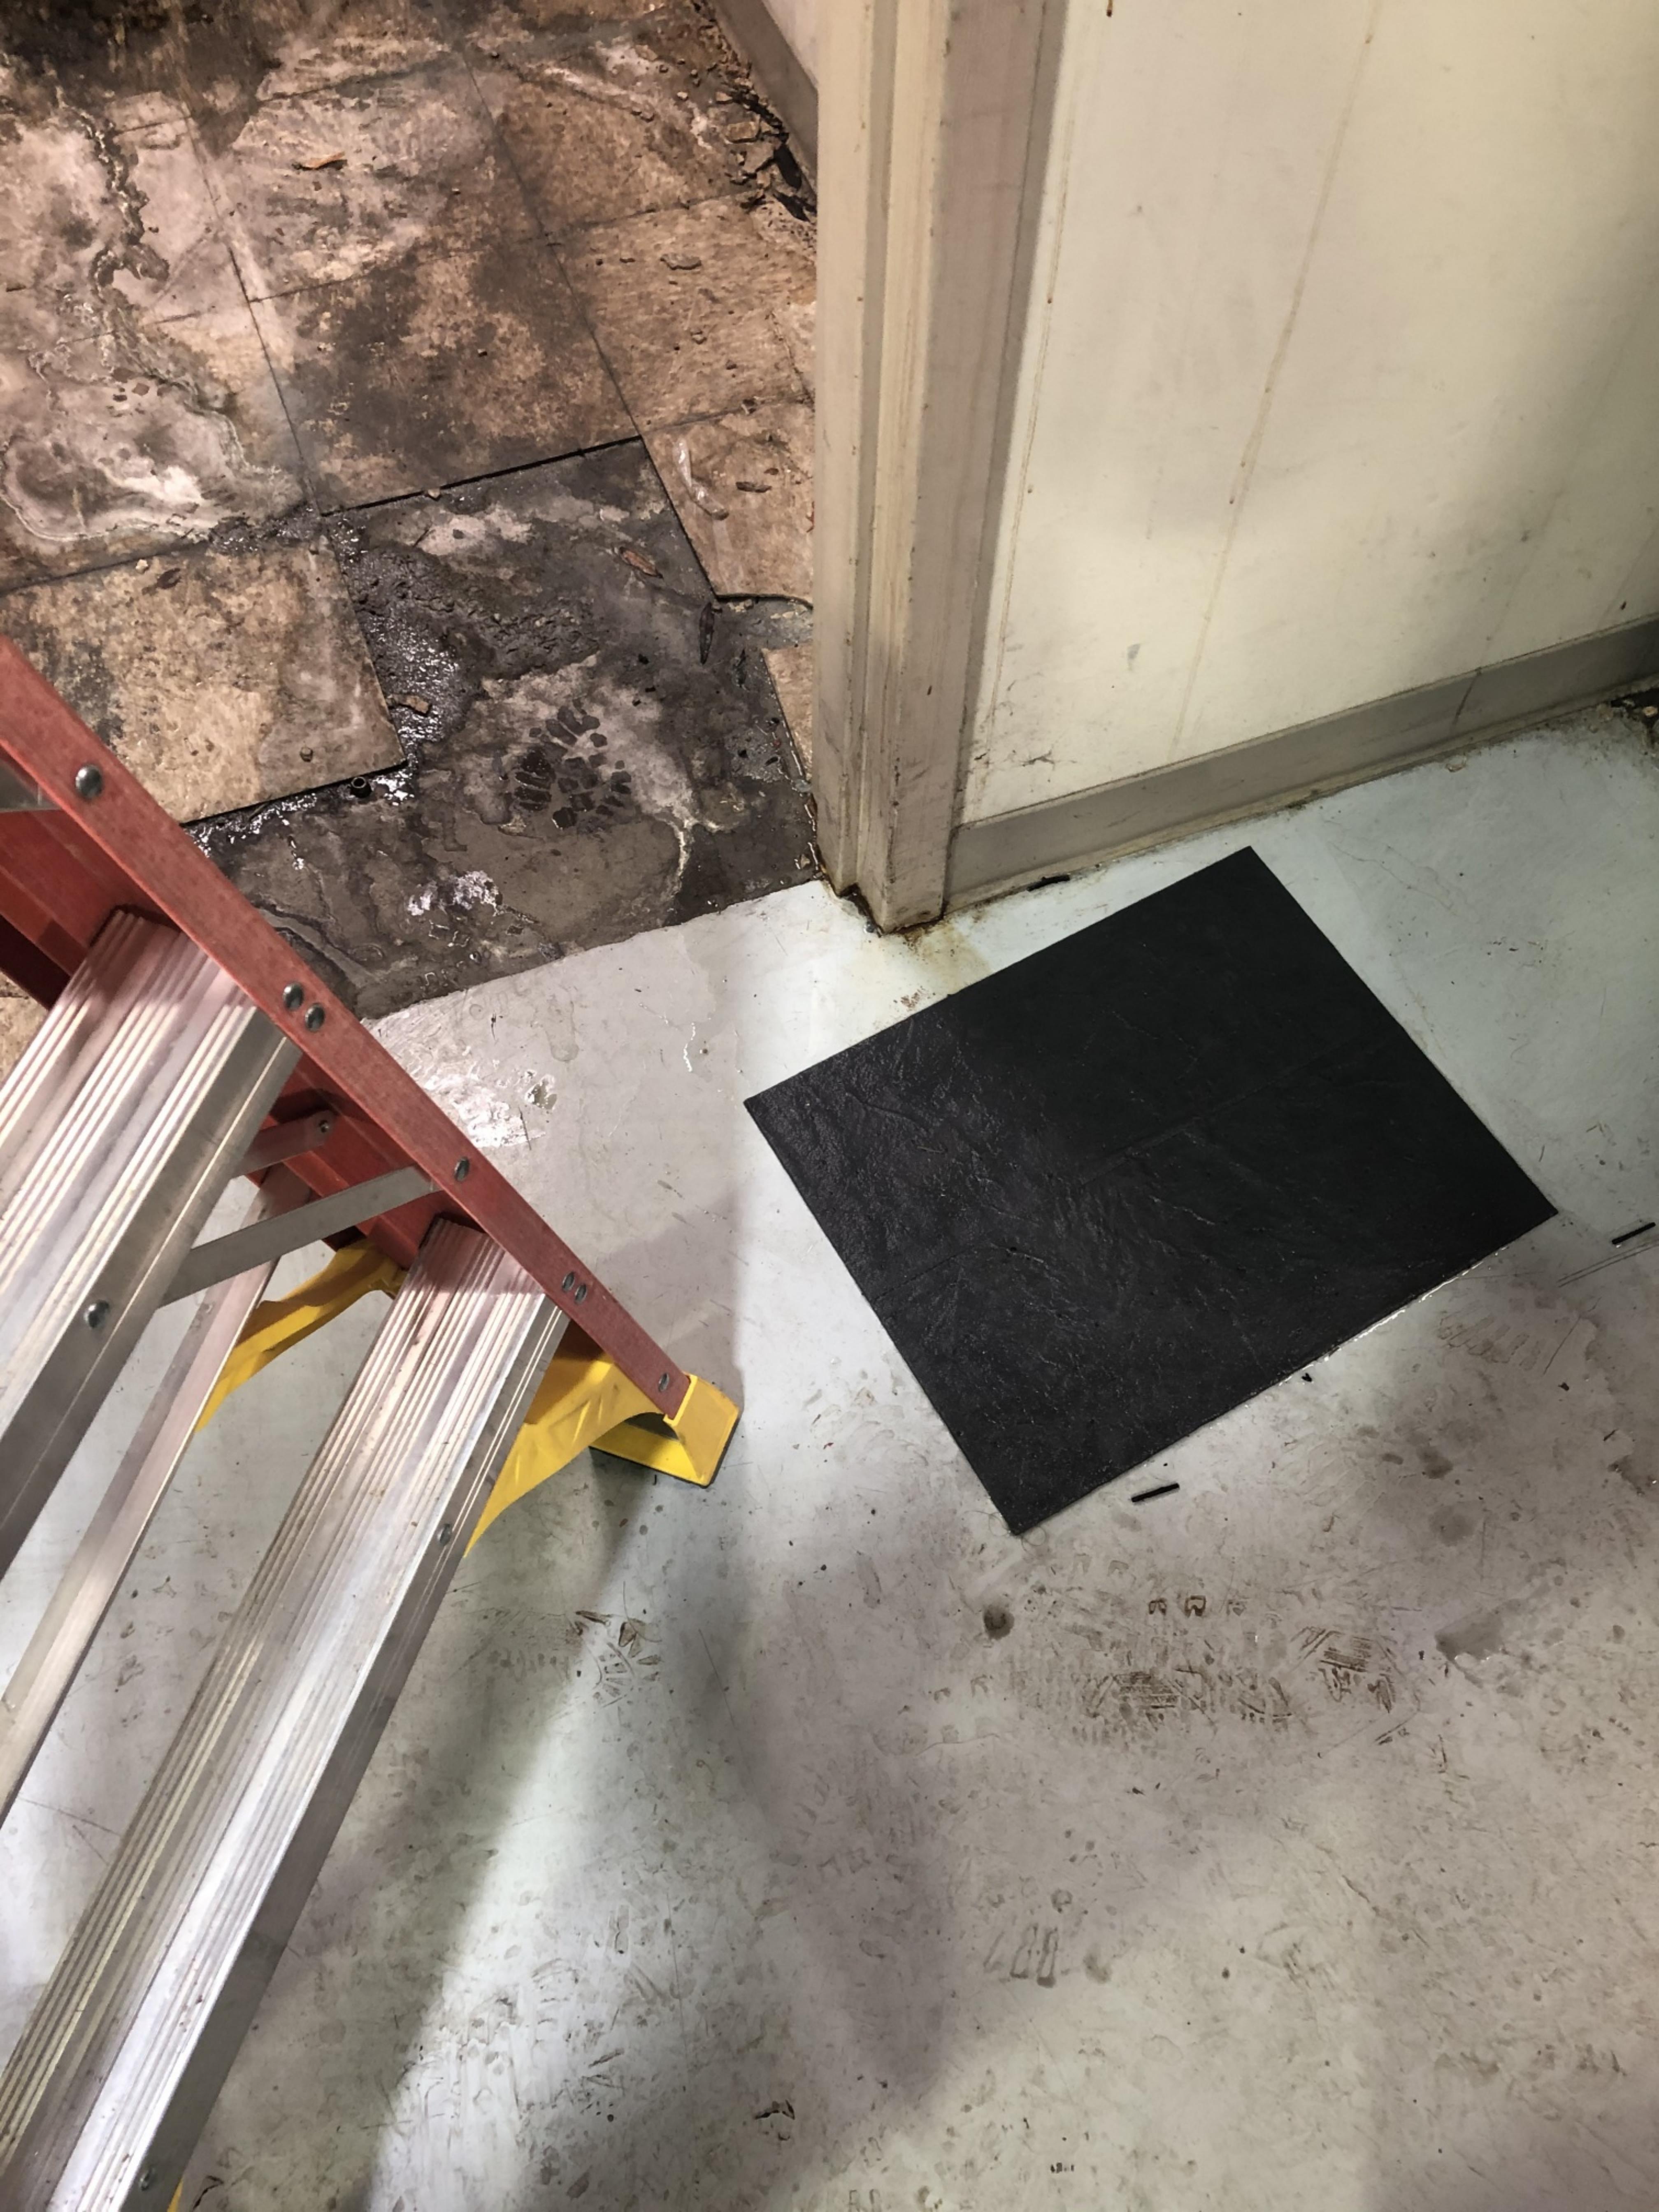
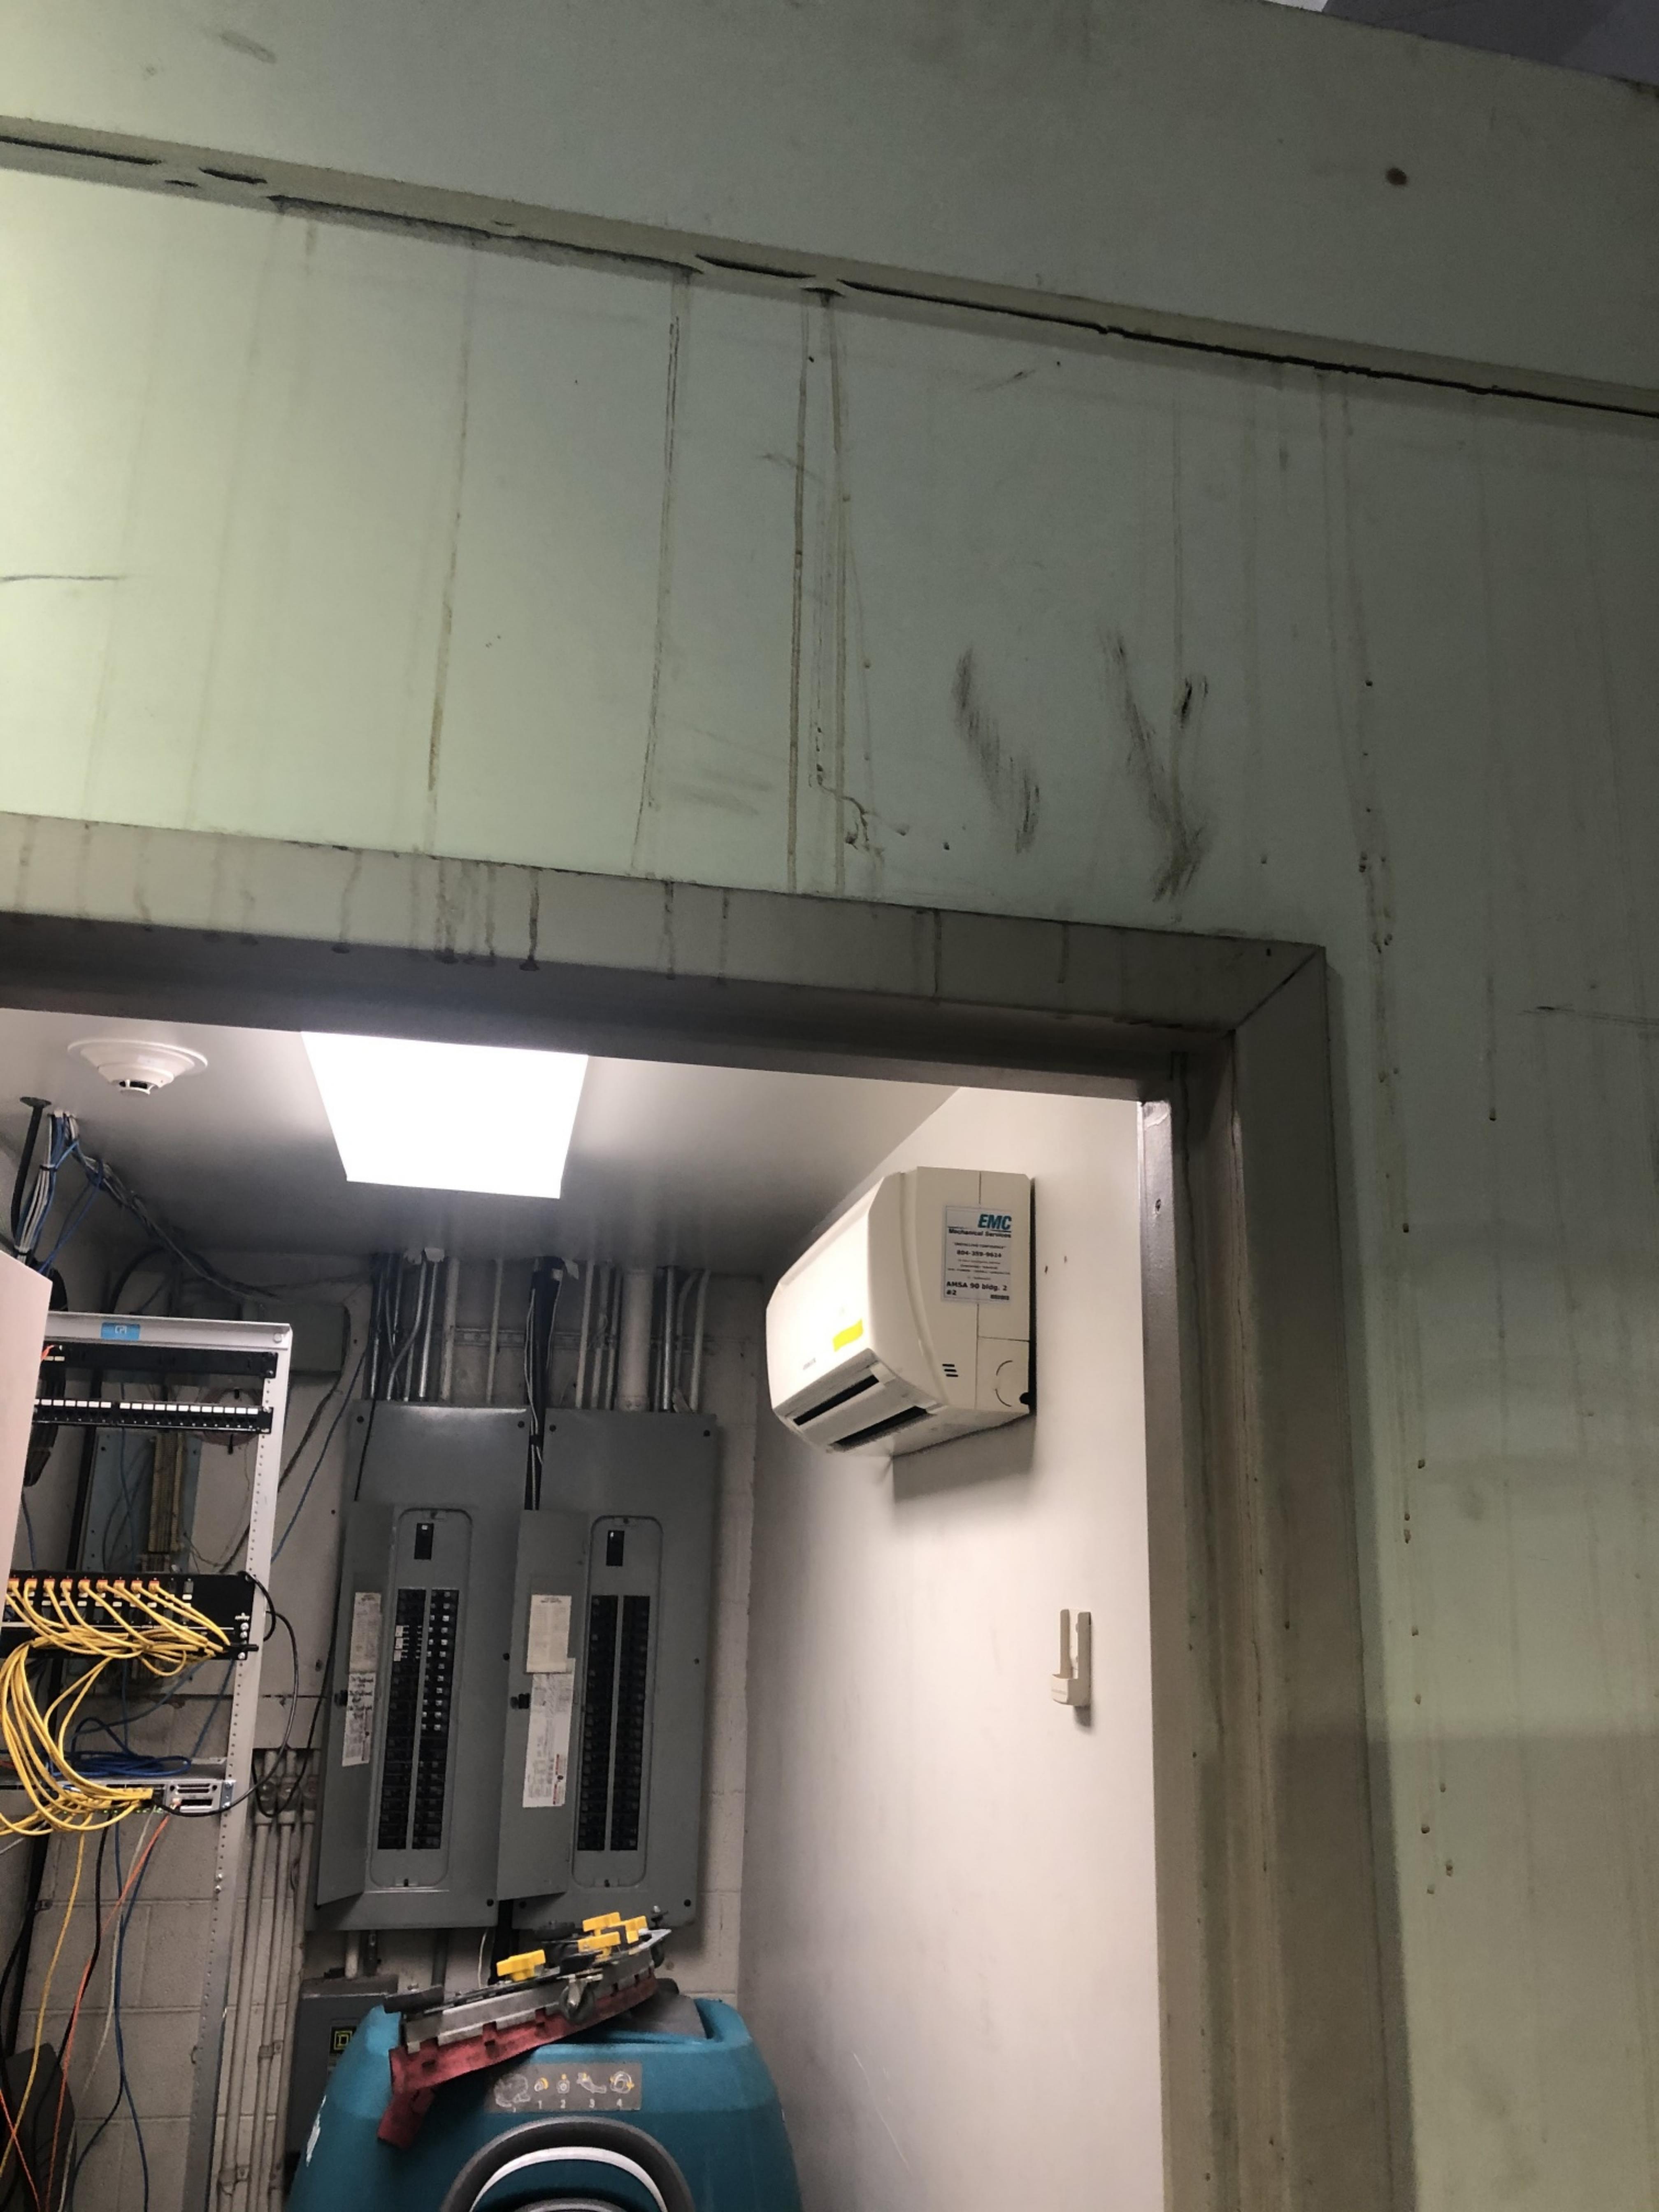
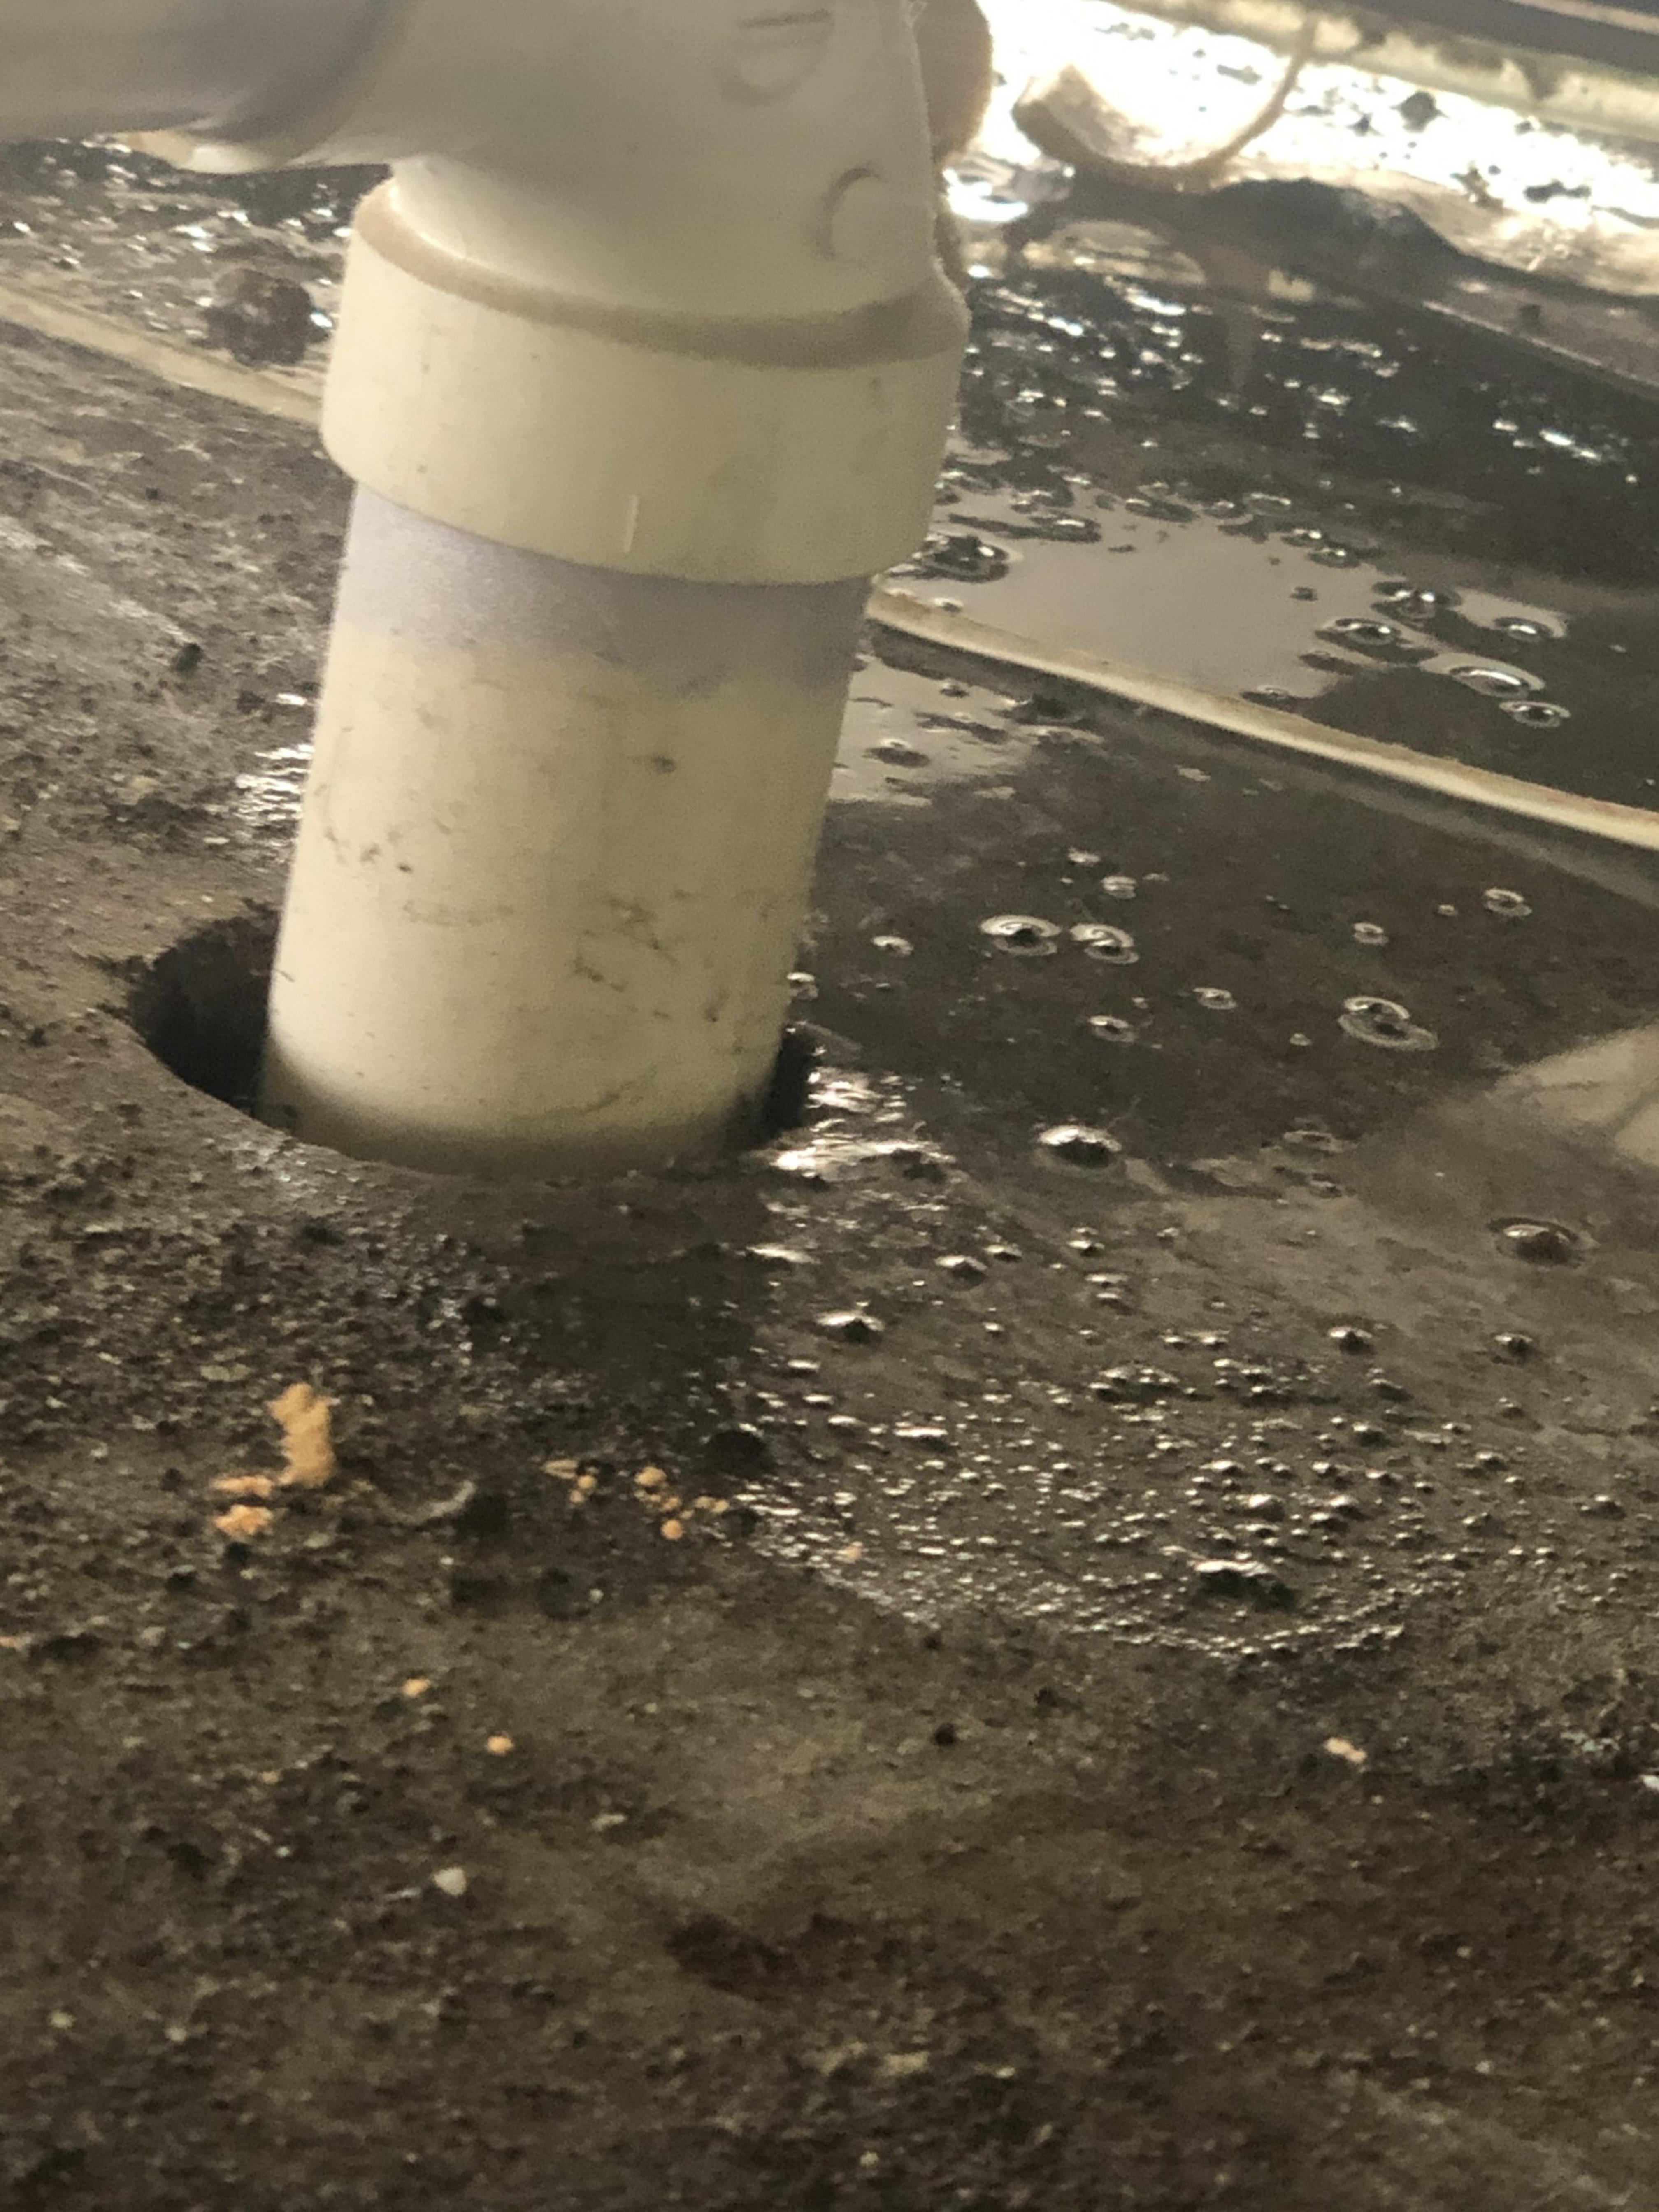
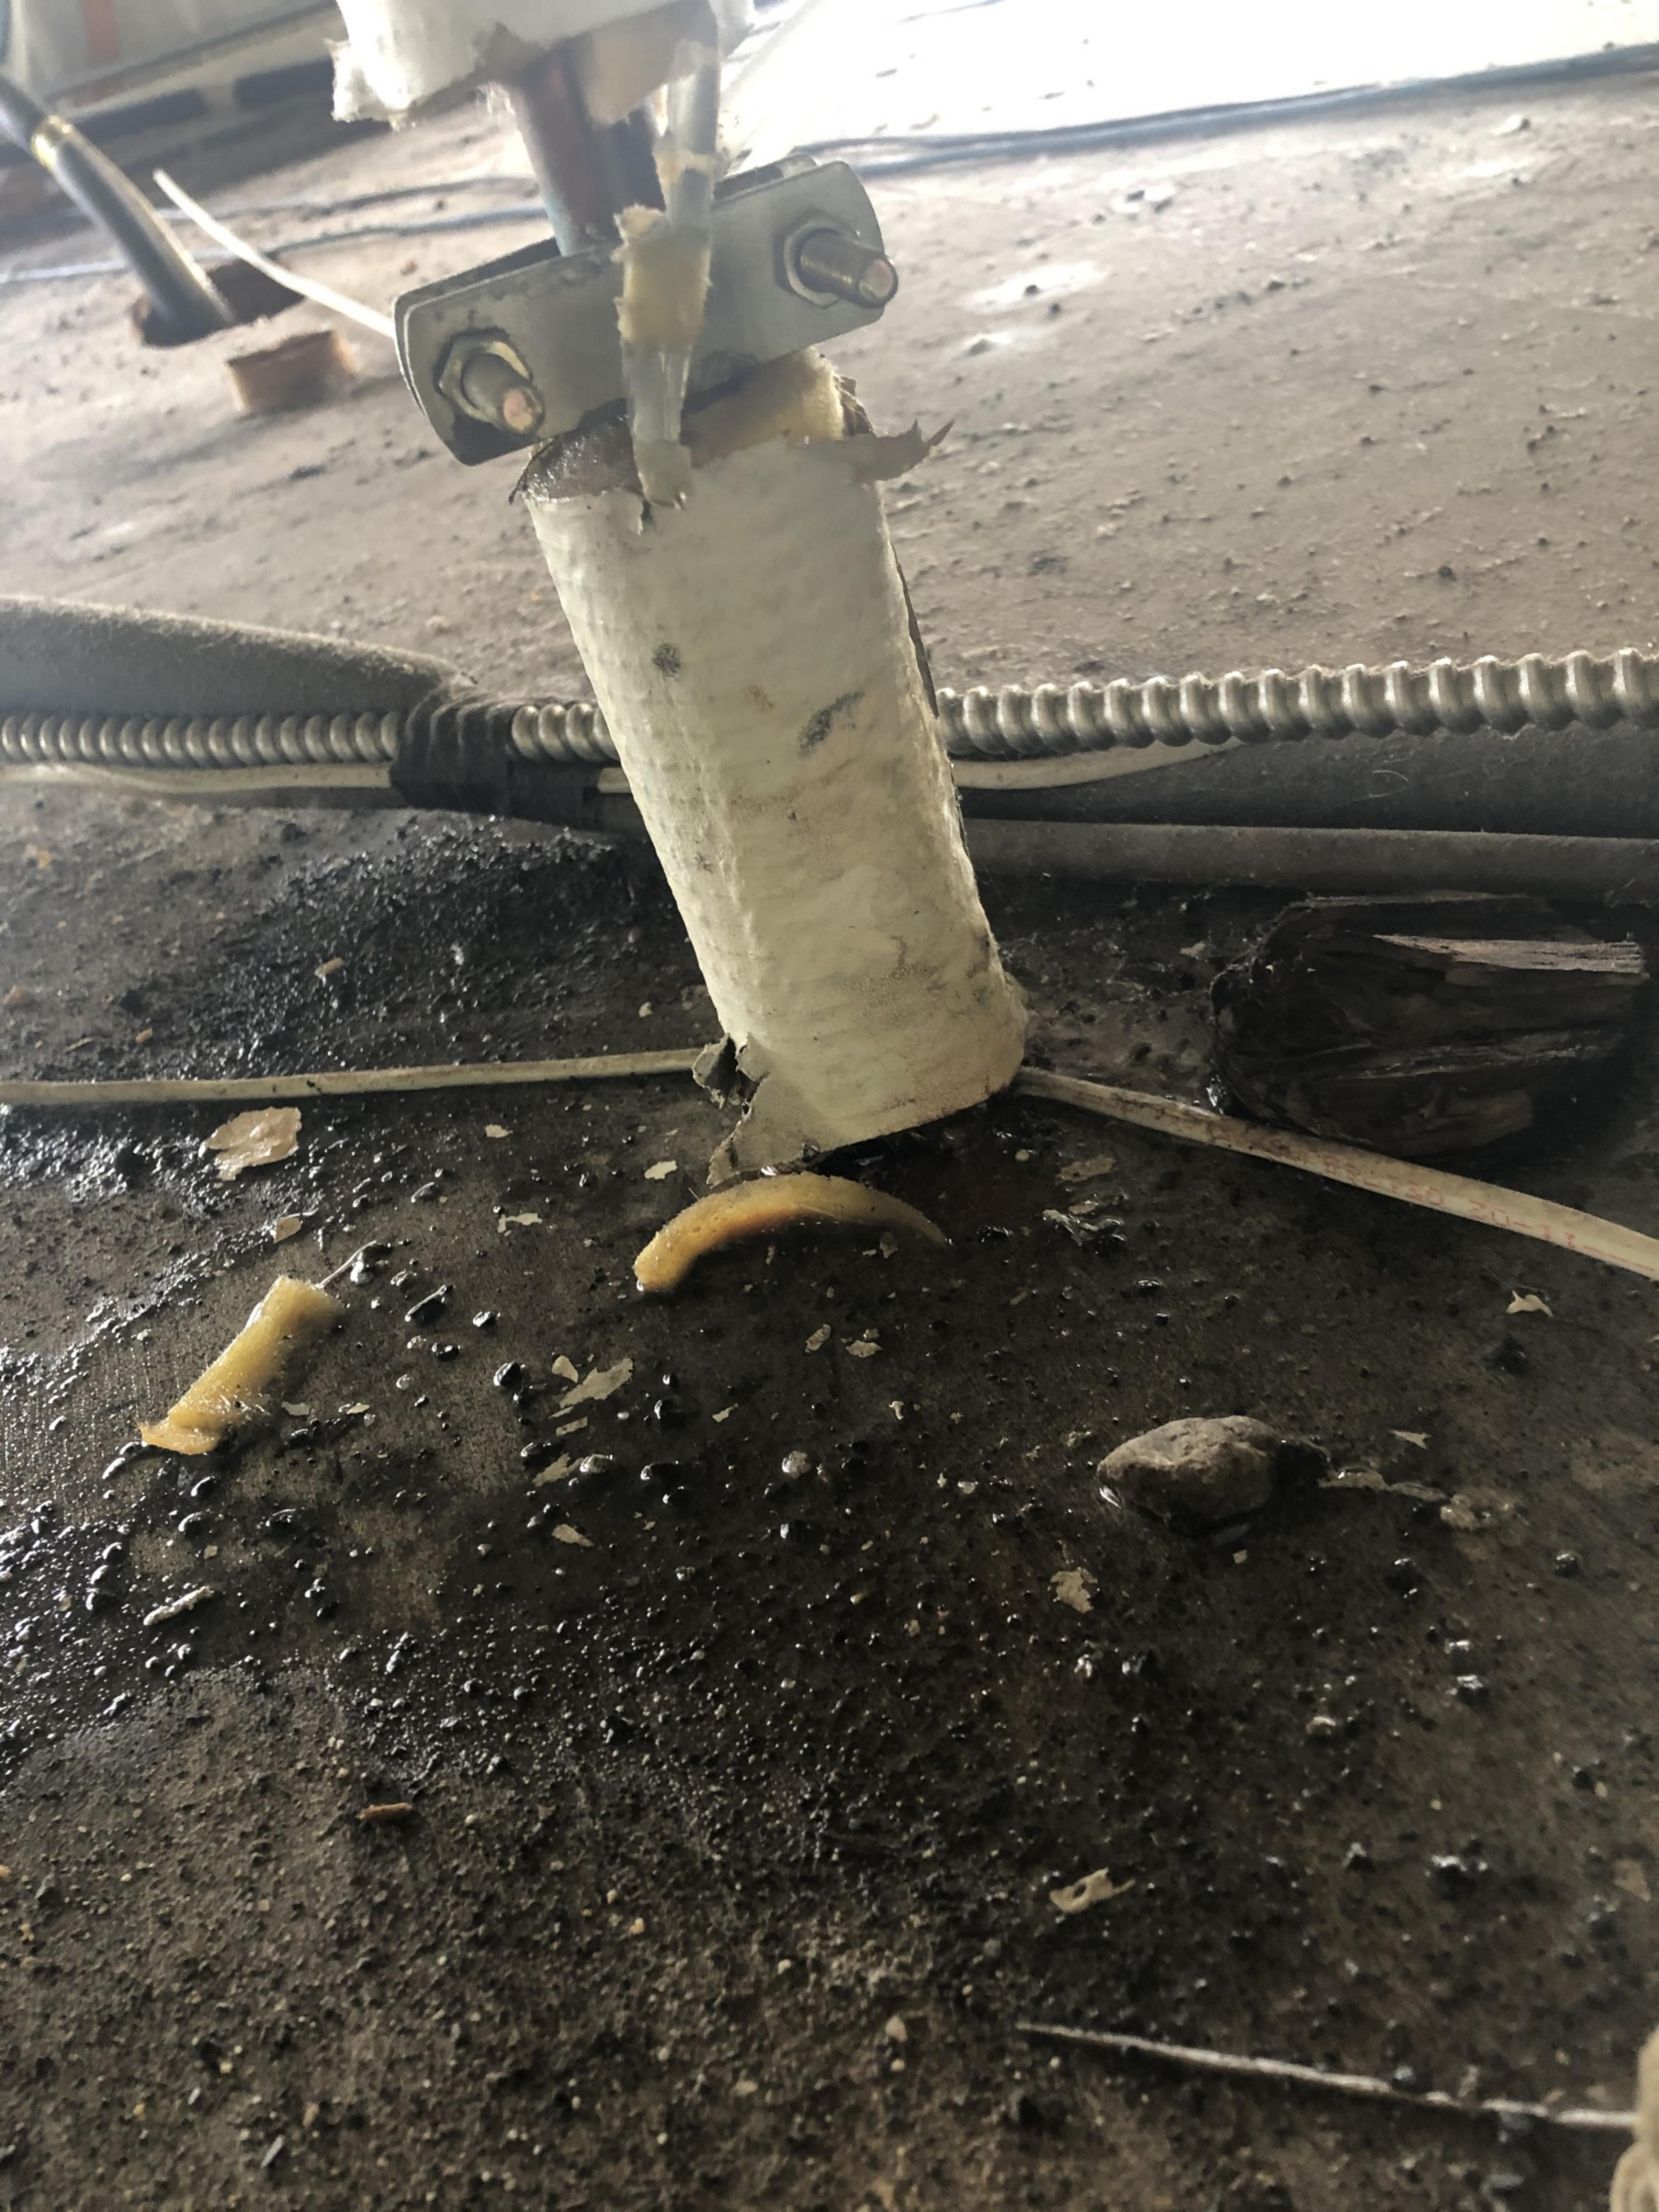
VA048 AMSA shop  
Above electrical room/office  
Leak from hw supply tap

Labor and materials to replace leaking 1/4 in saddle valve on hot water supply line.
