Additional Funding Request

WORK ESTIMATE

CSS #: 31537

Work Order #: 14391

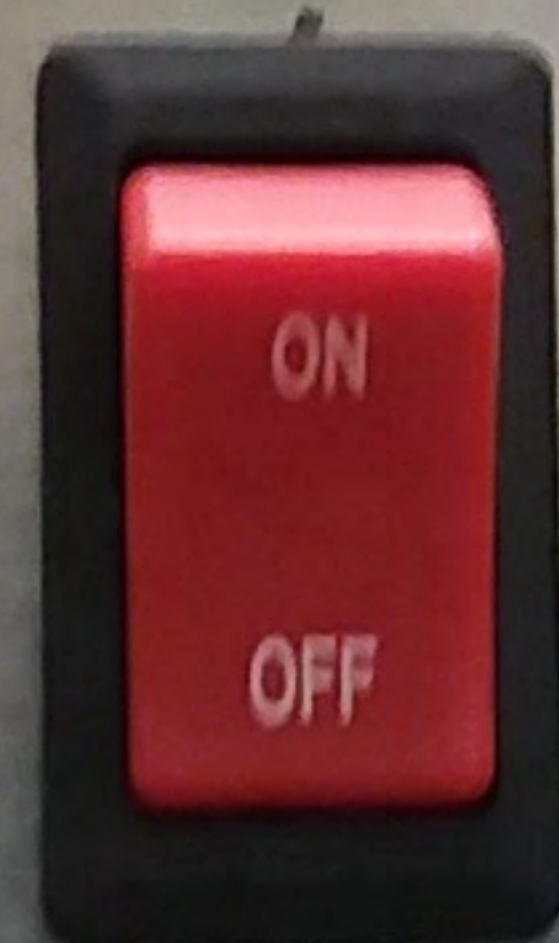
POWER
SWITCH

Labor and materials to replace temperature control switch due to bad relay and set the temperature, and run for 2 hours to test proper operation.
