Additional Funding Request

VA049	CSS# 31731 WO# 14672				
Description of Repairs	Moore's is proposing to replace two (2) failed damper actuator motors on air handler unit 1 that serves the second floor offices, as well as start, test, and ensure proper operation.				
Diagnosis: Initial Work Order	AC out on 2nd floor in command suite.				
Diagnostic Fee	\$ 360 Labor \$120/hr x 3				
Additional Labor Cost to Perform Repairs	\$ 480 Labor \$120/hr x 4				
Additional Material Cost to Perform Repairs	\$ 753.47 <table border="1" style="width: 100%; border-collapse: collapse;"> <tr> <td style="width: 50%;">Materials (see attached detail)</td> <td style="width: 10%; text-align: center;">1</td> <td style="width: 10%; text-align: center;">753.47</td> <td style="width: 10%; text-align: center;">753.47</td> </tr> </table>	Materials (see attached detail)	1	753.47	753.47
Materials (see attached detail)	1	753.47	753.47		
Total Cost of Repair	\$ 1,593.47

Proposal

Unit 1
Trane
Model # CGAM070A
Serial # U10C14744

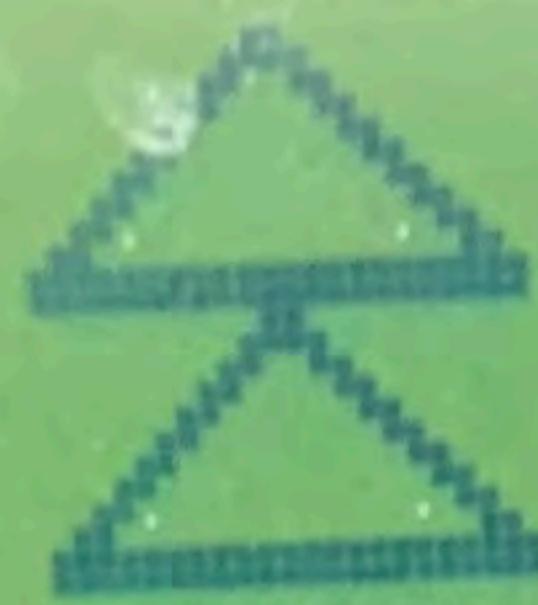
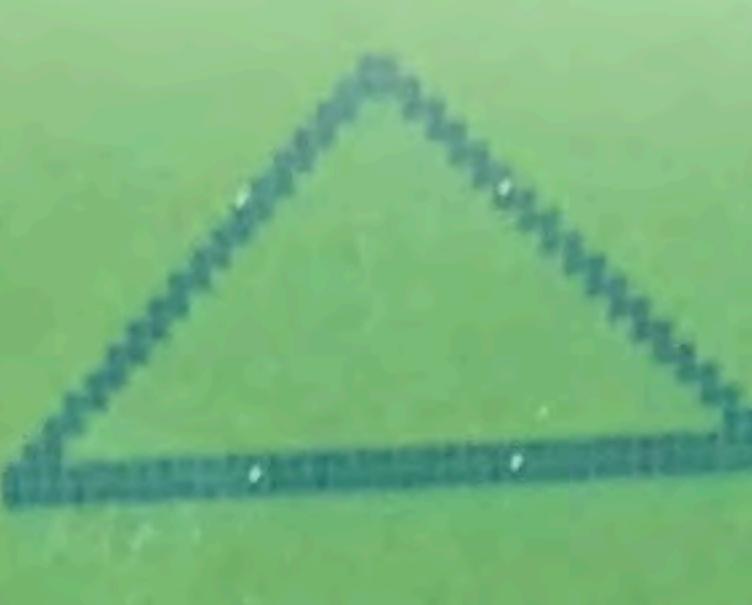
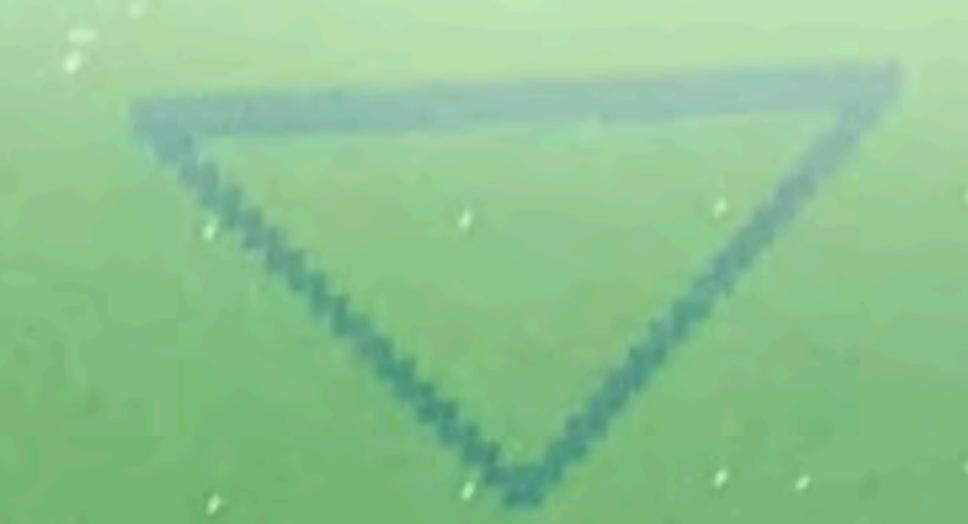
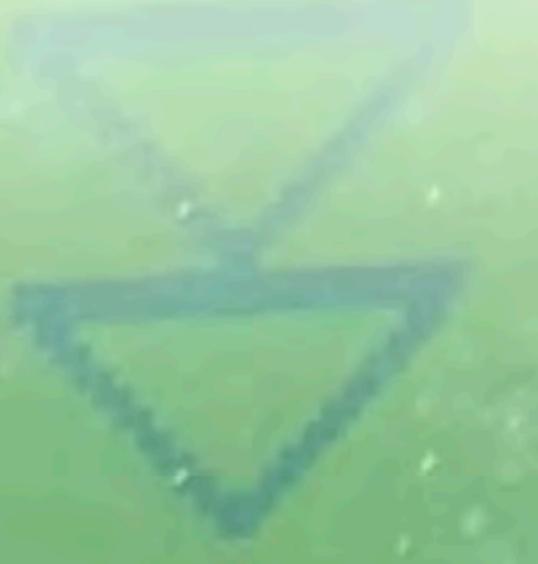
Chiller Mode: Running

Circuit 1 Mode: Running

Circuit 2 Mode: Running

Active Chilled Water Setpoint: 42.5 F

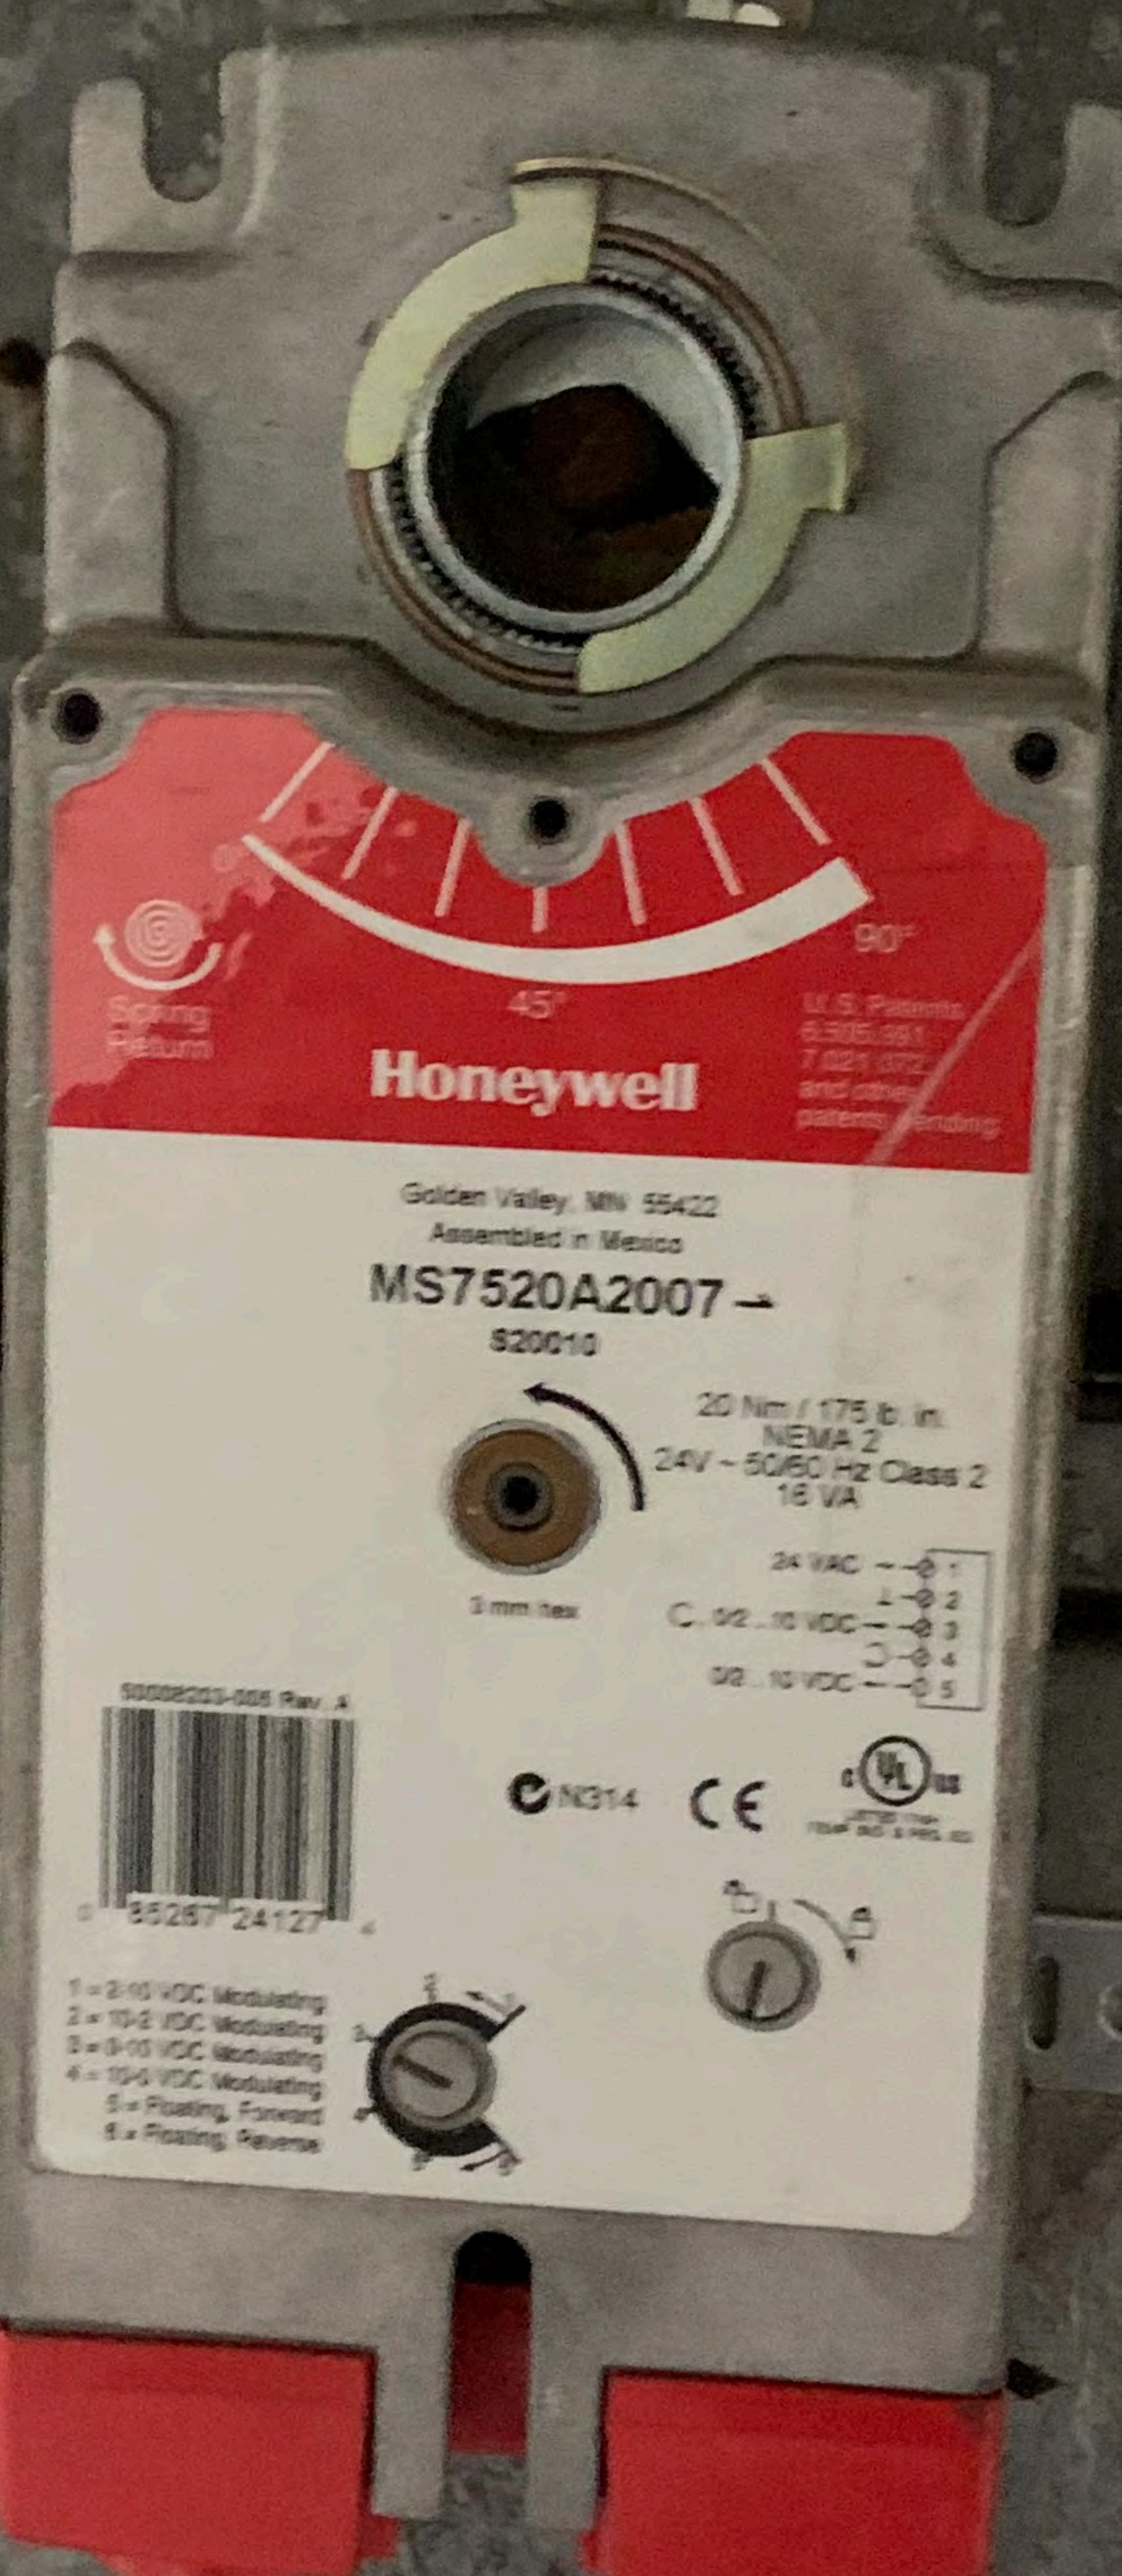
Zone Dampers AHU-1

Space Temp	Heat SP	Cool SP	ACT SP	Damper %	SF Status
Zone 1-1	66.9	70.0	72.0	70.0	0.0	Active
Zone 1-2	71.2	70.0	72.0	72.0	0.0	Active
Zone 1-3	72.9	68.0	75.0	72.0	100.0	Active
Zone 1-4	71.9	70.0	72.0	72.0	40.4	Active
Zone 1-5	68.5	69.0	72.0	72.0	0.0	Active

Moore's is proposing to replace two failed damper actuator motors on air handler unit 1 that serves the second floor offices. Will start, test, and ensure proper operations.
