Additional Funding Request

VA701	CSS# 33428 WO# 15416							
Description of Repairs	Tidewater proposes labor and equipment to replace 24 ceiling tiles in the drill hall.							
Diagnosis: Initial Work Order	Fourteen of the vents in the drill hall has dirt or mold forming and needs to be cleaned and investigate root cause. It was found that the issue was not on the vents, but smeared on the ceiling tiles.							
Diagnostic Fee	<p>\$ 360</p> <p>Moore's Labor cost incurred \$120/hr x 3</p>							
Additional Labor Cost to Perform Repairs	<p>\$ 320</p> <p>Labor \$80/hr x 4</p>							
Additional Material Cost to Perform Repairs	<p>\$ 630.35</p> <table border="1" style="width: 100%; border-collapse: collapse;"> <tr> <td style="width: 50%;">Scissor Lift 24-26' Electric 30-36" Wide (1 day rental)</td> <td style="width: 10%;">1</td> <td style="width: 10%;">630.35</td> <td style="width: 10%;">630.35</td> </tr> </table>				Scissor Lift 24-26' Electric 30-36" Wide (1 day rental)	1	630.35	630.35
Scissor Lift 24-26' Electric 30-36" Wide (1 day rental)	1	630.35	630.35					
Total Cost of Repair	\$ 1,310.35

WORK ESTIMATE

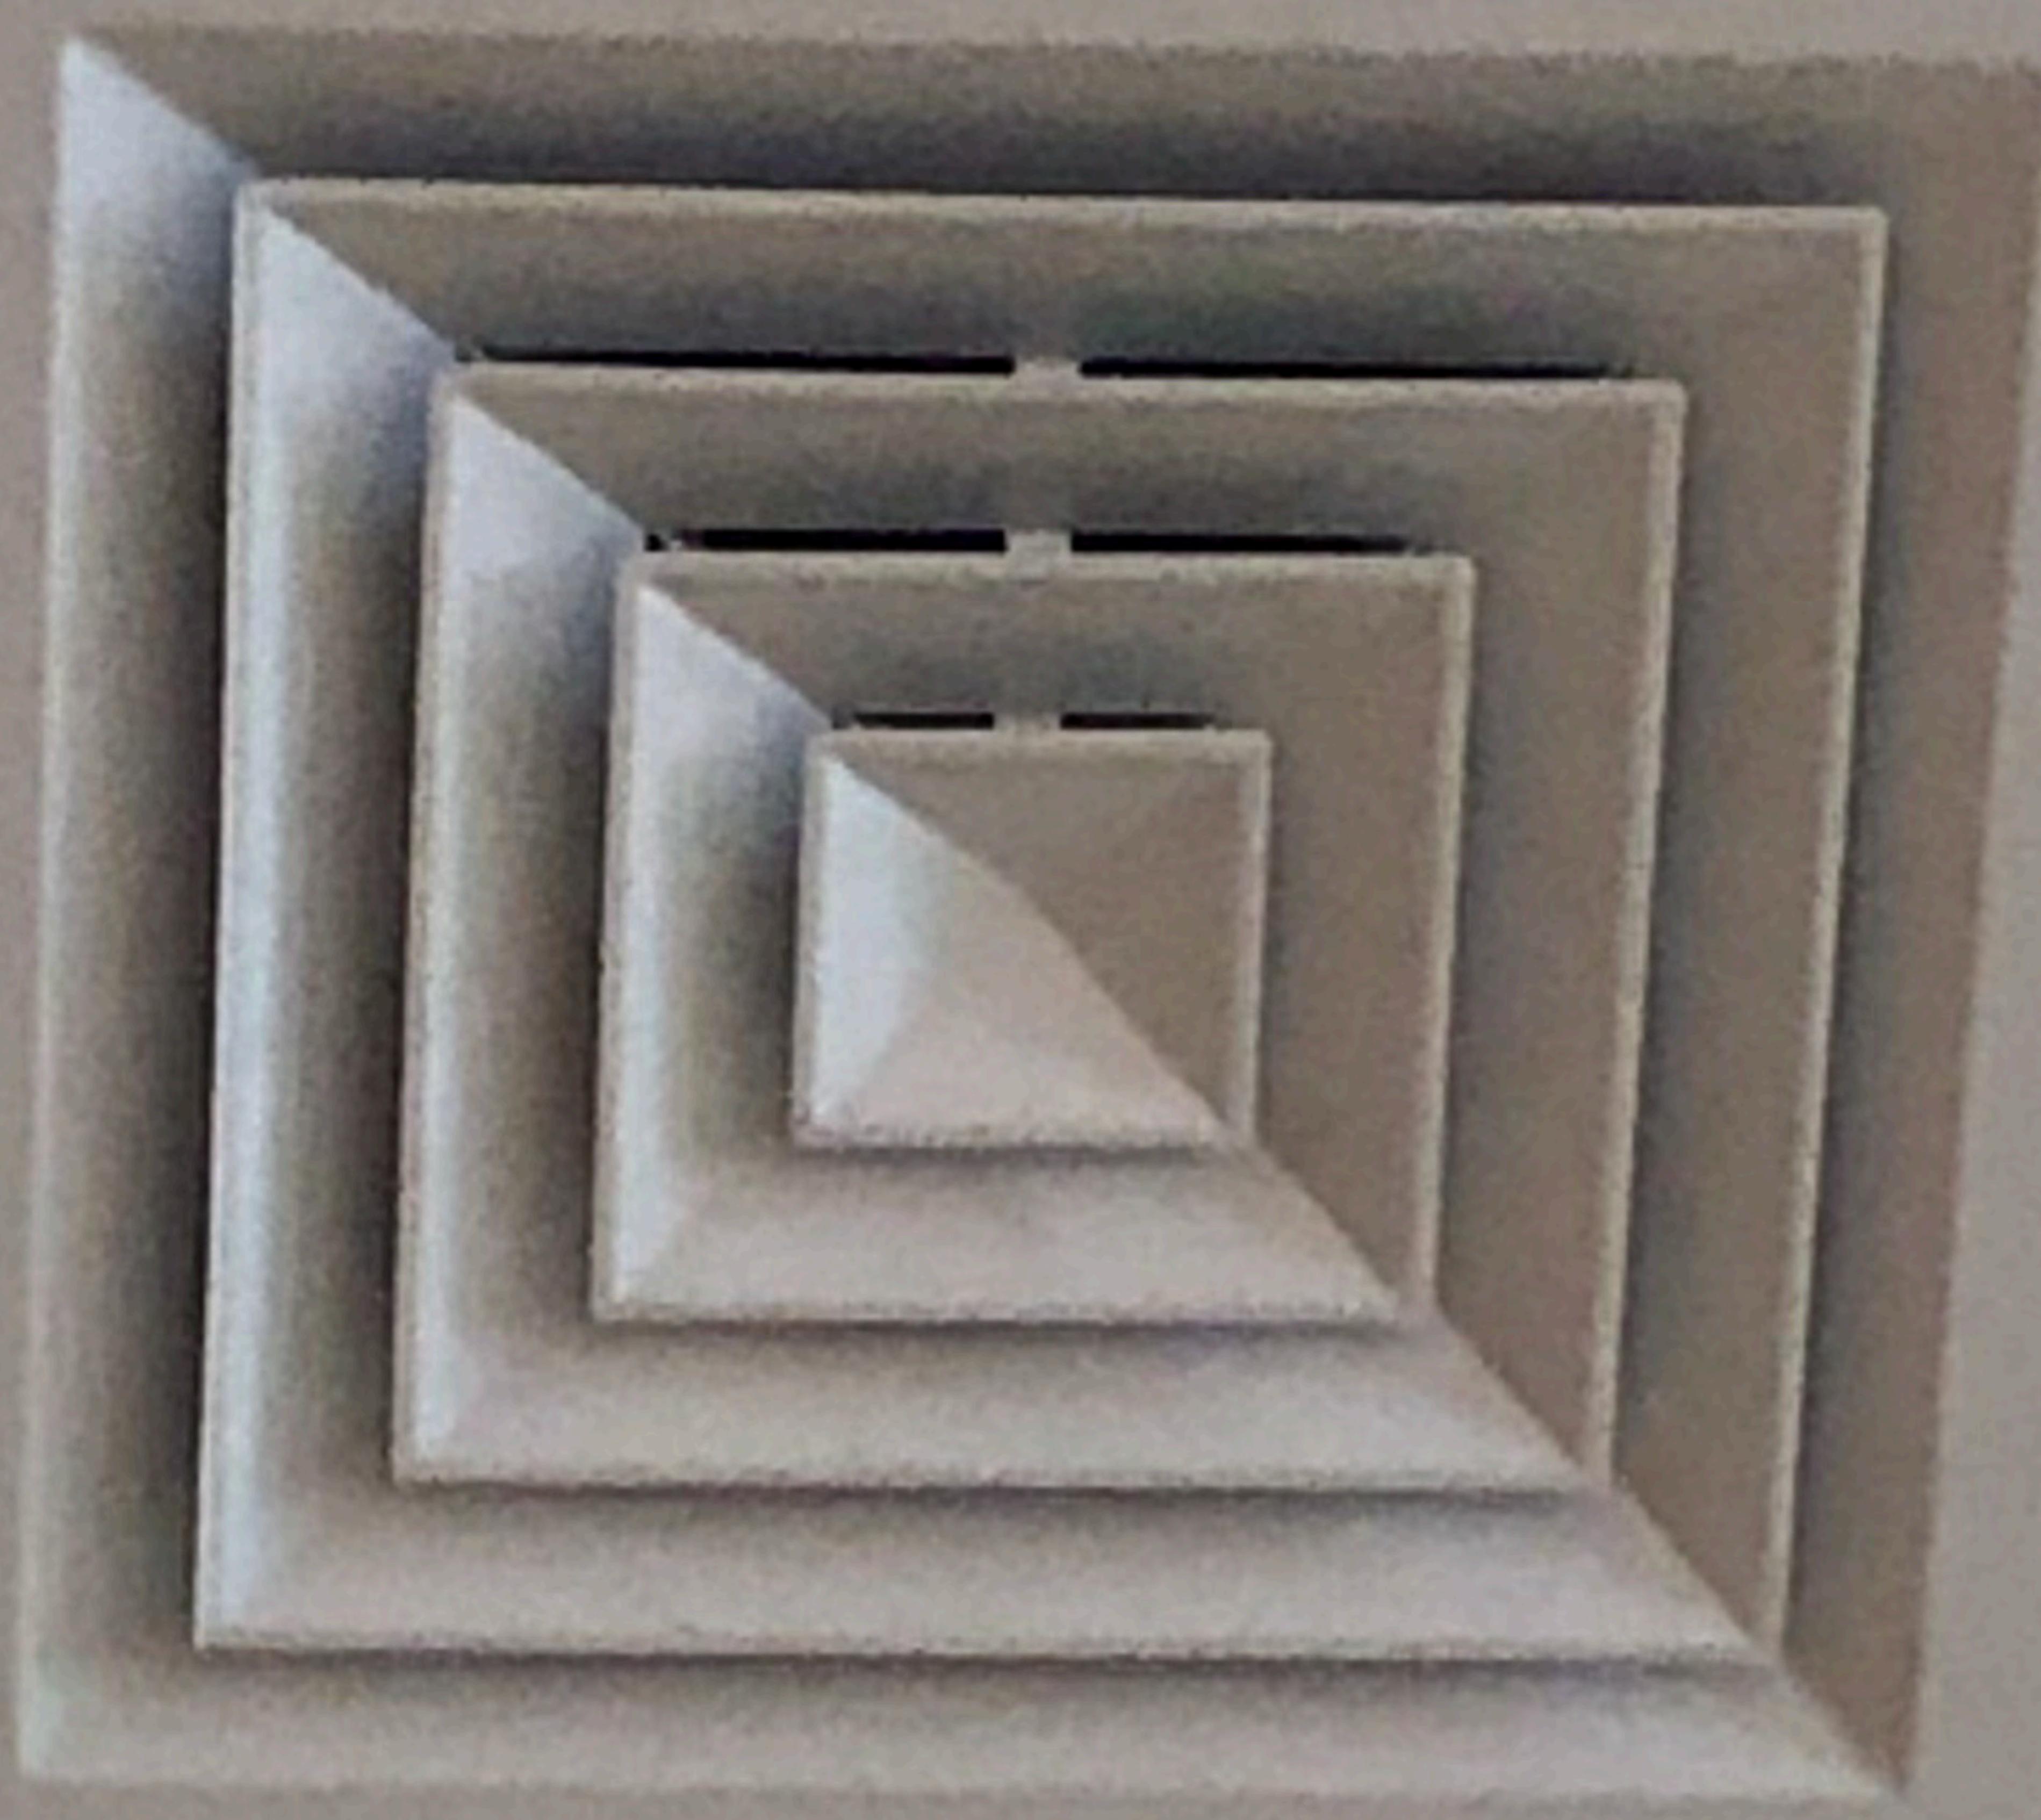
Tech: JACOB LONG, Date: 11/18/21 - Accessed front training room where contaminated vents were reported. From ground level it appears to be dust gathered all along the surrounding tiles located directly around ceiling registers. Ceiling height is 16+ feet in the air and will need a second man with 14' ladder to safely access and clean. Spoke with CSR and received approval to proceed. Awaited ASM to arrive with ladder and after closer examination we found the vents themselves are clean free of dust only the ceiling tiles have some type of microbial growth, attempted to clean but was unsuccessful due to the type of growth and or type of material ceiling tiles are made out. Tiles just became smeared and stained. Spoke with Rick who requested we quote to replace all affected tiles.

Root cause of the issue is unknown as there are many factors and variables e.g. humidity levels, air temperature coming from vents crossing temperature of high ceiling temp along with having a reaction to the material used in tiles. Ceiling tiles aren't standard and are made of minimum 81% recycled materials. Spoke with SFC Casey who was able to find the part numbers for the tiles used for ordering. Will submit quote for replacement of 24 tiles.

Labor and equipment to replace 24 ceiling tiles in the drill hall using existing extra tiles which are onsite.
