Perform mold abatement in the basement in rooms 21 and 22. On 9 September a mold assessment was done in rooms 21-23 located in the basement. Mold was identified, non-threatening, and needs to be removed by a certified NYS specialist.

# Microbial Assessment & Mitigation Recommendations

**Re: Microbial Assessment & Mitigation Recommendations**  
**Amherst United States Army Reserve Center**  
**100 North Forest Road**  
**Amherst, NY 14221**  
**Project ID: 24-0909MN-A**

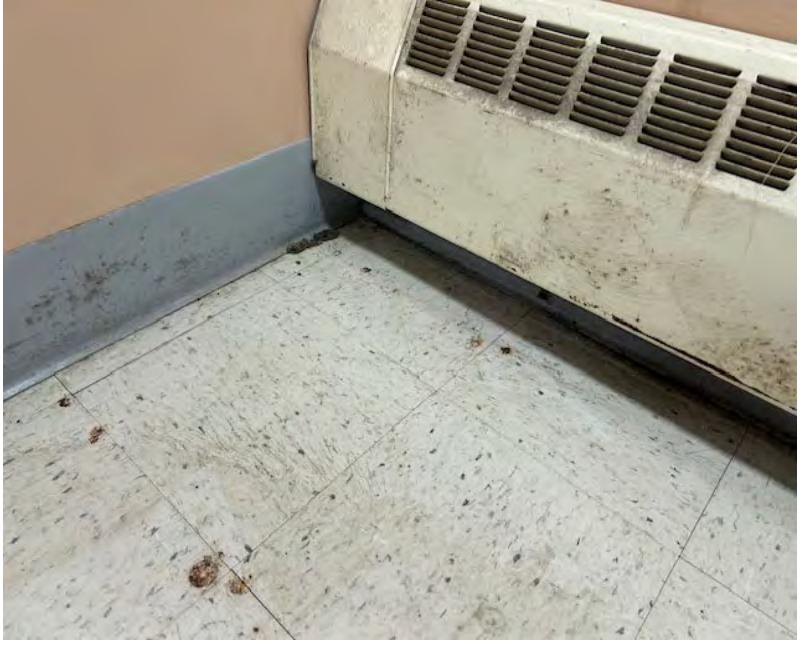
<p><b>Location:</b> Basement -Classroom</p> <p><b>Observation:</b> -Visible microbial growth on lower walls, baseboard, floors, and radiators</p>

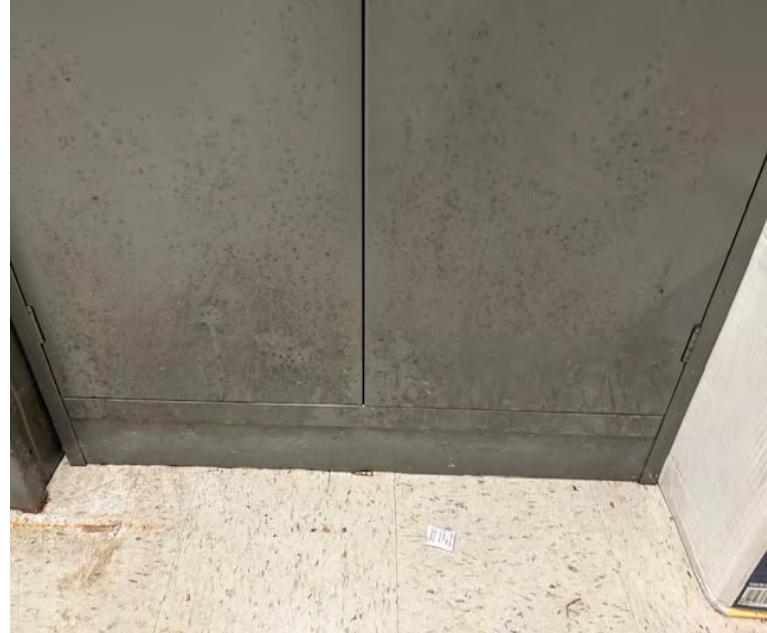
<p><b>Location:</b> Basement -Classroom</p> <p><b>Observation:</b> -Visible microbial growth on metal storage cabinets</p>

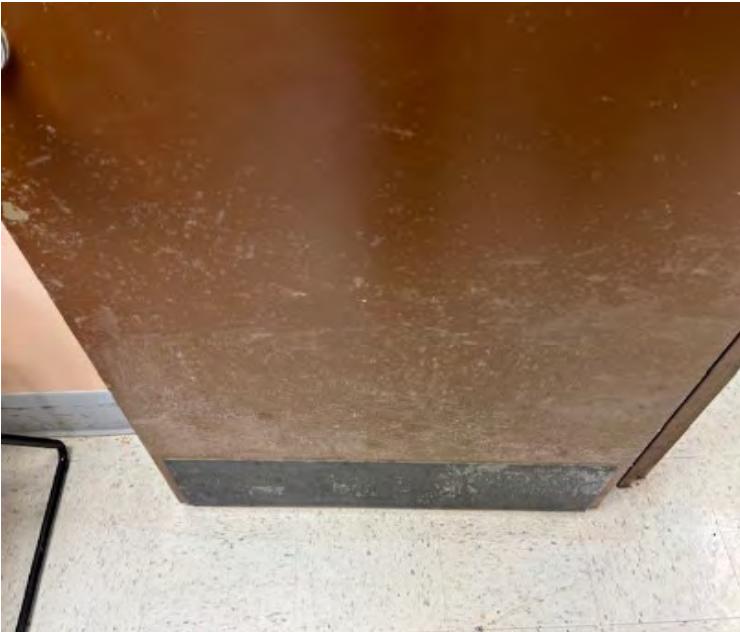
<p><b>Location:</b>  Basement  -Classroom</p> <p><b>Observation:</b>  -Visible microbial growth on doors throughout</p>

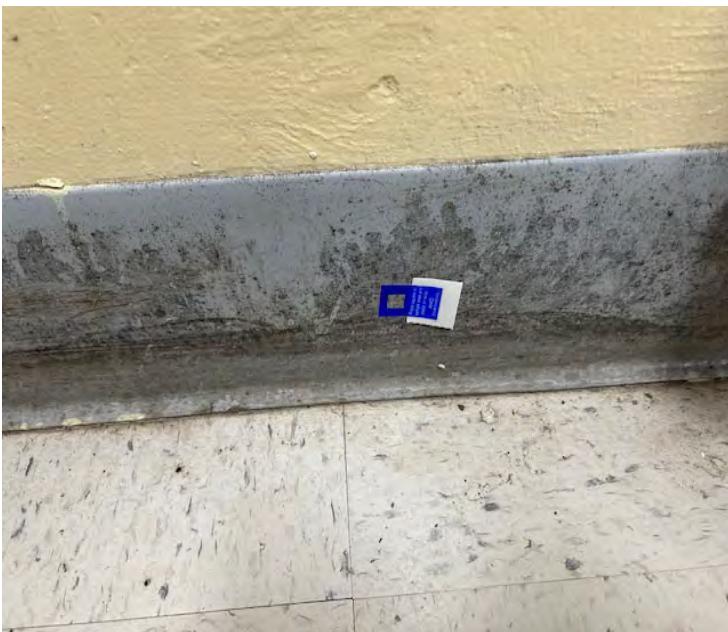
<p><b>Location:</b>  Basement  -Classroom</p> <p><b>Observation:</b>  -Visible microbial growth on surfaces confirmed by tape lift sample and analysis</p>

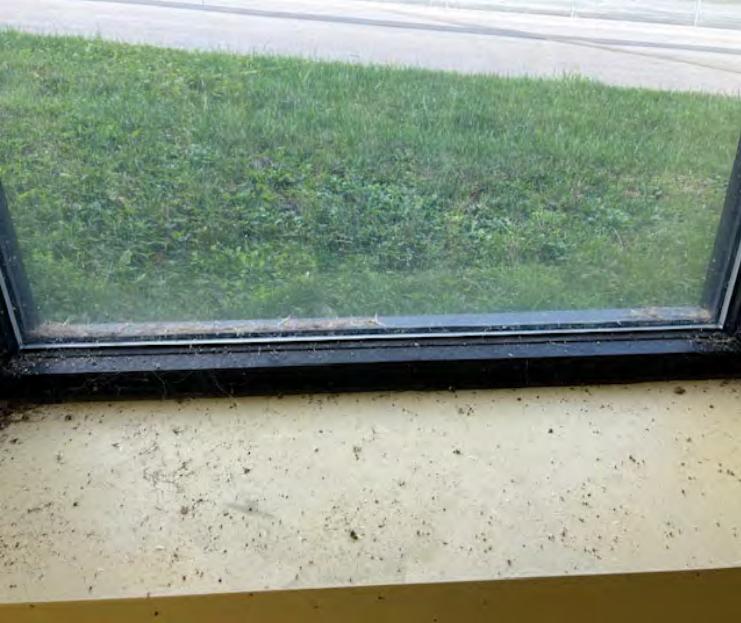
<p><b>Location:</b>  Basement  -Classroom</p> <p><b>Observation:</b>  -Visible microbial growth on window components including glass.</p>

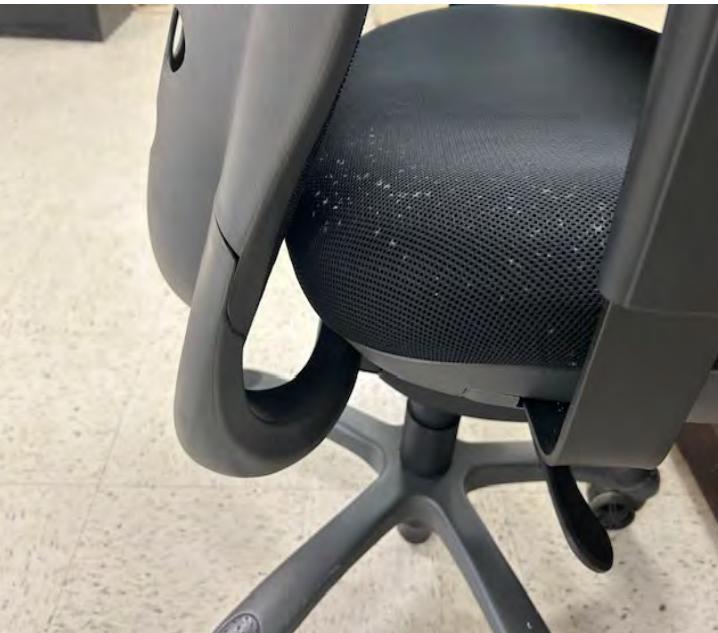
<p><b>Location:</b>  Basement  -Classroom</p> <p><b>Observation:</b>  -Visible microbial growth on furniture.</p>

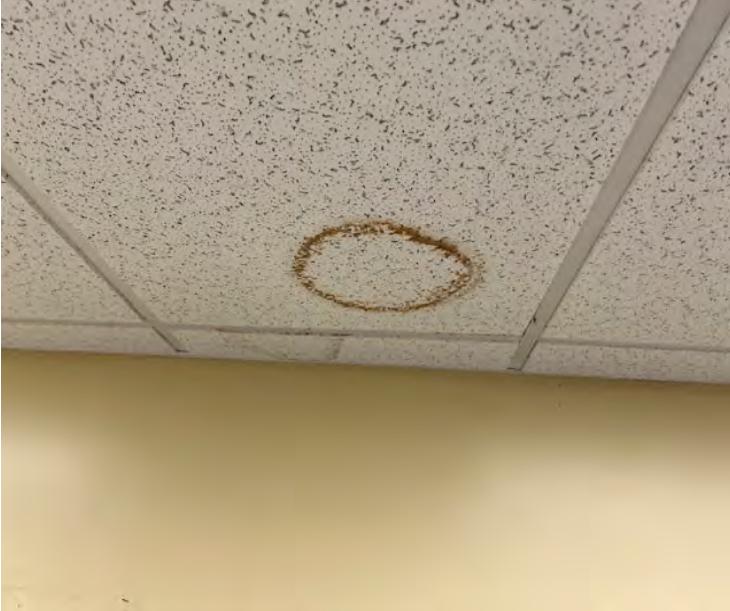
<p><b>Location:</b>  Basement  -Classroom</p> <p><b>Observation:</b></p> <ul style="list-style-type: none"> <li>-Visible water stains at a small number of ceiling tiles</li> <li>-No visible moisture intrusion source or internal plumbing leaks were detected at these stained locations on the day of the inspection</li> </ul>

- **Surface mitigation** to all affected areas to include walls, baseboards, doors, floors, attachments, furniture, and stored items per section 4.4 and 4.5 of the “Microbial Mitigation Work Scope” included with this report **Affected Area 1300 SF.**
- **Remove, bag in place, and dispose of all visibly stained ceiling tiles.**

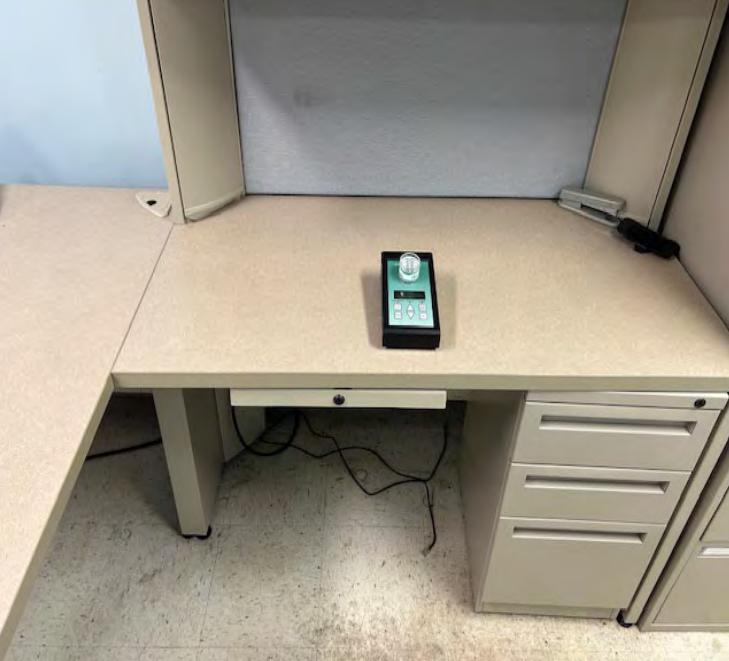
<p><b>Location:</b>  Basement  -Classroom</p> <p><b>Observation:</b></p> <ul style="list-style-type: none"> <li>-Representative air samples collected from the affected area confirmed elevations in allergenic mold spores</li> </ul>
