Fratello & Amico, Inc.

May 16, 2025

RE: WV010, Report of Oil Water Separator Cleaning and Preventative Maintenance Inspection, Clarksburg USARC/OMS, Rt 2, Box 77, Bridgeport, WV 26330

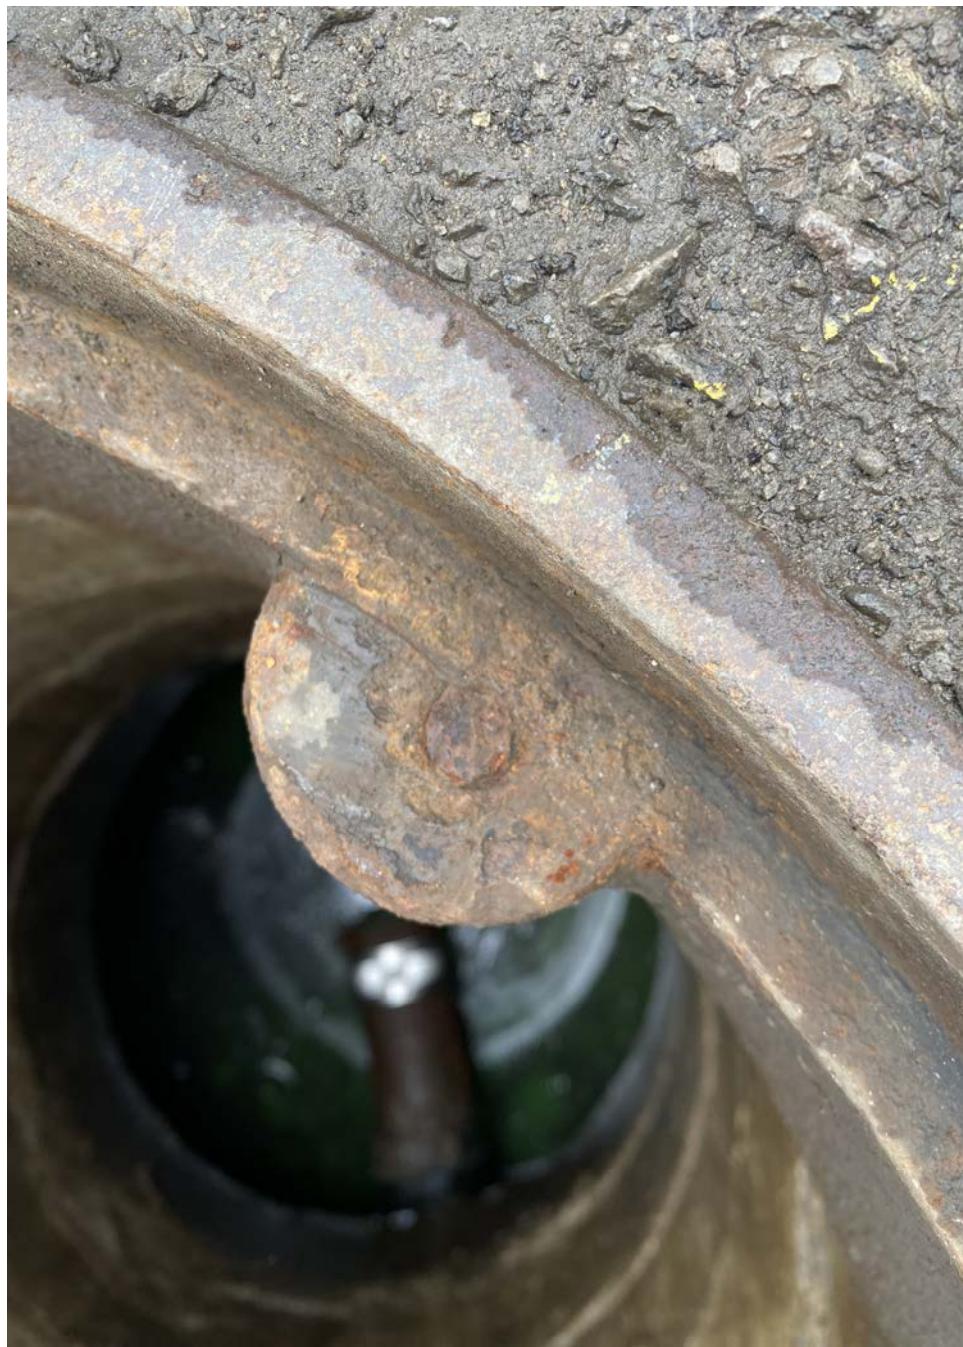
Three of the manhole cover bolts are sheared off and seized in the manhole cover bases, as we reported in 2021, and two of the covers have cracked edges.

Conclusions and Recommendations: The OWS system is working properly, but we would recommend the repair of the manhole cover bolts.
