Fratello & Amico, Inc.

RE: WV022, Report of Oil Water Separator Cleaning and Preventative Maintenance Inspection, Preston County USARC, 13 Albright Rd, Kingwood WV 26537

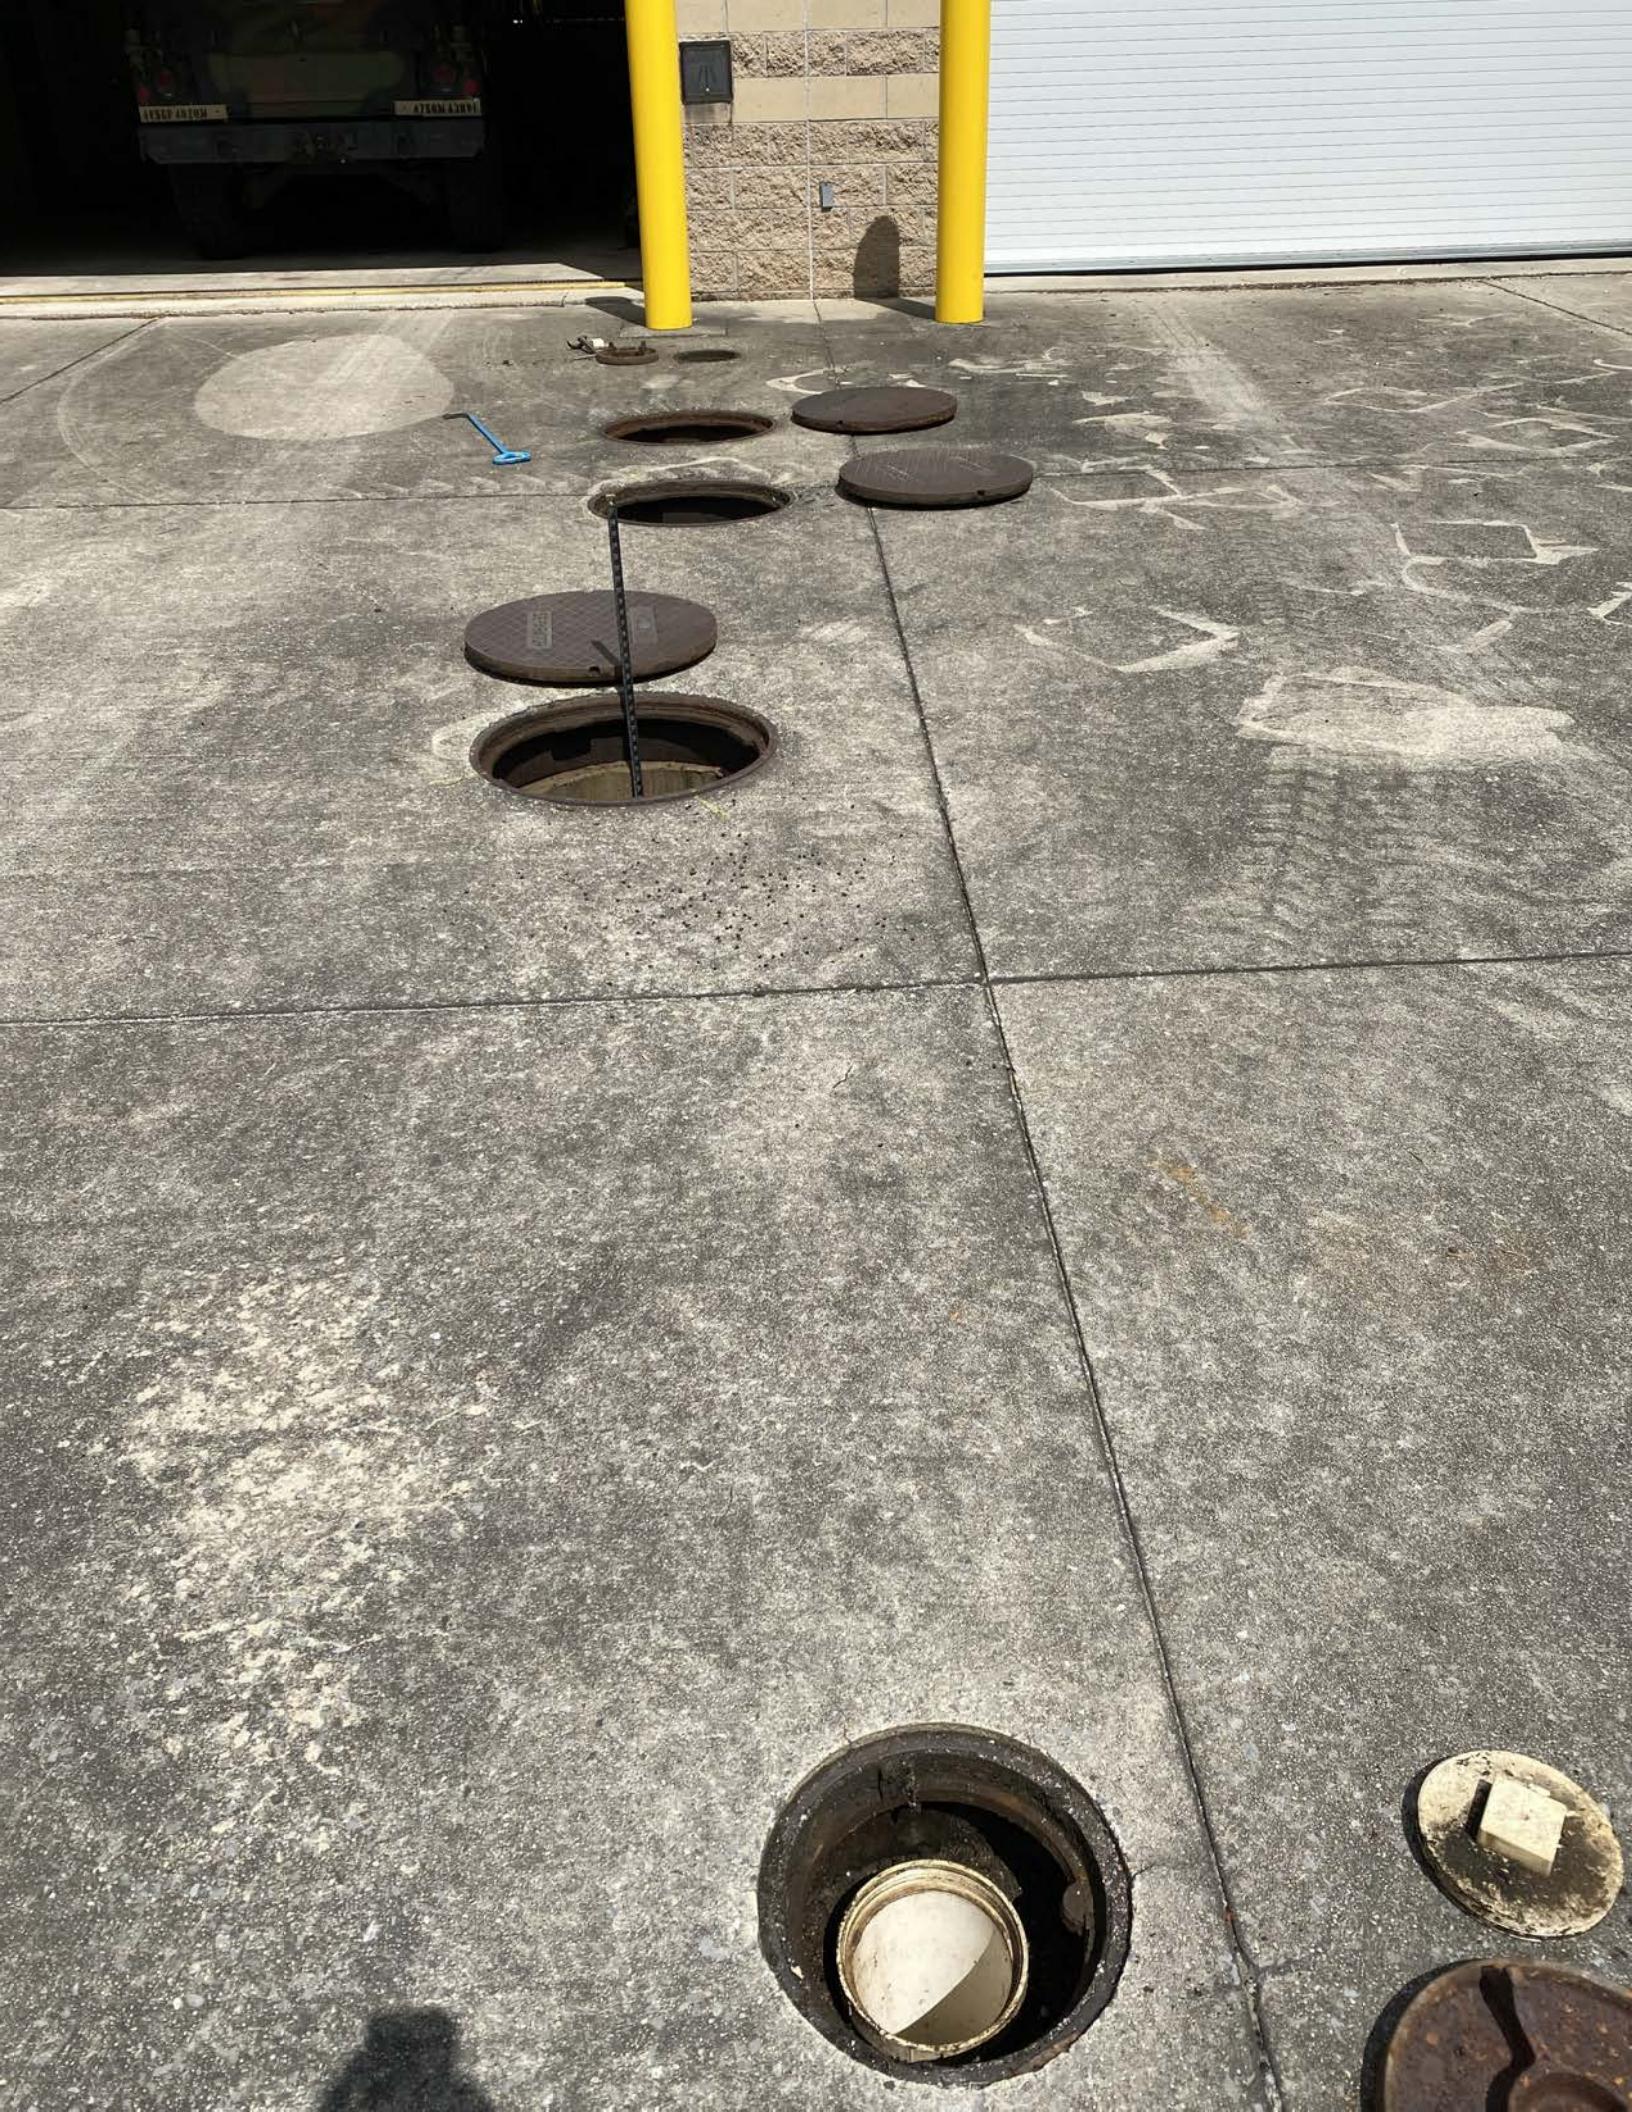
Site Service Performed: We mobilized to the facility on the afternoon of Wednesday, May 14, 2025. The three chambers of the system were accessed by the removal of three manhole covers.

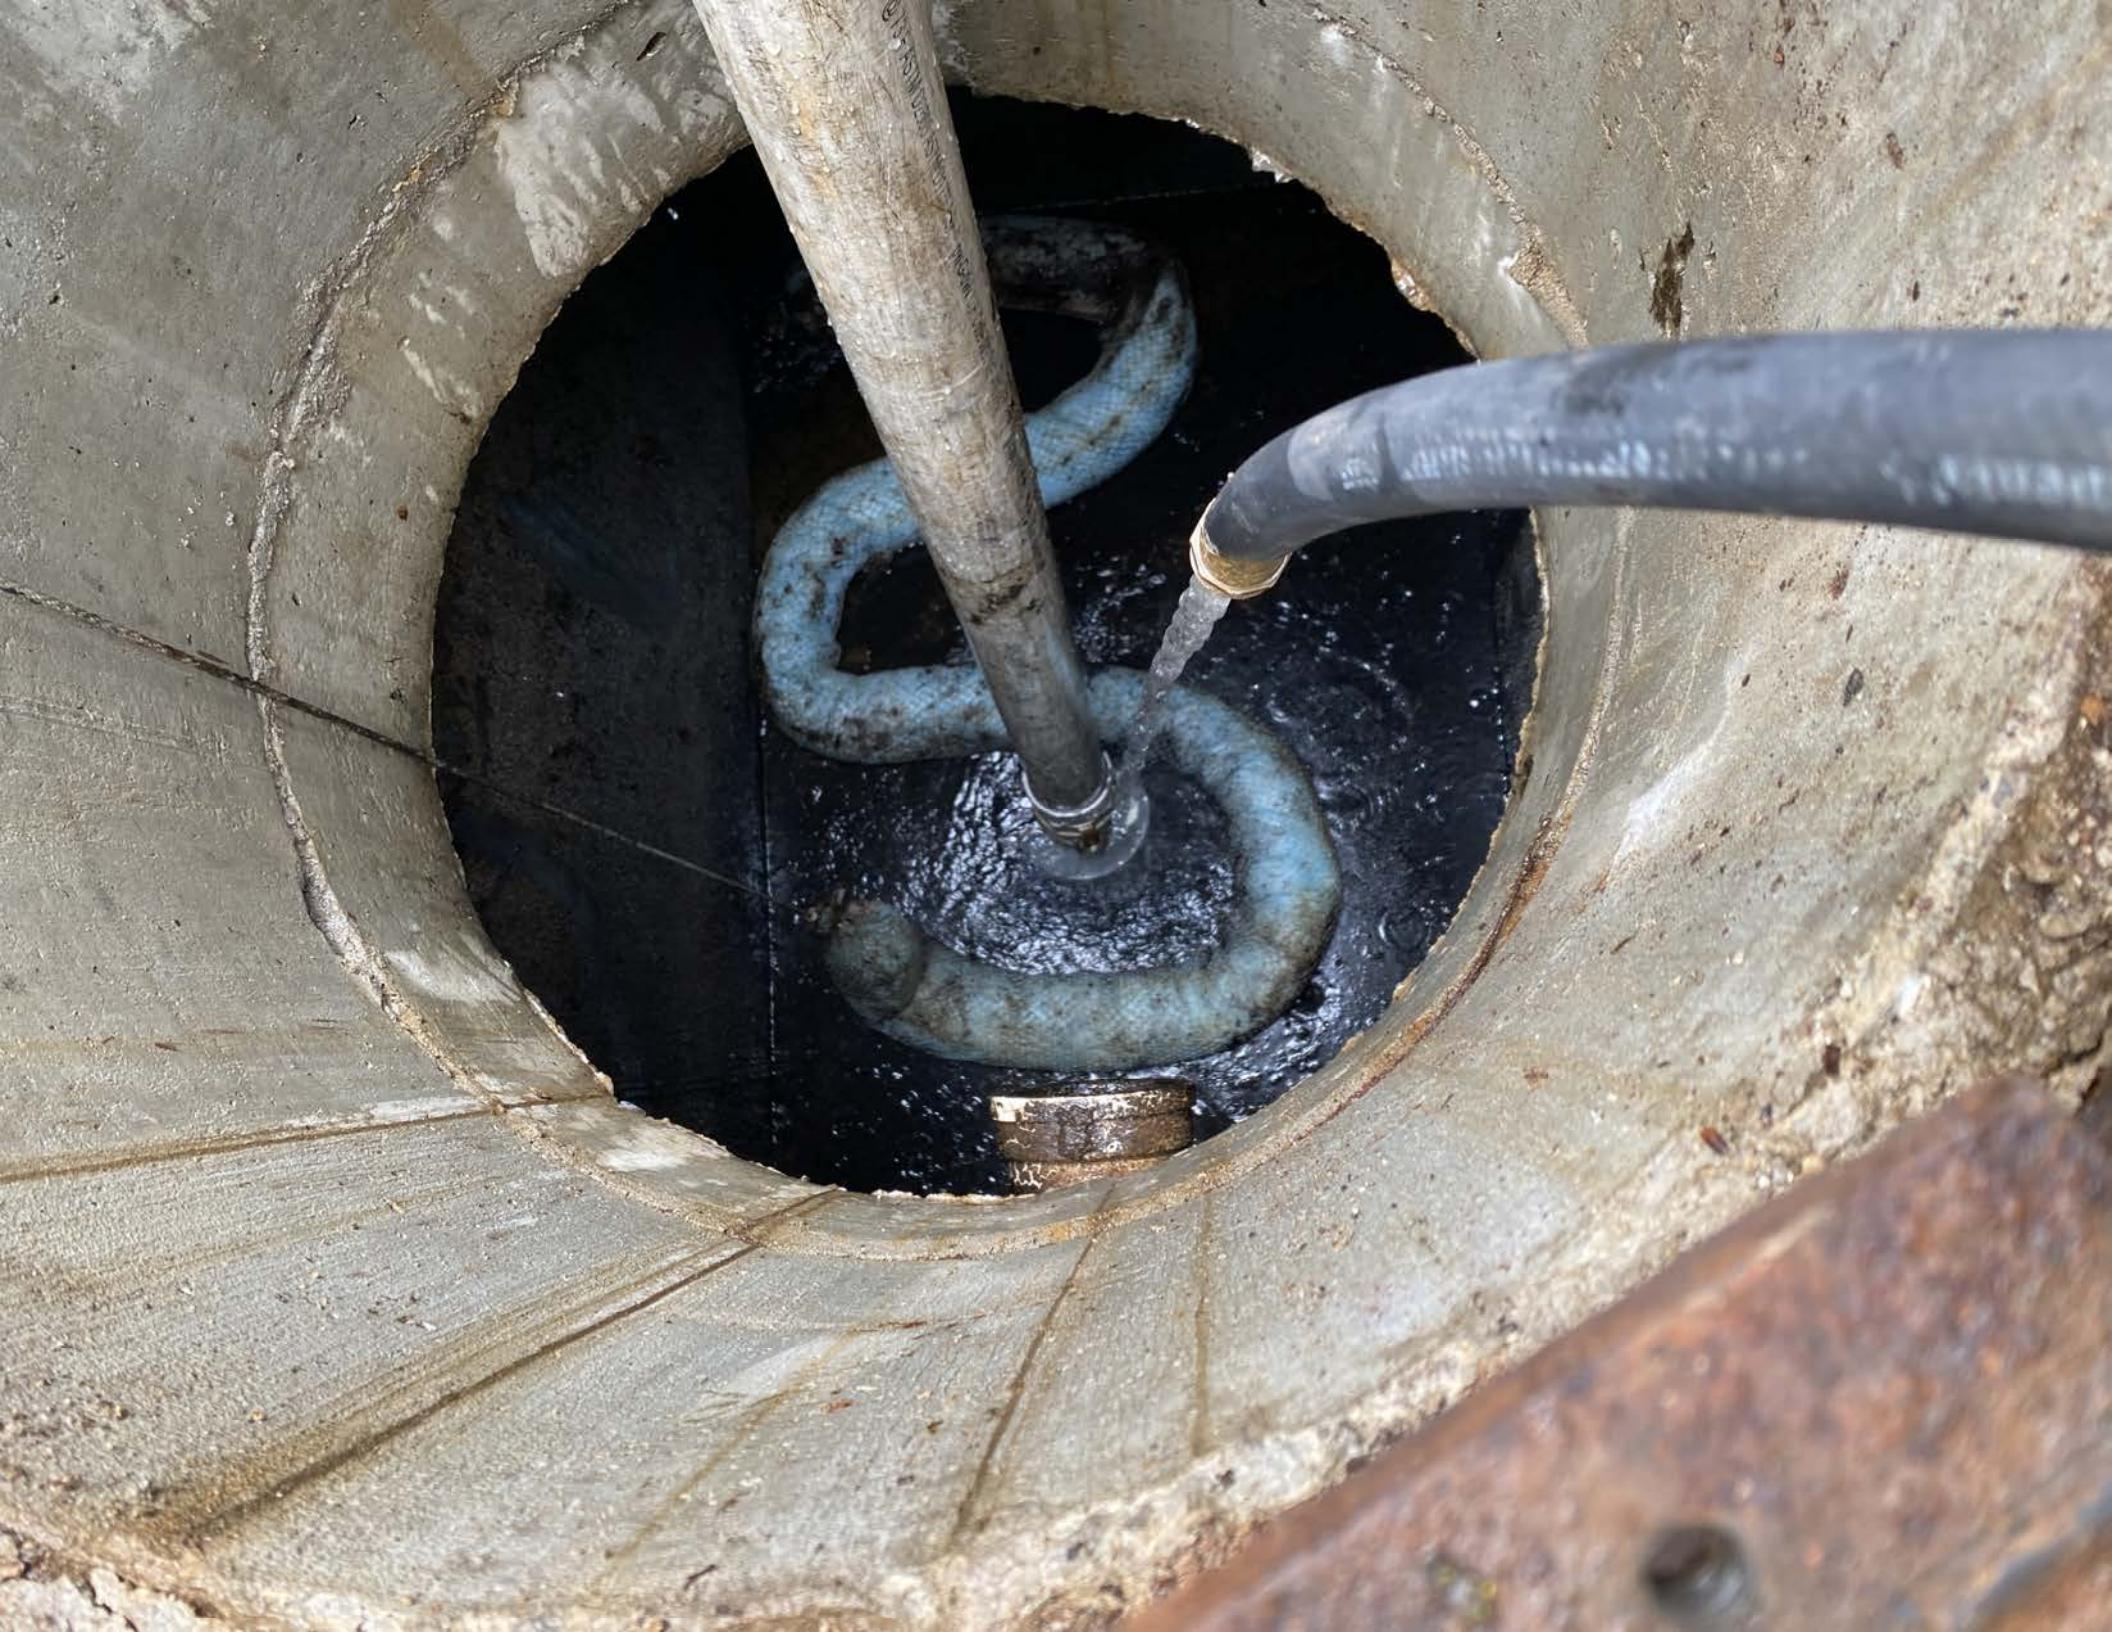
Free floating oil was removed from the chambers and the water phase was filtered and processed through the system until the bottom of each chamber was visible. No measurable sludge was encountered in any of the three chambers during the dewatering operation.
