Management Report

CMI Management
USARC - AMSA
99 Soldiers Lane, Coraopolis, PA

USARC - AMSA
99 Soldiers Lane
Coraopolis, PA**Site Overview**

Deficiencies

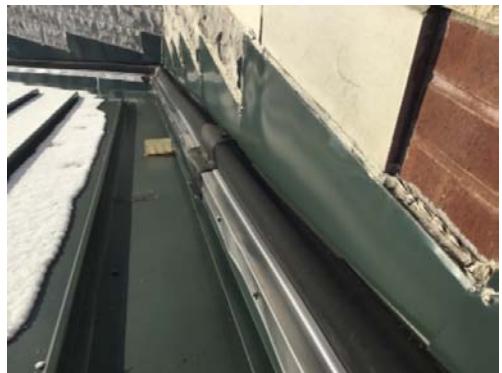
Sheet Metal - Exp Jnt - Roof to Wall - Open Seam (Emergency)

Quantity: 75 LF

Roof expansion joints are a structural separation between two building elements that allows free movement between the elements without damage to the roofing or waterproofing system.

The fasteners in the expansion joint should be removed and the area underneath should be investigated for signs of leaks. After the investigation, if leaks are present, proper repairs should be made. The expansion joint should then be reinstalled with new fasteners, water cut-off mastic, and demonic caulking to properly seal. Pricing for this will be provided in the proposal for work to be performed.

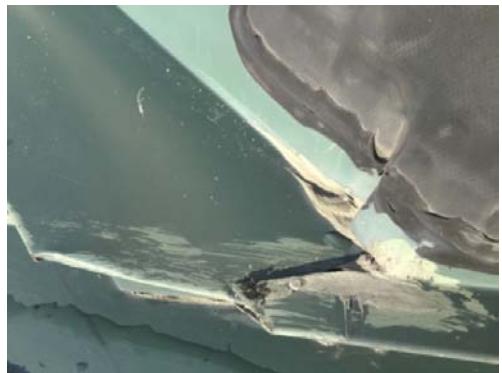
Metal Roofing Systems - Metal Edge - Open Laps (Emergency)

Quantity: 10 LF

Metal edge joints are open and leaking. The open laps edge can cause damage to the roof system, deck and building interior.

Clean and secure all open joints and properly seal joints. Pricing for this repair will be included in the proposal for work to be performed.

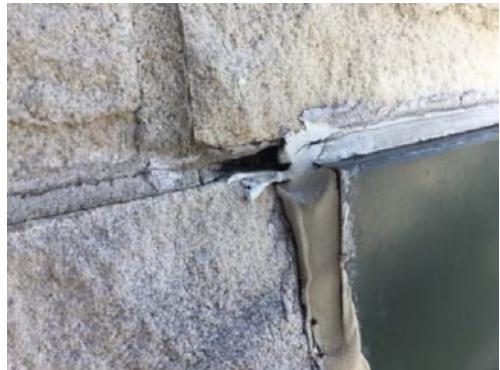
Metal Roofing Systems - Caulking Deterioration (Emergency)

Quantity: 10 LF

Missing, loose, cracked or improperly applied lap seal.

Our recommendation will be to remove any loose material, clean the area and install new lap seal as required. Pricing for this repair will be included in the proposal for work to be performed.

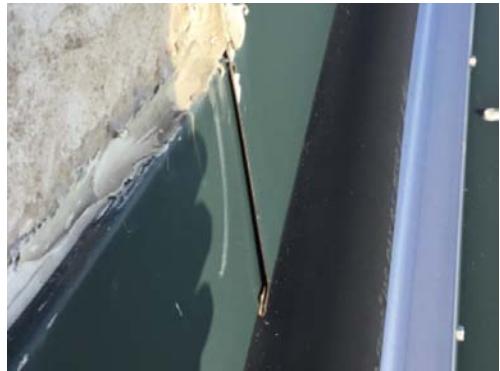
Sheet Metal - Counter Flashing (Remedial)

Quantity: 20 EA

Counter flashing is installed to protect the top edge of wall and curb flashings to prevent water infiltration into the wall or curb flashing, roof system and building interior.

Apply new dymonic caulking to open laps of counter flashing. The pricing for this repair will be included in the proposal for work to be performed.

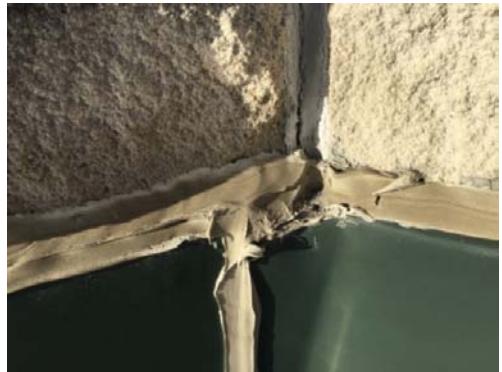
Metal Roofing Systems - Caulking Deterioration (Emergency)

Quantity: 100 LF

Missing, loose, cracked or improperly applied lap seal.

Our recommendation will be to remove any loose material, clean the area and install new lap seal as required. This has occurred in multiple areas along the expansion joint. The pricing for this repair will be included in the proposal for work to be performed.
