Over and Above Estimate

**Location:** MD002

### USAFRC BALTIMORE PHASE II BAS

# Tustin Energy Solutions, LLC Preventative Maintenance Report

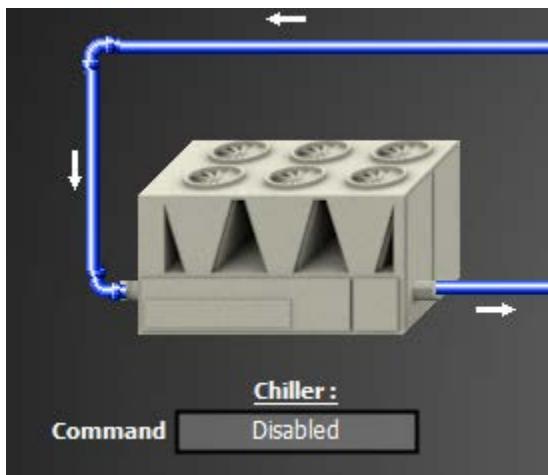
1. Chiller controls are incomplete. It appears that a BACnet connection to the chiller was planned but not connected. Wires are pulled from the chiller control panel out to the chiller but left unterminated.
2. Chiller package (including chilled water pumps) run standalone. The chiller is currently enabled/disabled by the switch at the chiller control panel and will run continuously if nobody attends to it. The BAS system shows a chiller command point which does not work:

There is no work completed at this time. It is recommended at a minimum that the chiller enable point and pump status points are completed. This includes wiring, hardware, software and graphics. Control logic is already present to enable/disable the chiller based on chilled water valve demand. Chilled water supply temperature reset should be considered as an energy saving strategy.

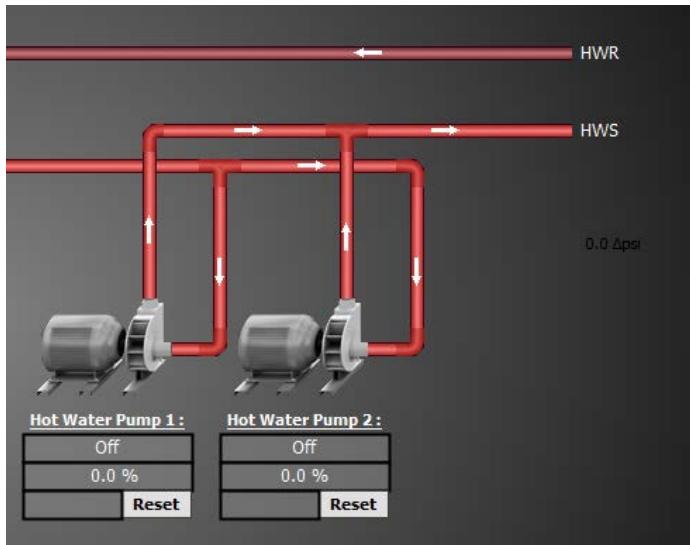
5. Boiler hot water pumps are VFD controlled to maintain system differential pressure setpoint:

The system is also equipped with a hot water bypass valve which is not shown on the graphic. Differential pressure setpoint is also not shown on the graphic. Differential pressure reads very low and as a result pumps are continually ramped to 100 percent. System differential pressure control and hardware devices should be checked for proper operation.

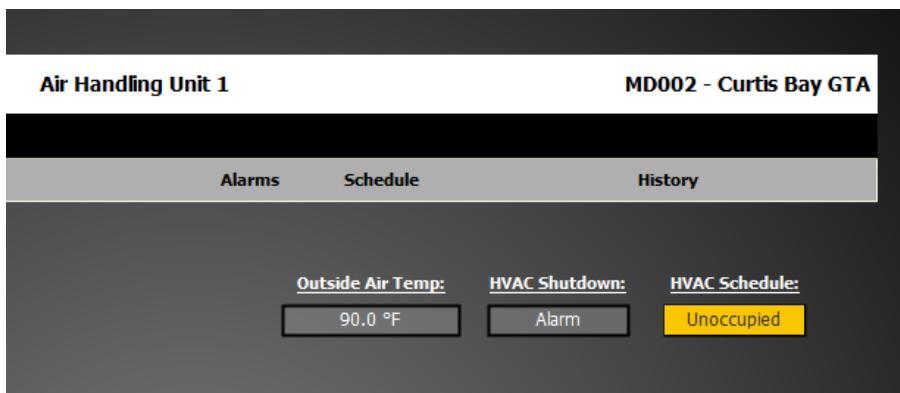
- Unit is scheduled from the graphical interface:

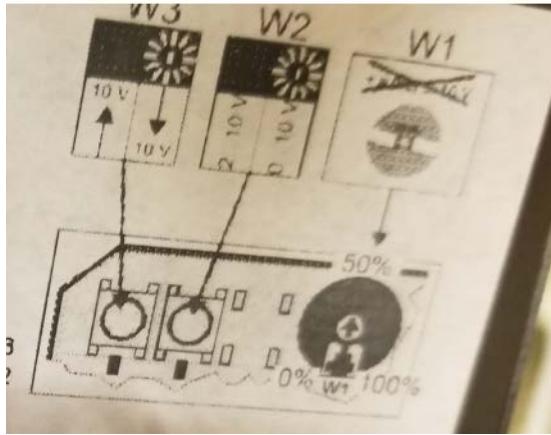
2. Control valves reconfigured to match the programming / software for AHU and HRU units. Note that each hot water and chilled water valve has a setting for 2-10VDC signal or 0-10VDC signal (W2). There is also a direct or reverse acting setting (W3). The correct setting is a 2-10VDC signal. The direct or reverse acting setting depends on whether the valve is used for chilled water or hot water. If the valve seems to be operating in reverse, then change this setting.

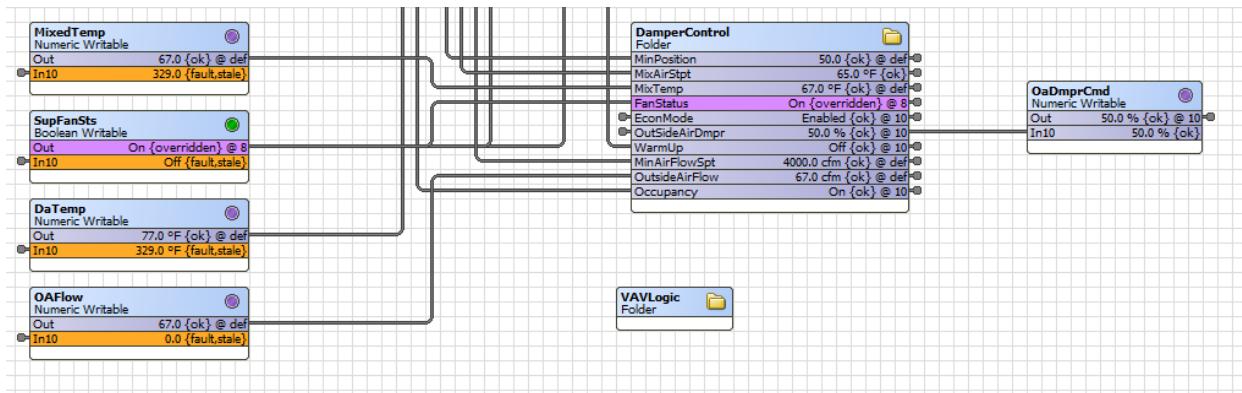
- Supply air fan status remains off when the fan is commanded to run. VFD will remain at minimum speed unless this point is overridden on. The fan proving device needs adjustment or replaced to correct this deficiency.
- Existing AHU mixed air damper control takes outside air airflow into control logic. There is no airflow station installed. This portion of software and mixed air damper control should be corrected:

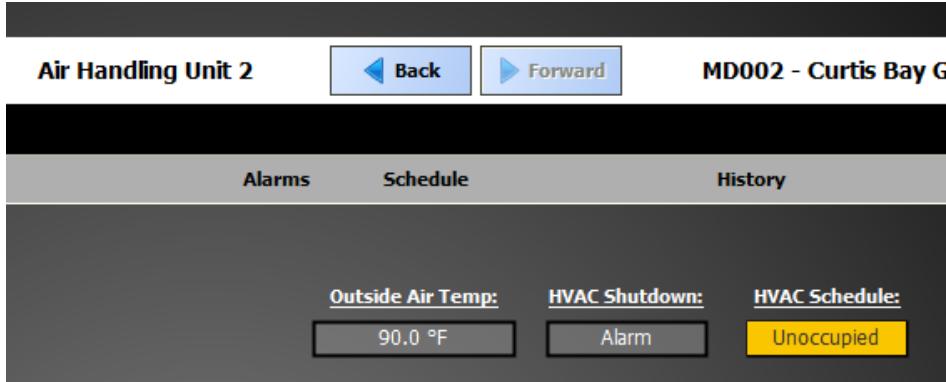
1. Unit is scheduled from the graphical interface:

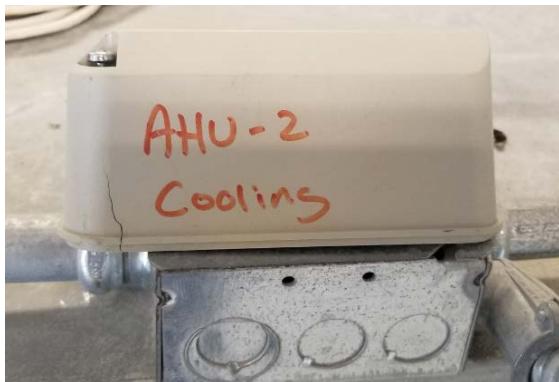
1. AHU-2 cooling valve actuator has failed and needs to be replaced:

- b. Replace the existing CHW valve actuator; valve body replacement not included
  - c. Add return air CO2 sensor, wiring, programming and graphic
- AHU-3

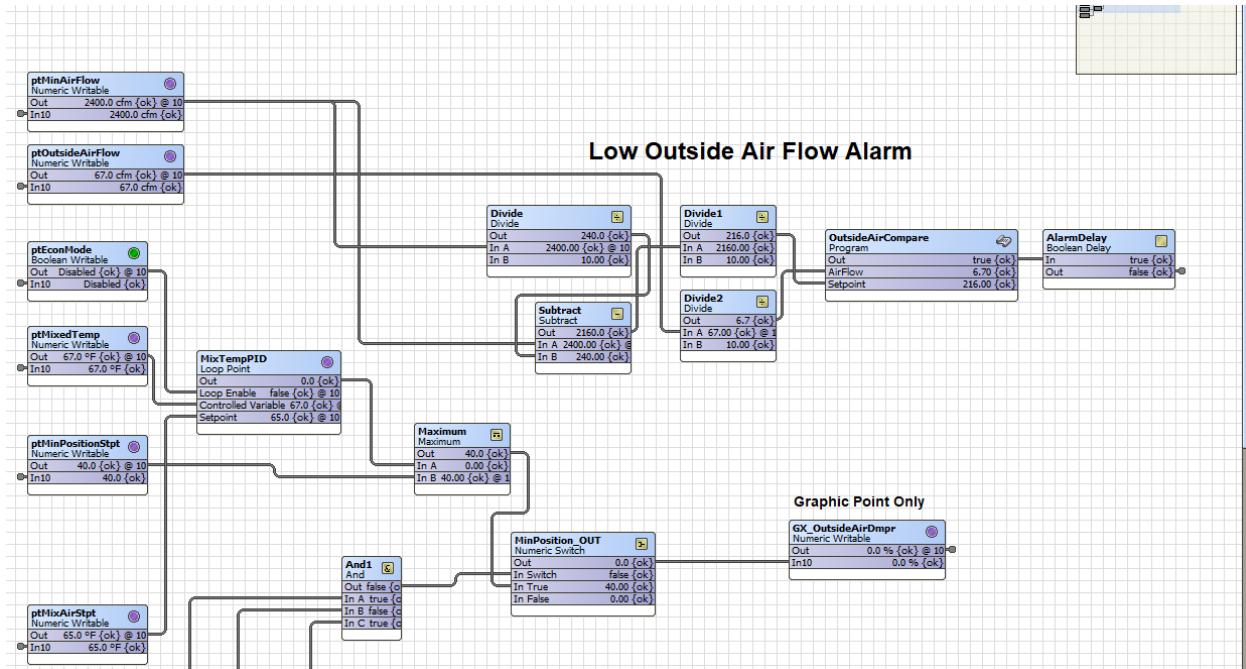
2. There is no airflow station installed. This portion of software should be corrected:

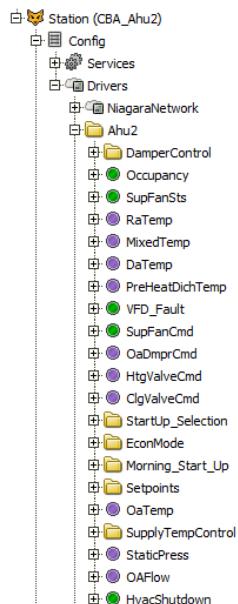
5. Points for Static Pressure and VFD Fault are found in the point database. This is a constant volume AHU:

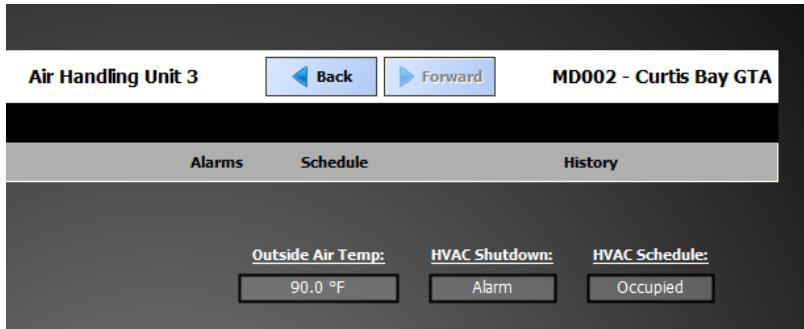
1. Unit is scheduled from the graphical interface:

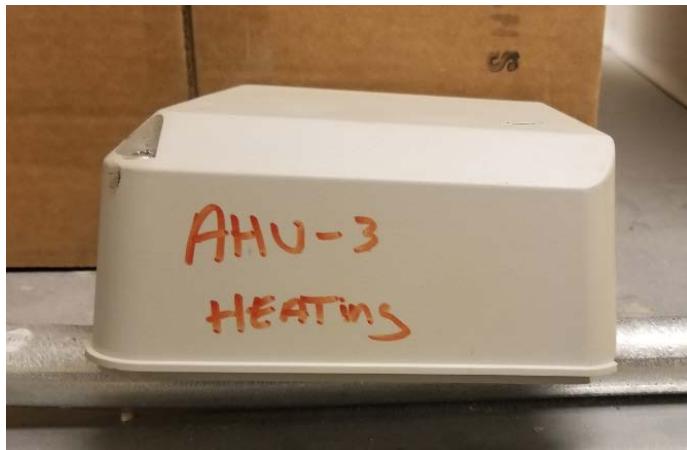
1. AHU-3 heating valve actuator has failed and needs to be replaced:

- a. Programming modifications as required for proper unit operation
  - b. Replace the existing HHW valve actuator; valve body replacement not included

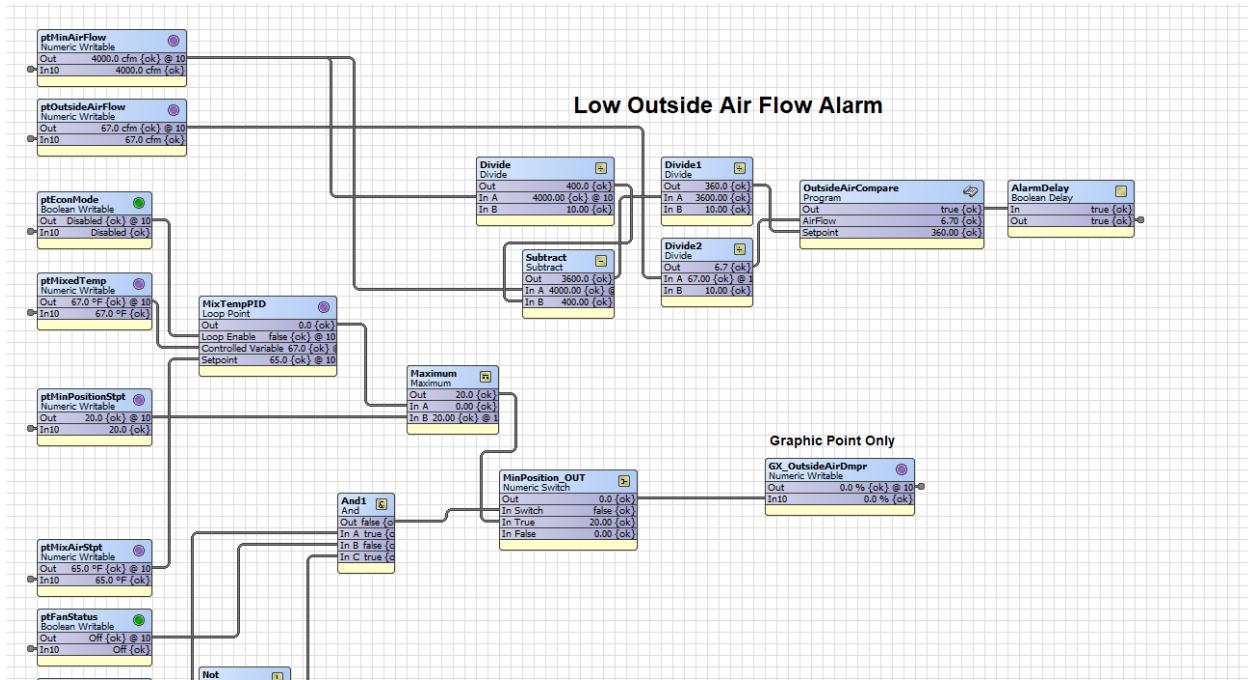
2. There is no airflow station installed. This portion of software should be corrected:

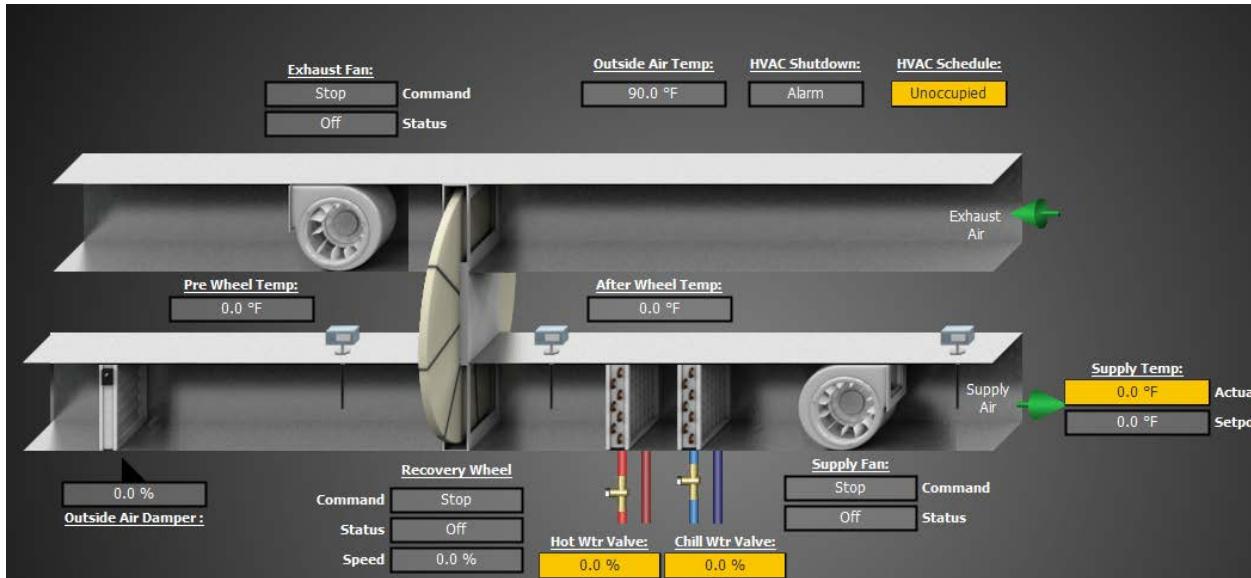
1. The energy recovery wheel remains on when the unit shuts down.
2. Graphics do not show the supply air and exhaust air isolation dampers. These are modulating dampers but really should act as 2 position open/closed dampers only. End switches on damper actuators are recommended to prohibit fan operation unless dampers are proven open.
3. The bypass damper is not shown on the graphics.
4. The unit outside air damper was found to automatically modulate and starve the supply fan when closing. Either the outside air damper or bypass damper must be open to prevent supply fan starvation. During normal unit operation the outside air damper should be 100 percent open to make up for exhaust air exiting from the building:

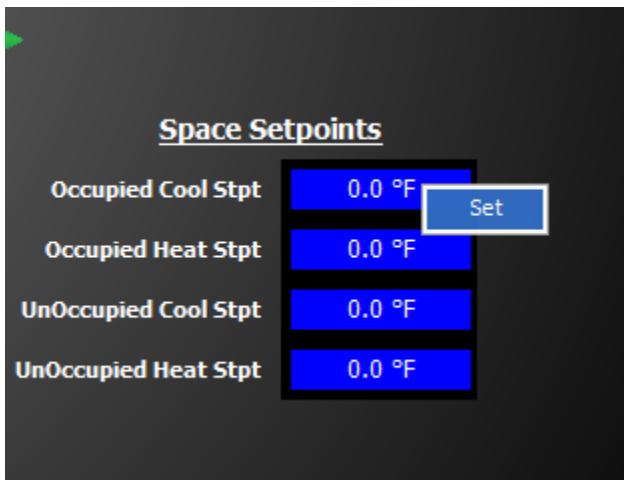
2. Modified all VAV and CAV graphics to allow changeable space temperature and CO2 setpoints:

Change the setpoint by right clicking in the blue box.
