## Over and Above Estimate

**Original Description:** Repair GFI outlet at 911

memorial side of Building #200, currently not working

## 911 Memorial GFCI Receptacle Repairs

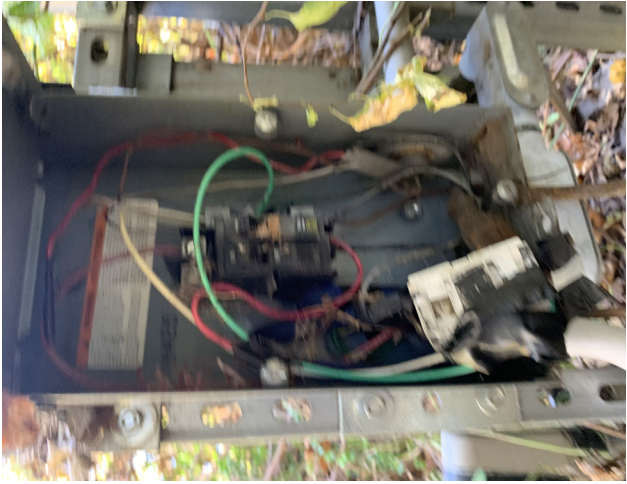
**Picture 1:** Step down transformer from 480 volts to 120 volts at 25 amps, which is more than comparable for the power needed.

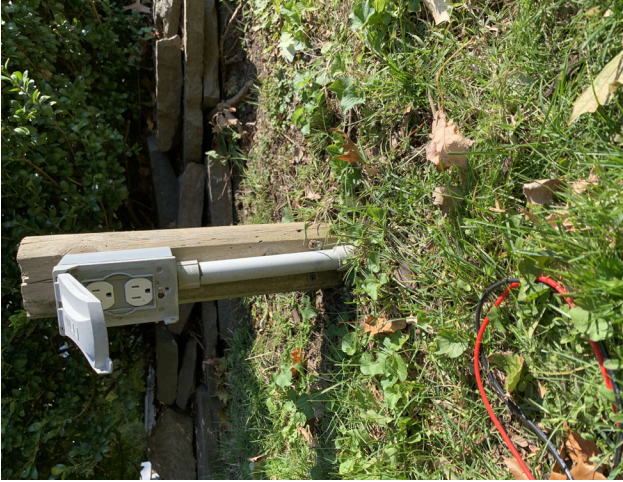
The current issue with these receptacles is the Ground Fault Circuit Interrupter receptacles have been removed and replaced with regular indoor receptacles. We are not sure who did this but aside from a code violation, a total safety issue and the receptacles not being rated for outdoors the problem still exists and has become hazardous.

**Picture 3:** Receptacle outlet box located to the west of the memorial. This shows the incorrect indoor, non GFCI receptacle installed. In addition a single conduit resulting in a buried splice box.

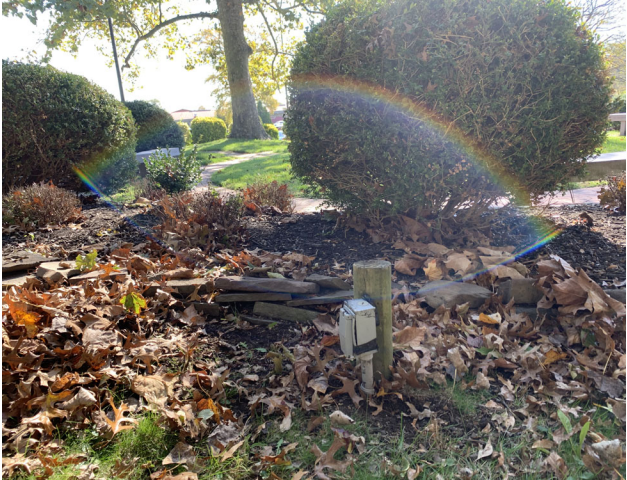
**Picture 4:** Receptacle outlet box located to the east of the memorial. This shows the box damaged beyond repair and must be replaced.
