## Additional Funding Request

<b>Site: NY023</b>	<b>WO# 13980 CSS #31220</b>
Description of Repairs	Replace damaged return line on ceiling mounted coil unit.
Diagnosis: Initial Work Order	Repair overhead hot water return pipe in bay 11 of AMSA 12. Pipe is overhead and was hit with a forklift and has a slow drip despite closing the shutoff valve
Explanation of Additional Costs for Repairs	
Additional Labor Cost to Perform Repairs	8hrs @ 245.00 per hour = \$1960.00
Additional Material Cost to Perform Repairs	\$525.00
Total Cost of Repair	\$2485.00
	Quote is valid for 30 days

June 21, 2021

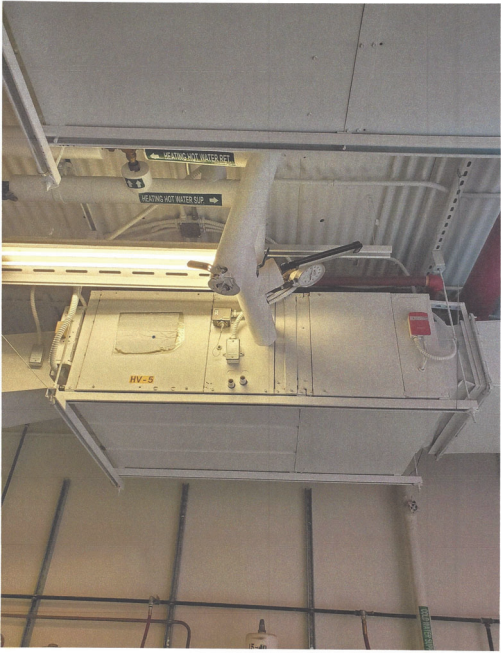
Qty.	Item#	Description	Unit Price	Line Total
		<p><b>THIS REPAIR IS FOR THE RETURN LINE ONLY THE HEATING COIL MAY ALSO BE DAMAGED AND MAY REQUIRE ADDITIONAL REPAIRS</b></p> <p><b>THIS QUOTE WILL EXPIRE IN 30 DAYS</b></p> <p><b>TOTAL</b></p>		<p><b>\$2485.00</b></p>
TOTAL				<b>\$2485.00</b>

Qty.	Item#	Description	Unit Price	Line Total
1	1	NY023 AMSA (BAY 11)		
		REPLACE DAMAGED RETURN LINE ON CEILING MOUNTED COIL UNIT		
		<u>MATERIAL</u>		
		8FT 1" PIPE		
		4EA 90 DEGREE ELBOW'S		
		2EA COUPLINGS		\$525.00
		1EA REDUCING FLANGE		
		<u>LABOR</u>		
		8HRS @ \$245.00 PER HOUR		\$1960.00
