Additional Funding Request

Site: NY023	WO# 19758 CSS # 90570
Description of Repairs	The fresh air ventilation system is not working, and further diagnostic increase is requested. A complete diagnostic of the entire system, including all electrical and mechanical components, to develop an accurate scope of work for the repair of the system.
Diagnosis: Initial Work Order	building 121 repair ventilators
Explanation of Additional Costs for Repairs	
Additional Labor Cost to Perform Repairs	9 hours @ 250.00 (x2 men) = \$2250.00
Additional Material Cost to Perform Repairs	
Total Cost of Repair	\$2250.00

ESTIMATE 111122 CSS90570 WO19758

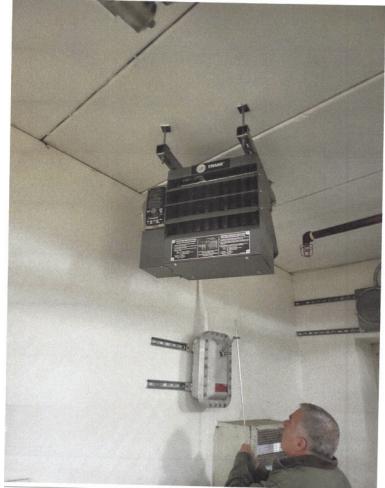
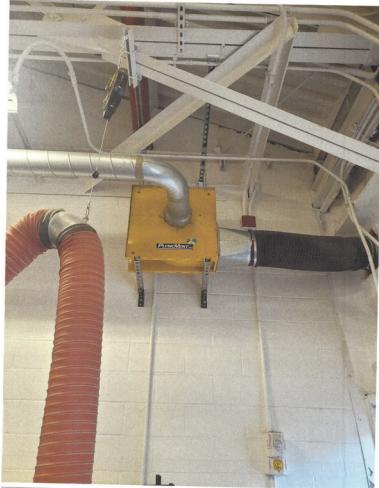
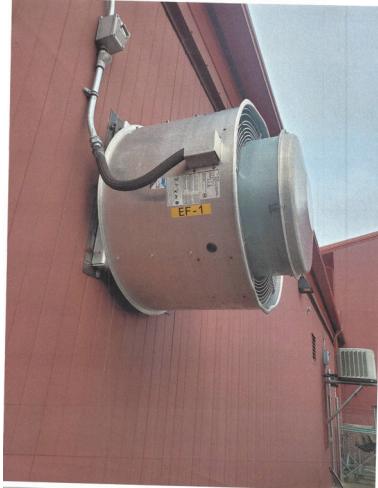
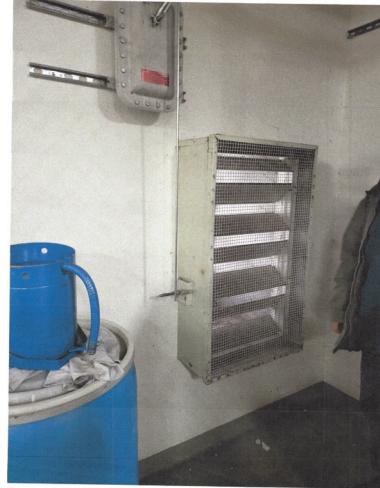
Qty.	Item#	Description	Unit Price	Line Total
		<p>NY23 (BLDG 121 OMS) FLUID STORAGE AREA LOCATED ON THE EAST END OF THE BUILDING</p> <p>FRESH AIR VENTILATION SYSTEM IS NOT WORKING</p> <p>A COMPLETE DIAGNOSTIC HAS TO CONDUCTED OF THE ENTIRE SYSTEM TO INCLUDE ALL ELECTRICAL AND MECHANICAL COMPONENTS IN ORDER TO DEVELOP AN ACCURATE SOW FOR THE REPAIR OF THIS SYSTEM</p>

Qty.	Item#	Description	Unit Price	Line Total
		<p>THIS REPAIR IS COMPLICATED SINCE NO GOVERNMENT PERSONNEL ON SITE HAVE ANY INFORMATION ON THE OPERATION OF THE SYSTEM AND WHAT COMPONENT IS DEFECTIVE</p> <p><u>LABOR</u></p> <p>9 HRS @ \$250.00</p> <p>(2 MEN 4.5 HRS EA)</p>		
		TOTAL		\$2250.00
				TOTAL \$2250.00
