### Over and Above Estimate

**CSS #:**90570

**Maximo Work Order No. 19758**      **Asset#:**

**Original Description:** building 121 repair ventilators

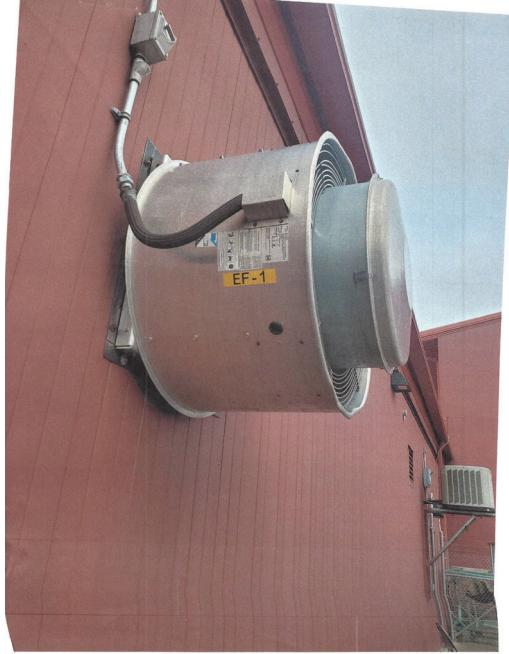
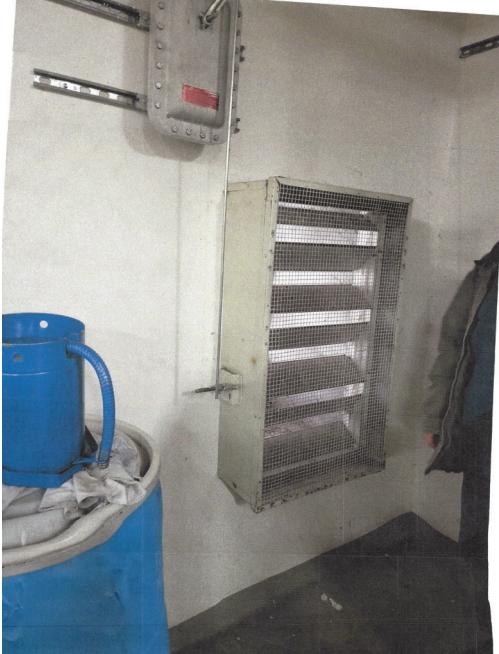
**Description of Repairs:** Fresh air ventilation system is not working. Completed diagnostic of the entire system to include all electrical and mechanical components. Two components are inoperative. The large mushroom vent on the rear of the building and the fresh air intake vent on the east side of the building near the entrance. CNTR will need to erect scaffolding to rebuild the mushroom vent. Replace the shaft, bearings, pulleys, and belts. Lubricate the system and reassemble it.

Qty.	Item#	Description	Unit Price	Line Total
		<p><b>NY23 (BLDG 121 OMS) FLUID STORAGE AREA LOCATED ON THE EAST END OF THE BUILDING</b></p> <p><b>FRESH AIR VENTILATION SYSTEM IS NOT WORKING</b></p> <p><b>A COMPLETE DIAGNOSTIC HAS BEEN CONDUCTED OF THE ENTIRE SYSTEM TO INCLUDE ALL ELECTRICAL AND MECHANICAL COMPONENTS</b></p> <p><b>TWO COMPONENTS HAVE BEEN FOUND TO BE INOPERATIVE THE LARGE MUSHROOM VENT ON THE REAR OF THE BUILDING</b></p>

Qty.	Item#	Description	Unit Price	Line Total
		<p>AND THE FRESH AIR INTAKE VENT ON THE EAST SIDE OF THE BUILDING NEAR THE ENTRANCE</p> <p>SCAFFOLDING WILL NEED TO BE ERECTED TO REBUILD THE MUSHROOM VENT</p> <p>REPLACE THE SHAFT, BEARINGS, PULLEYS AND BELTS</p> <p>LUBRICATES THE SYSTEM AND REASSEMBLE</p> <p>TEST OPERATION</p> <p>THE FRESH AIR VENT WILL NEED TO BE DISASSEMBLED, VENTS REALIGNED AND LUBRICATED, REASSEMBLED AND TESTED.</p>		
		<b><u>MATERIAL</u></b>		
		NEW SHAFT, BEARINGS BELTS		\$825.00
		MISC. HARDWARE		
		<b><u>LABOR</u></b>		
		20 HRS @ \$250.00		\$5000.00
		<b>TOTAL</b>		\$5825.00
				<b>TOTAL \$5825.00</b>

The fresh air bent will be disassembled, vents realigned and lubricated, reassembled and tested for proper operation.
