## Additional Funding Request

<b>Site: NY023</b>	<b>WO# 20211 CSS # 90993</b>
Description of Repairs	While performing work on CSS 90684 found a moisture issue. The seasonal difference between outside and room temperature and the non-insulated wall has caused condensation. CNTR will install decorative perforated steel to cover the access hole and trim. Patch/Skim Trim. Work will stabilize the section of the wall by allowing air to transfer. This work needs to be done to complete work on CSS 90684
Diagnosis: Initial Work Order	while performing CSS# 90684 we discovered staining bleeding through new paint on outside wall need to diagnose and remedy
Explanation of Additional Costs for Repairs	
Additional Labor Cost to Perform Repairs	1500.00
Additional Material Cost to Perform Repairs	175.00
Total Cost of Repair	\$1675.00

## ESTIMATE 120522 CSS90993 WO20211

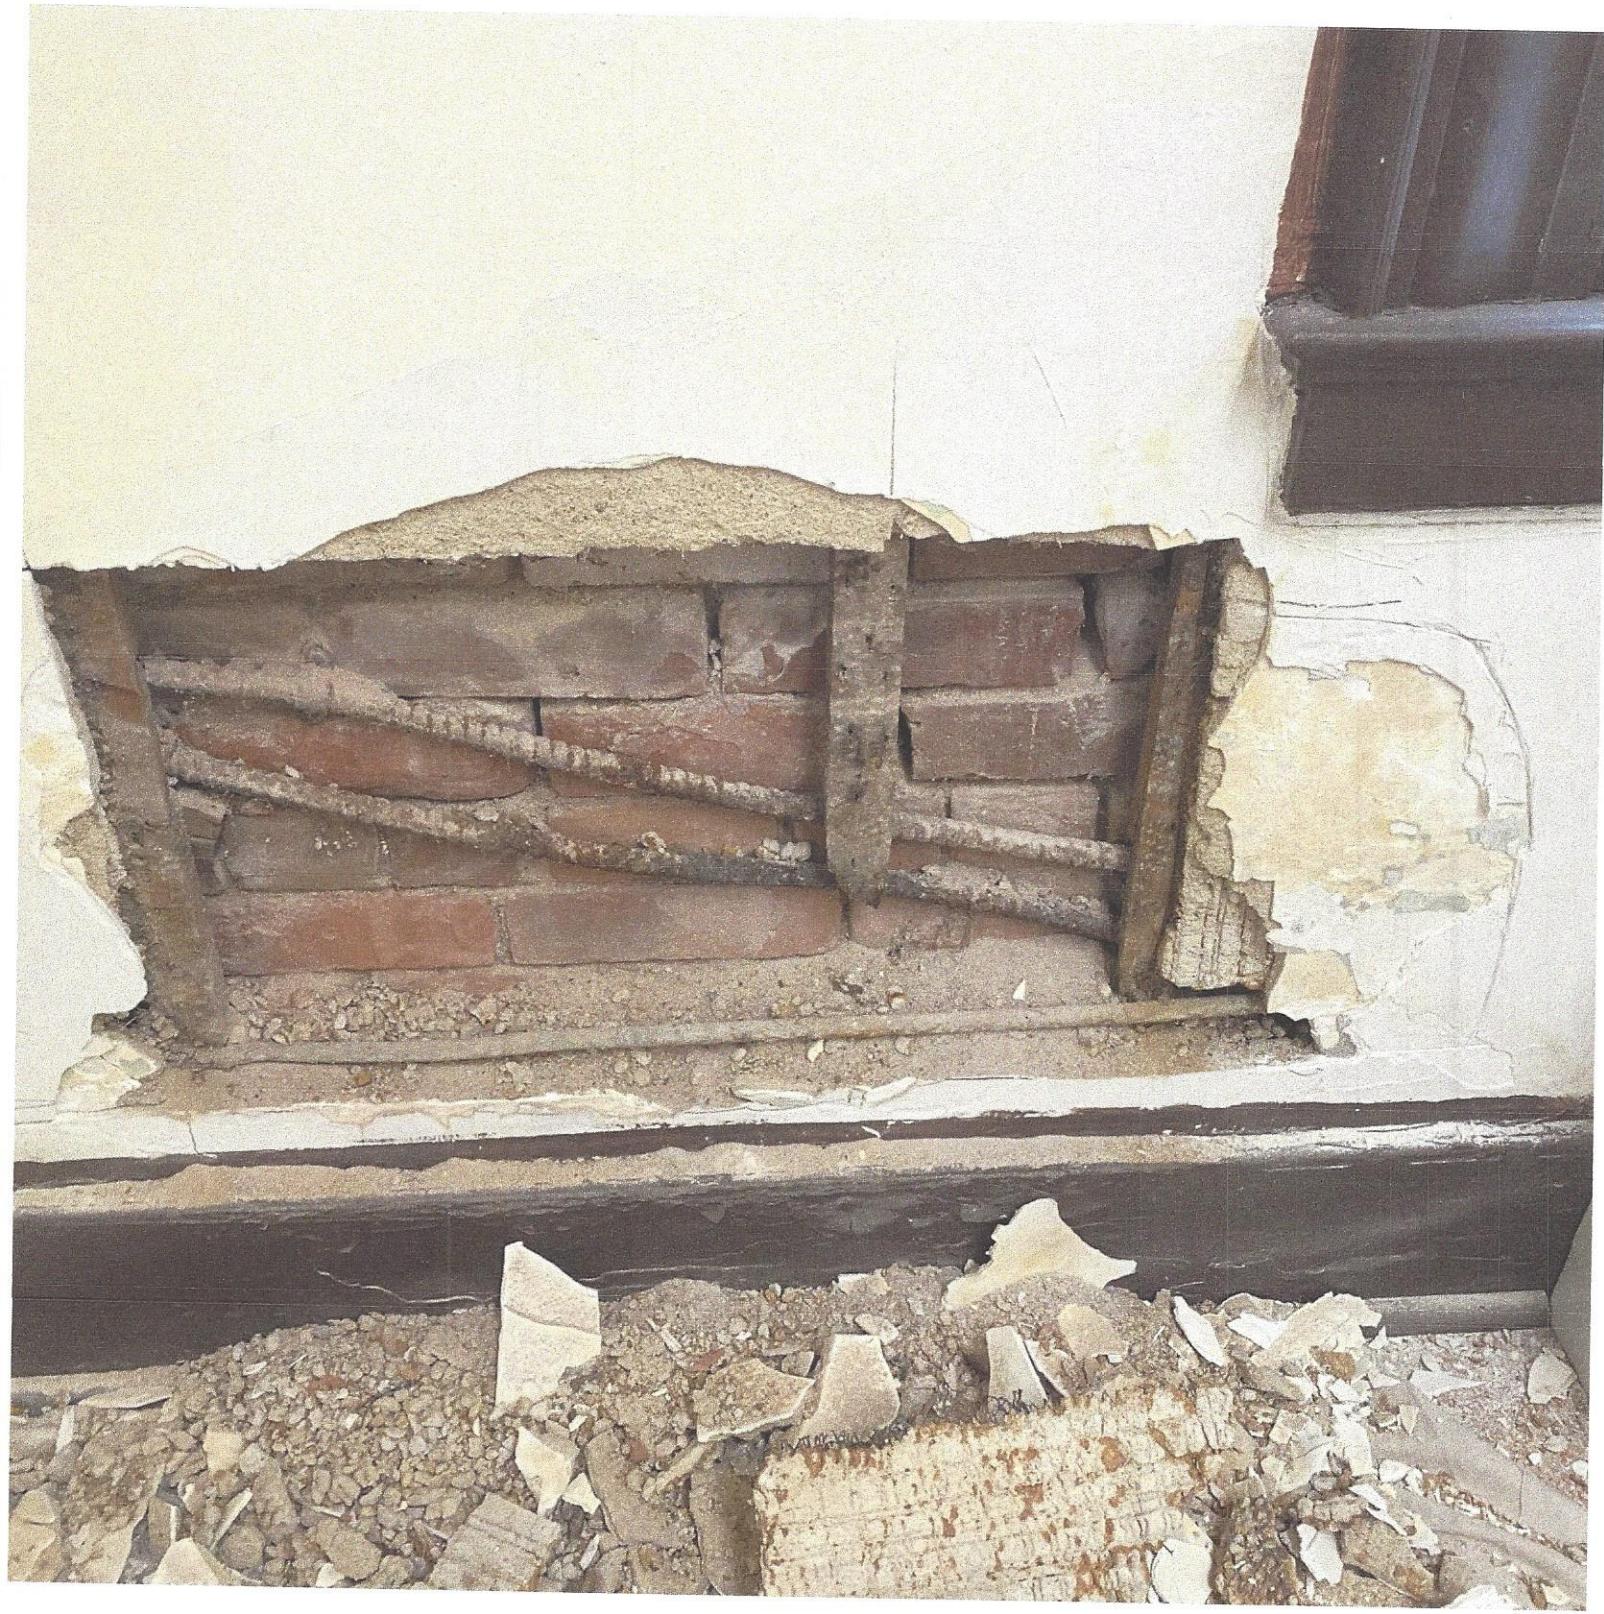
Qty.	Item#	Description	Unit Price	Line Total
		<p><b>NY23 (BLDG 206)</b></p> <p><b>STAINING/BLEEDING ON OUTSIDE WALL RM204</b></p> <p><b>On a previously repaired the outside wall damage and painted on another ticket, it was apparent that there was a moisture issue that probably created the problem.</b></p> <p><b>Remove a section of wall to explore the possible causes. While there was moisture on surface, we found that while the bottom had deteriorated there was no condensation and/or staining “within” it.</b></p>

Qty.	Item#	Description	Unit Price	Line Total
		<p><b>Most probable cause of water staining on interior side of wall (facing the room) is the seasonal difference of outside temperature (cold) and room temperature (hot). The wall is not insulated so it remains cold, causing condensation on its painted face.</b></p> <p><b>Install decorative perforated steel to cover access hole and trim. Patch/skim to trim.</b></p> <p><b>Re-paint wall. This should stabilize that section of wall by allowing air transference</b></p> <p><b><u>MATERIAL</u></b></p> <p><b>PAINT SPACKLE COMPOUND</b></p> <p><b>DECORATIVE GRILL</b></p>		
				<b>\$175.00</b>
		<b><u>LABOR</u></b>		
		<b>6 HRS @ \$250.00</b>		<b>\$1500.00</b>
		<b>TOTAL</b>		<b>\$1675.00</b>
				<b>TOTAL \$1675.00</b>
