Additional Funding Request

| Site: NY023 | WO#21451 CSS # 92236 |

ESTIMATE 021922 CSS92236 WO21451

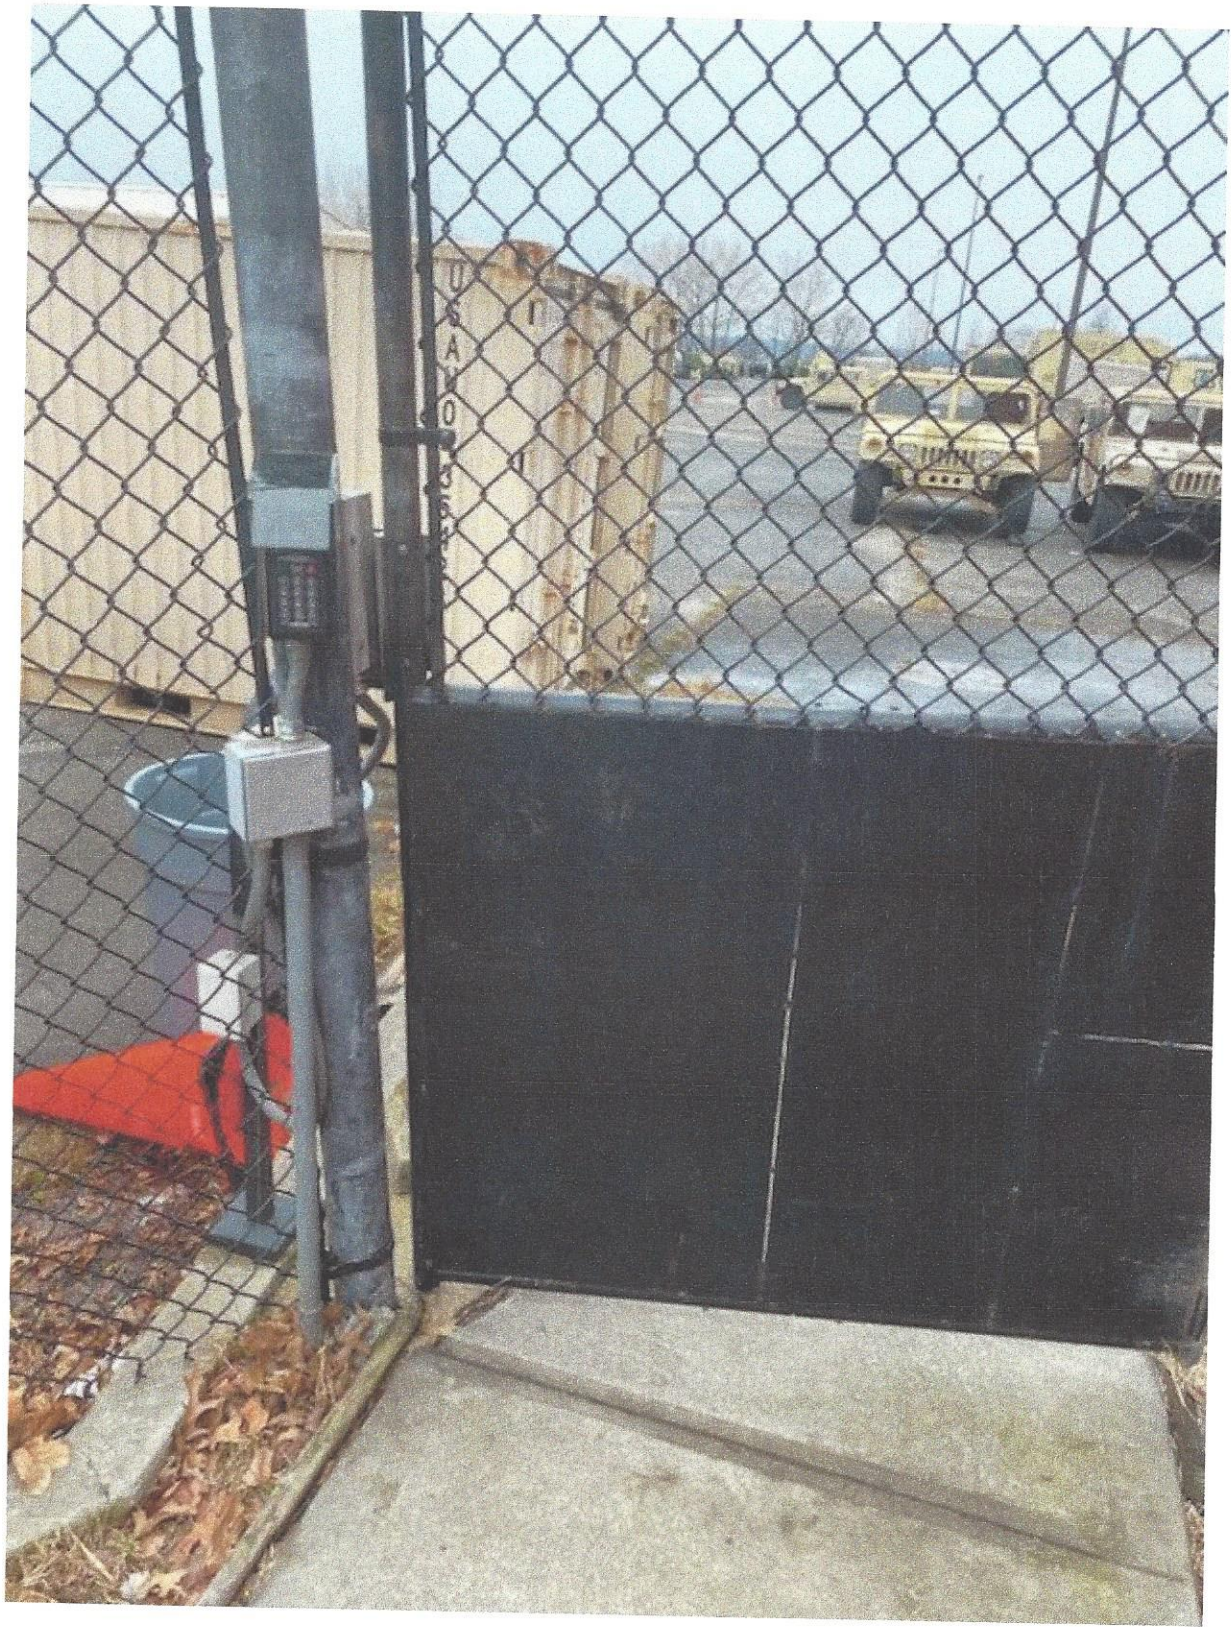
| Diagnosis: Initial Work Order | MEP man gate out of alignment doesn't close |

| Description of Repairs | Main gate is not operating properly. Will need to remove the gate, replace 2ea hinges, replace bolts and nuts. |
