Additional Funding Request

ESTIMATE 060922 CSS931 WO17654

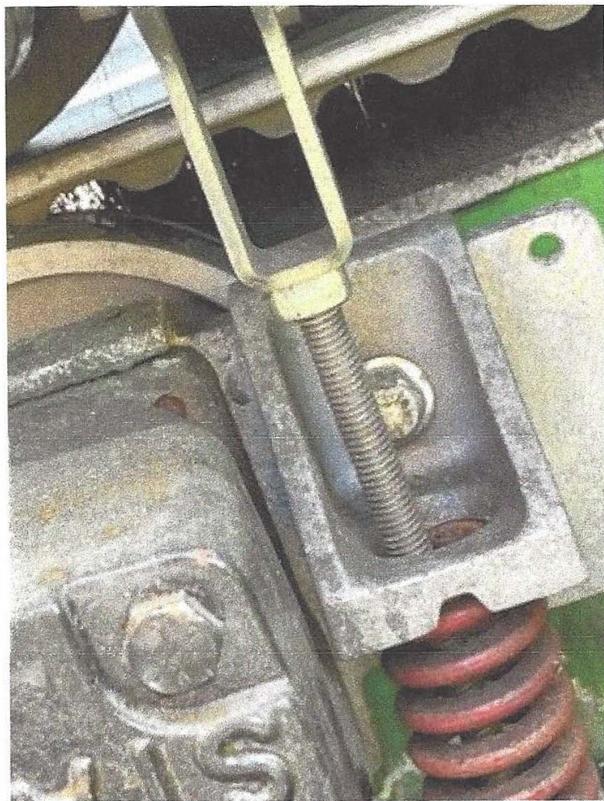
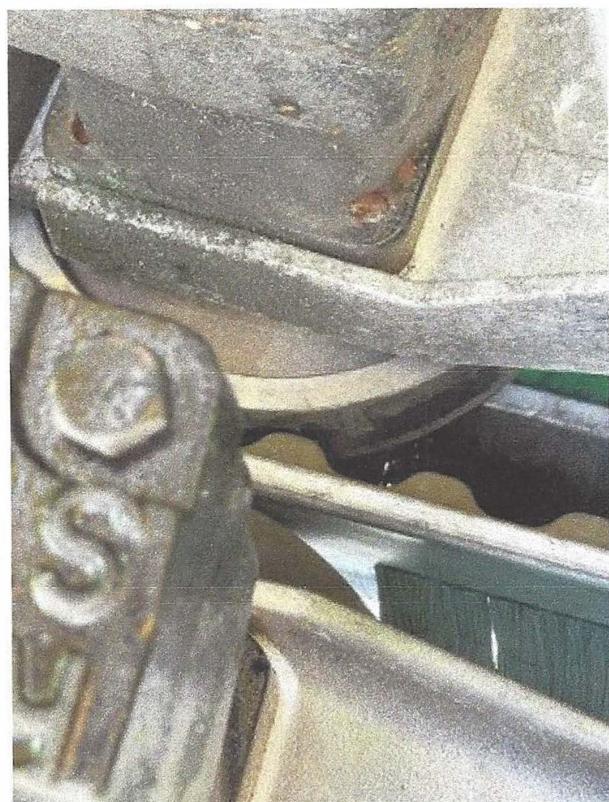
Site: NY023	WO# 17664 CSS # 931
Description of Repairs	Replace broken 6" extreme lower roller wheel adjust/realign track on entire gate.
Diagnosis: Initial Work Order	Repair upper parking lot gate at the third floor of building #200
Explanation of Additional Costs for Repairs	
Additional Labor Cost to Perform Repairs	<u>8hrs@235.00</u> = \$1880.00
Additional Material Cost to Perform Repairs	175.00
Total Cost of Repair	\$2055.00

Qty.	Item#	Description	Unit Price	Line Total
1	1	<p>NY23 BLDG 200 UPPER PARKING LOT GATE</p> <p>REPLACE BROKEN 6" "EXTREME" LOWER ROLLER WHEEL, ADJUST/REALIGN TRACK AND ENTIRE DATE</p> <p><u>MATERIAL</u></p> <p>1 EA 6" "EXTREME" LOWER ROLLER WHEEL</p> <p><u>LABOR</u></p> <p>8 HRS @ \$235.00 PER HOUR (2 MEN 4 HRS EACH)</p> <p><u>TOTAL</u></p>
