SERVICE REPORT

KONECRANES®
Lifting Businesses™

Customer	International Support Group LLC / US Army Reserve Center		
Business Location	US Army Reserve Center, Bayside, 200 Duane Rd		
City	Bayside		
Agreement			
Service Request	1-99083770702		
Description	PHI (NY) - SERVICE CALL / REPAIR Provide service technician and scissors lift to perform Service Call on 10 Ton Sisco Crane w/Yale Hoist to determine issue of "Jumped Guide" on Asset #H-1 per Quote# 1-19I63MAA.		
PO Number	Email Approval		
Billing Type	Fixed		
Customer Contact	Michele Dubois 954-900-1095 mdubois@internationalsupportgroup.com	Konecranes Contact	Brett Kenna 6104273521 brett.kenna@konecranes.com

H-1 Single girder EOT - 1 trolley wire rope hoist	Manufacturer SISSCO	Span 70ft		
Serial number A2840-A	Lift 25ft			
Criticality High	Volt/Ph/Hz 460-3-60			
Site Location H-1 / Truck shop				
Capacity/SWL 10 tons				
Model SGTRDM				
Service Products Planned Repairs				
Hoists				
Asset Description	Serial number	Model Type	Manufacturer	Capacity
	CK5835XC	EEW10-23PT19D4	YALE	10 t

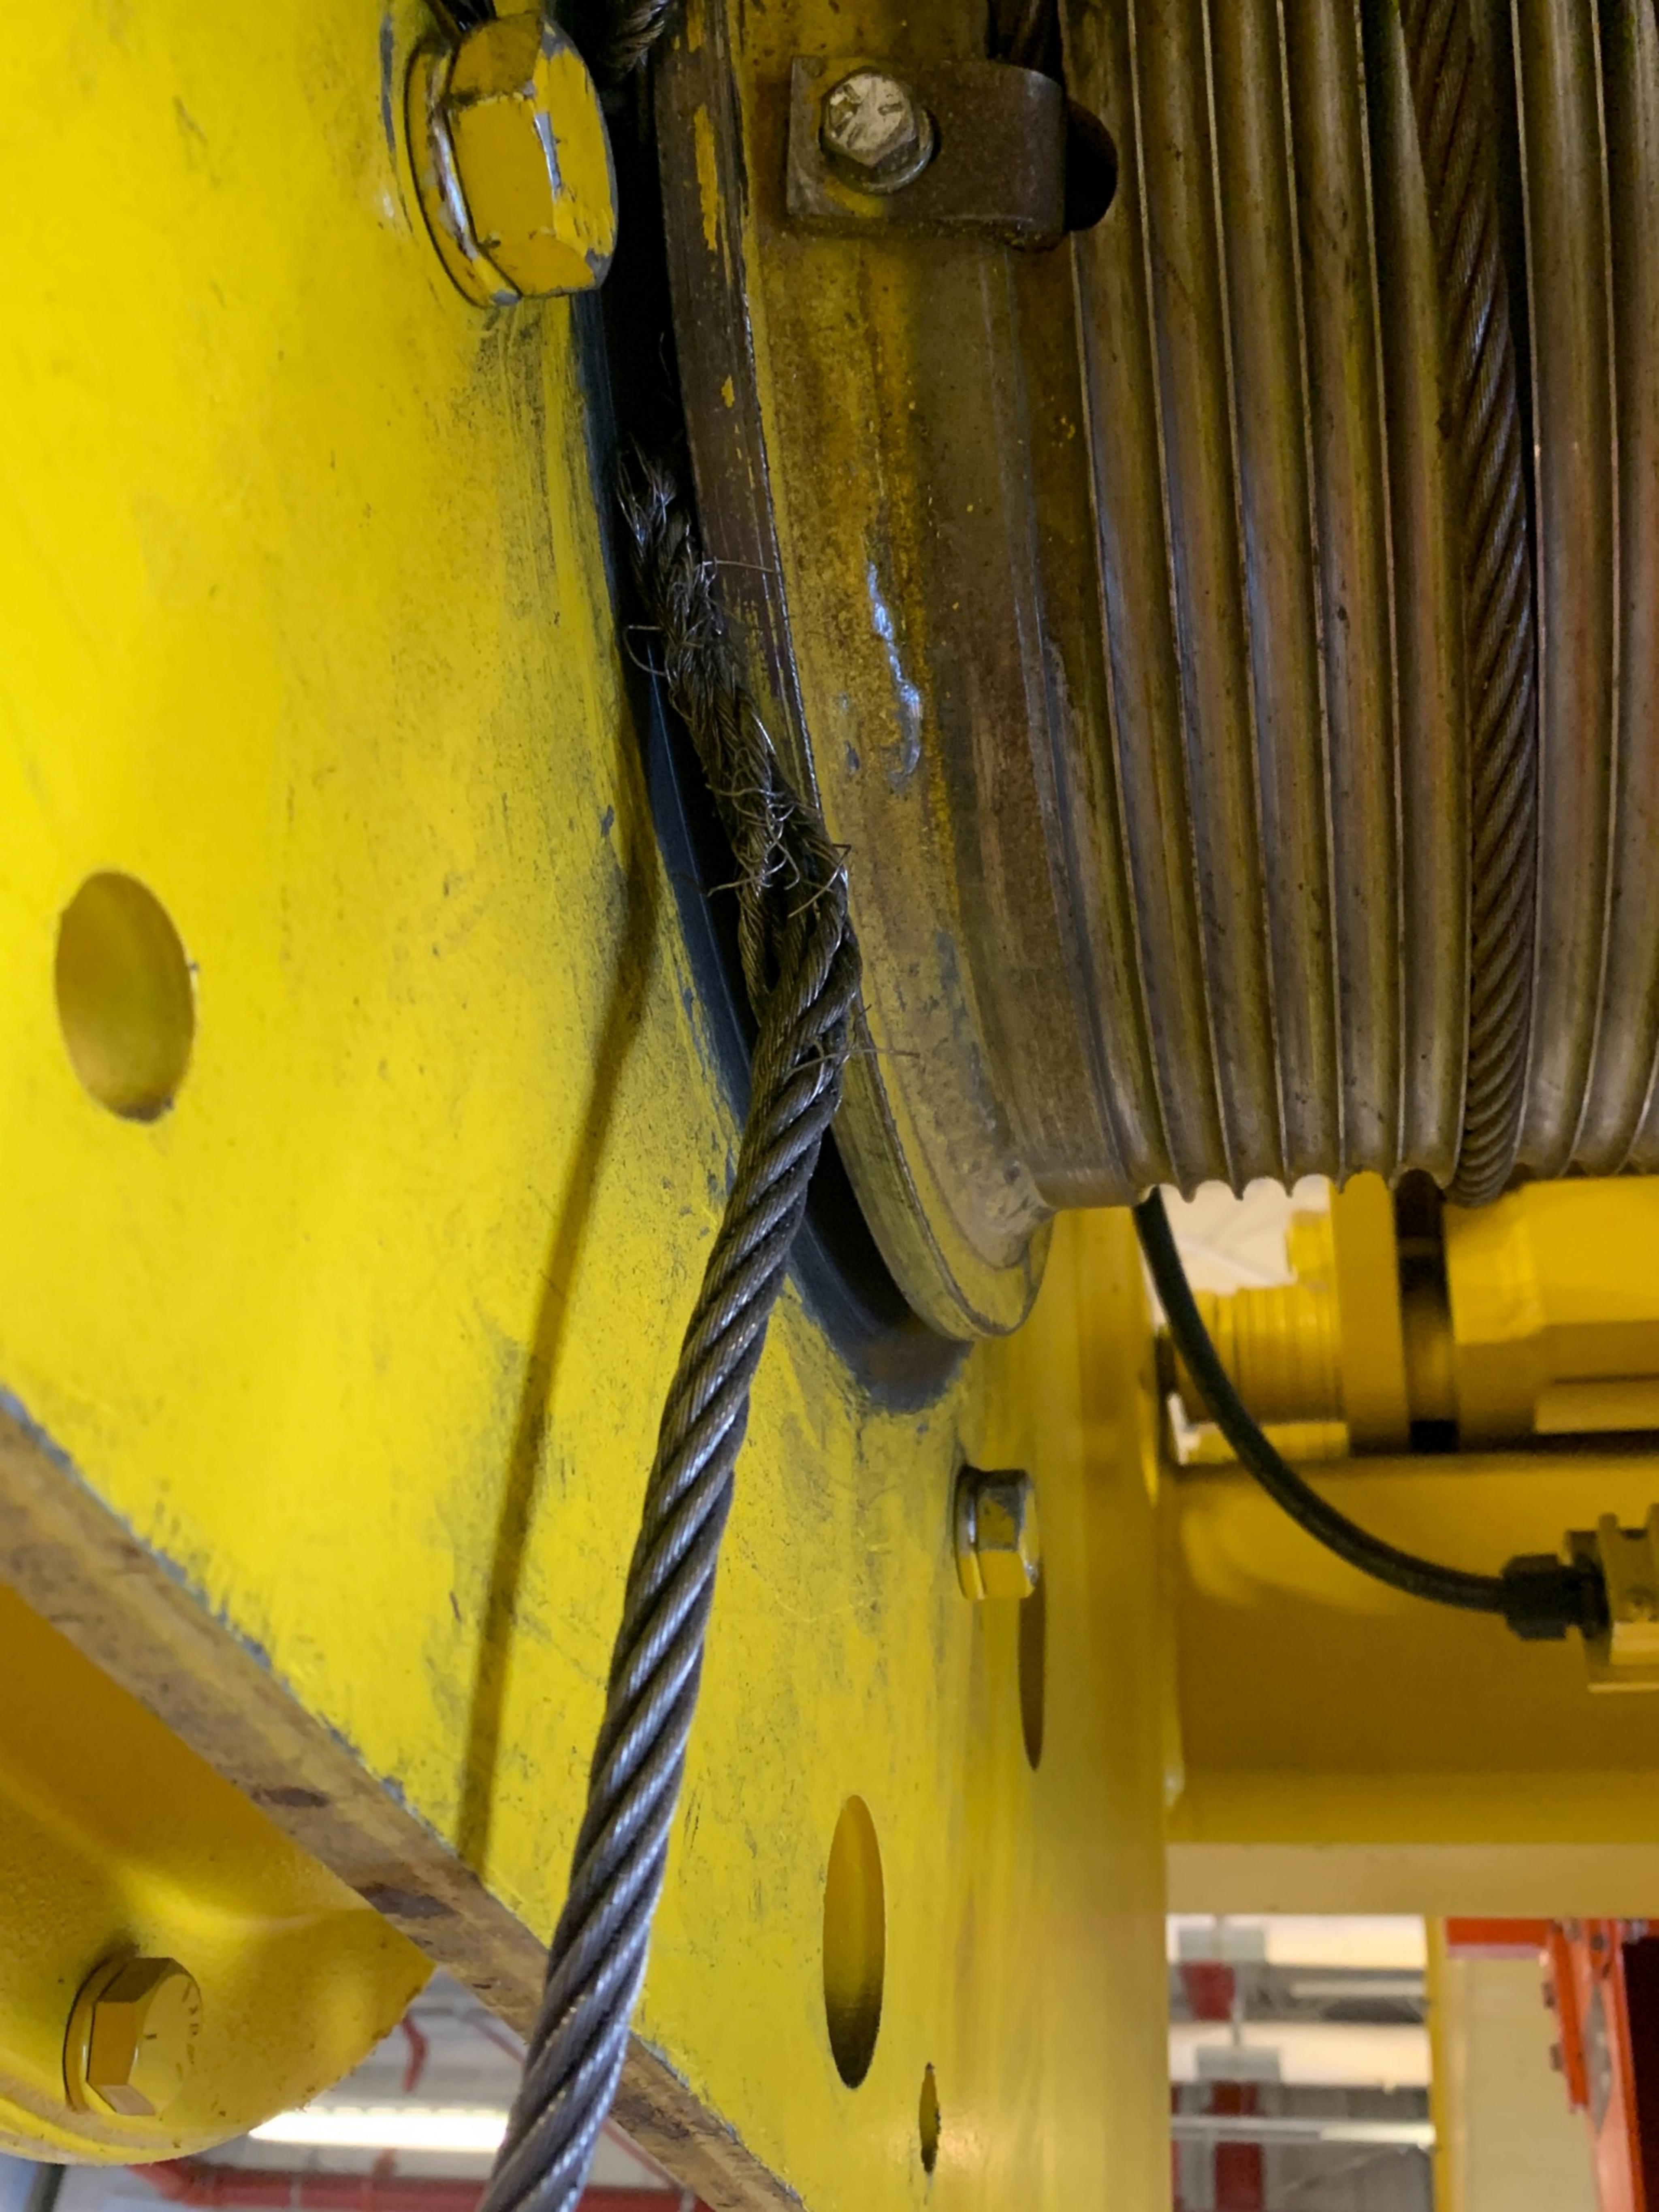
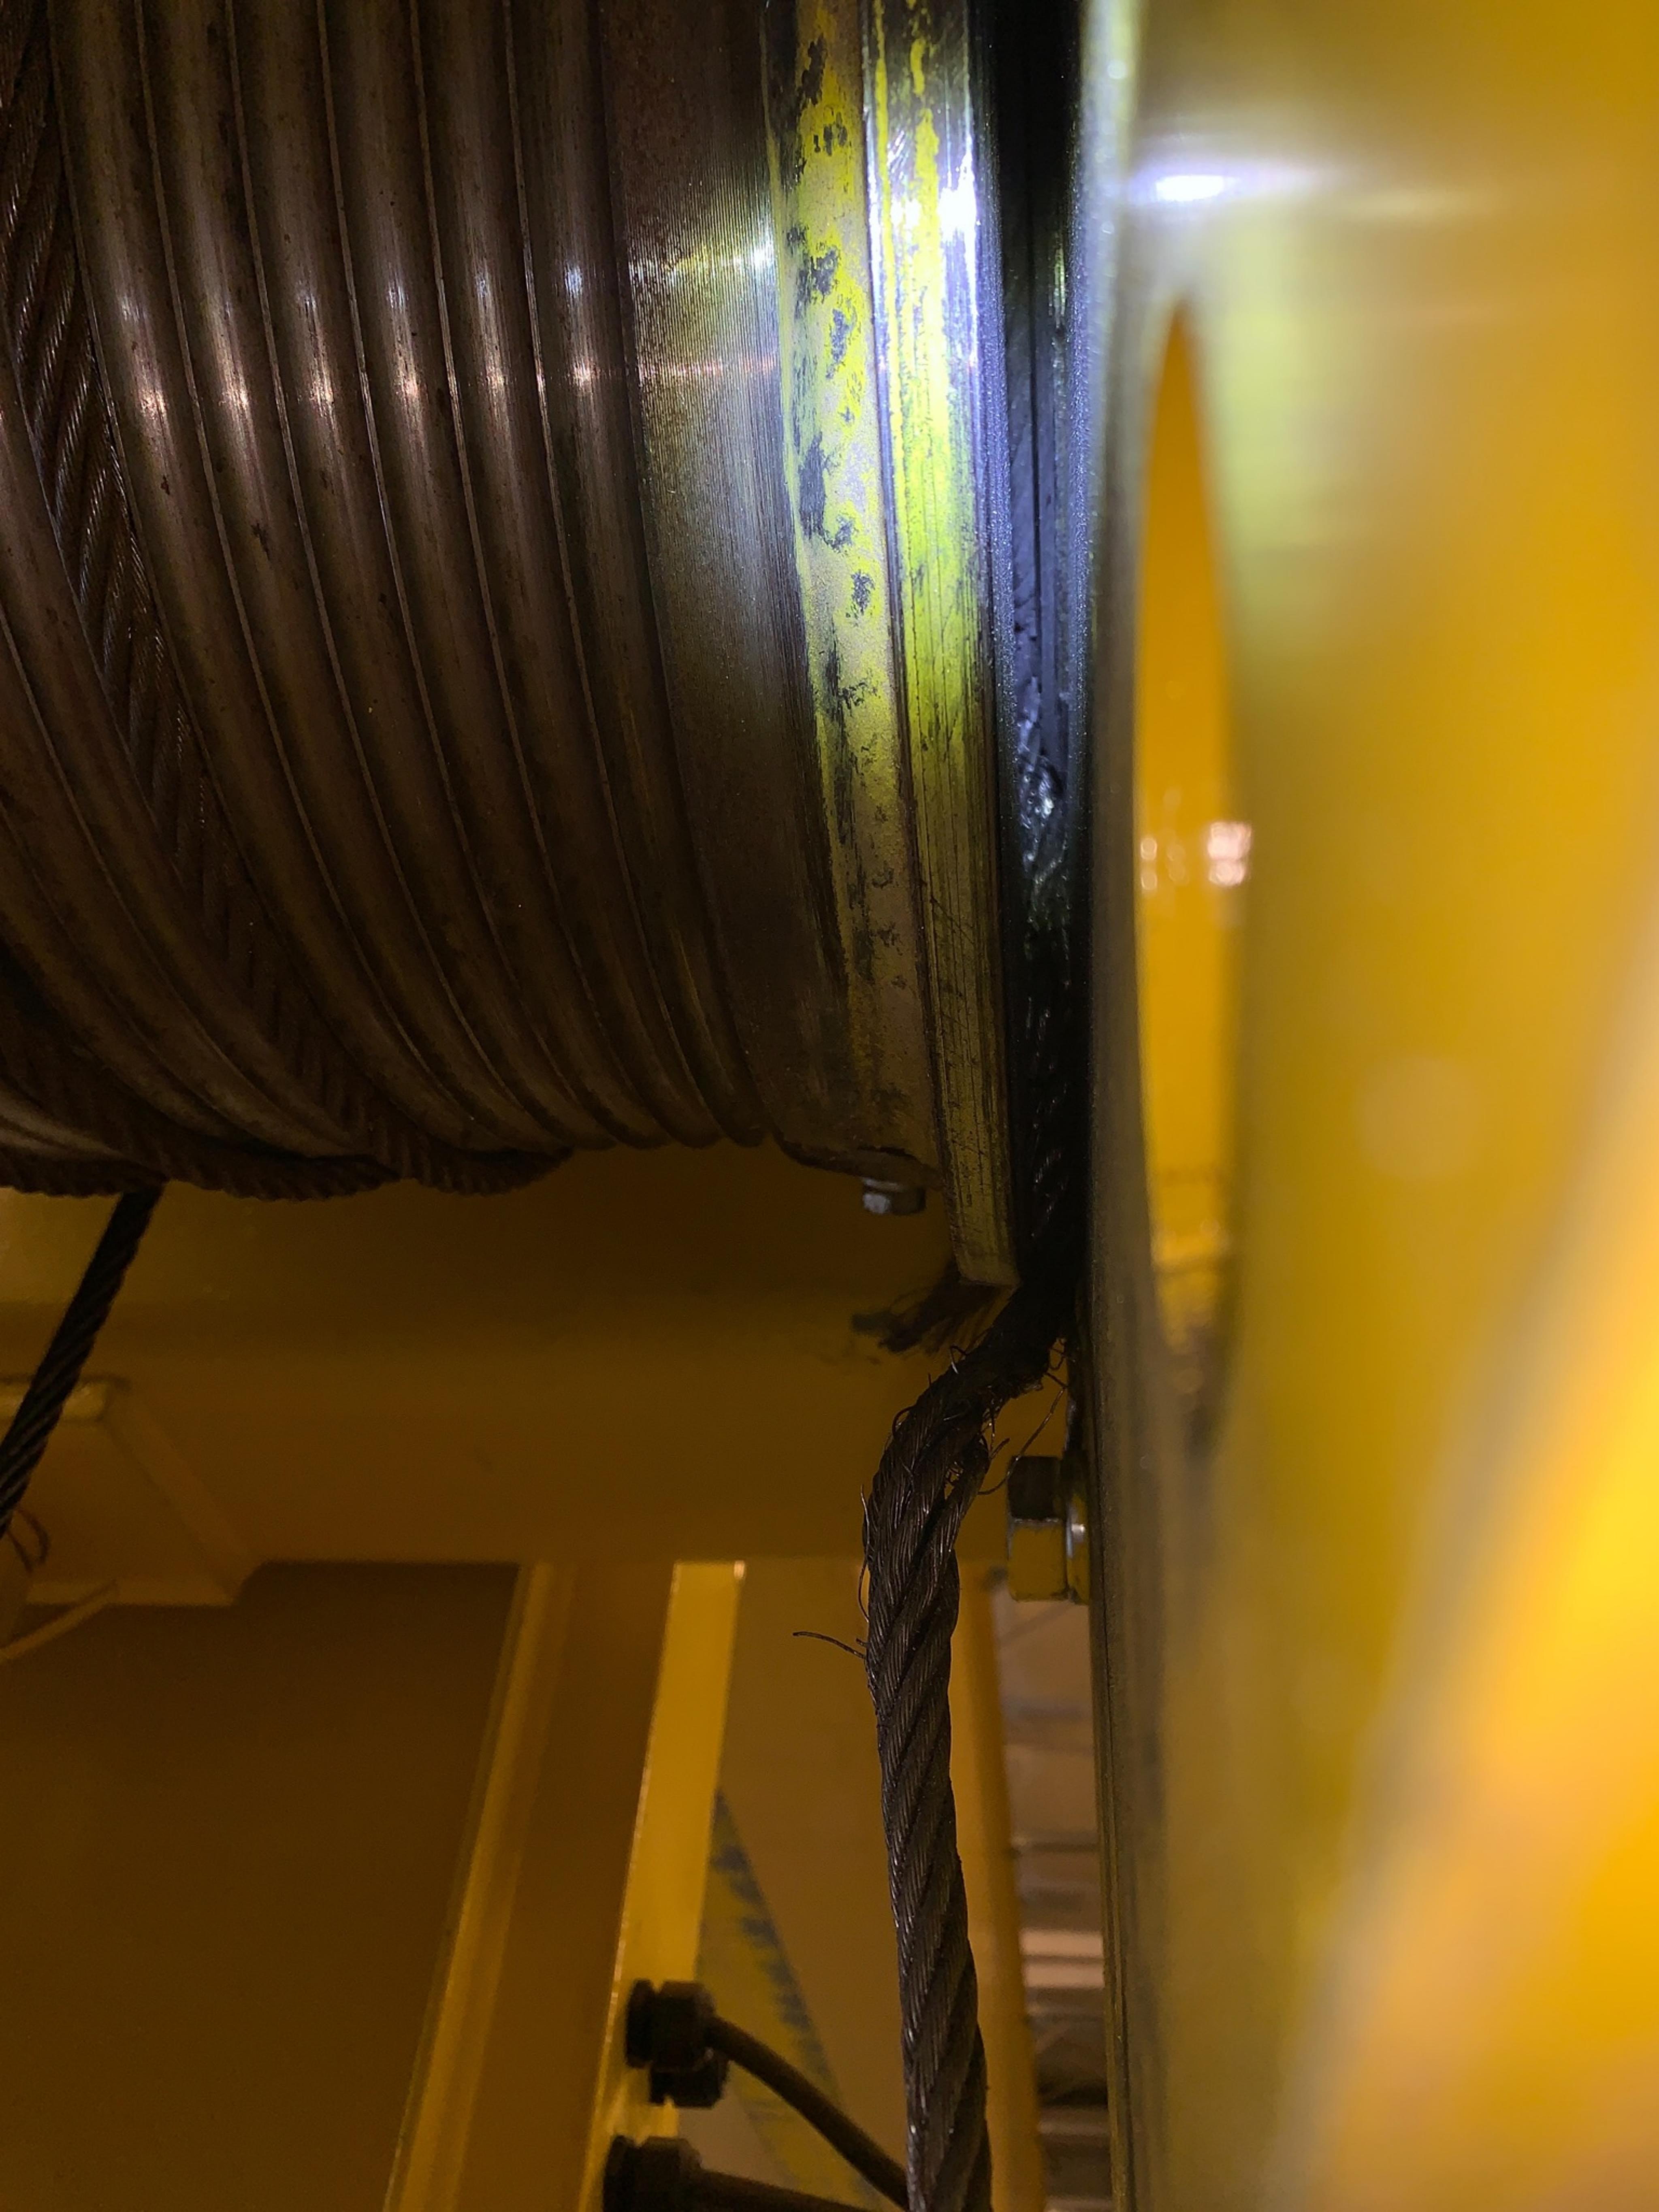
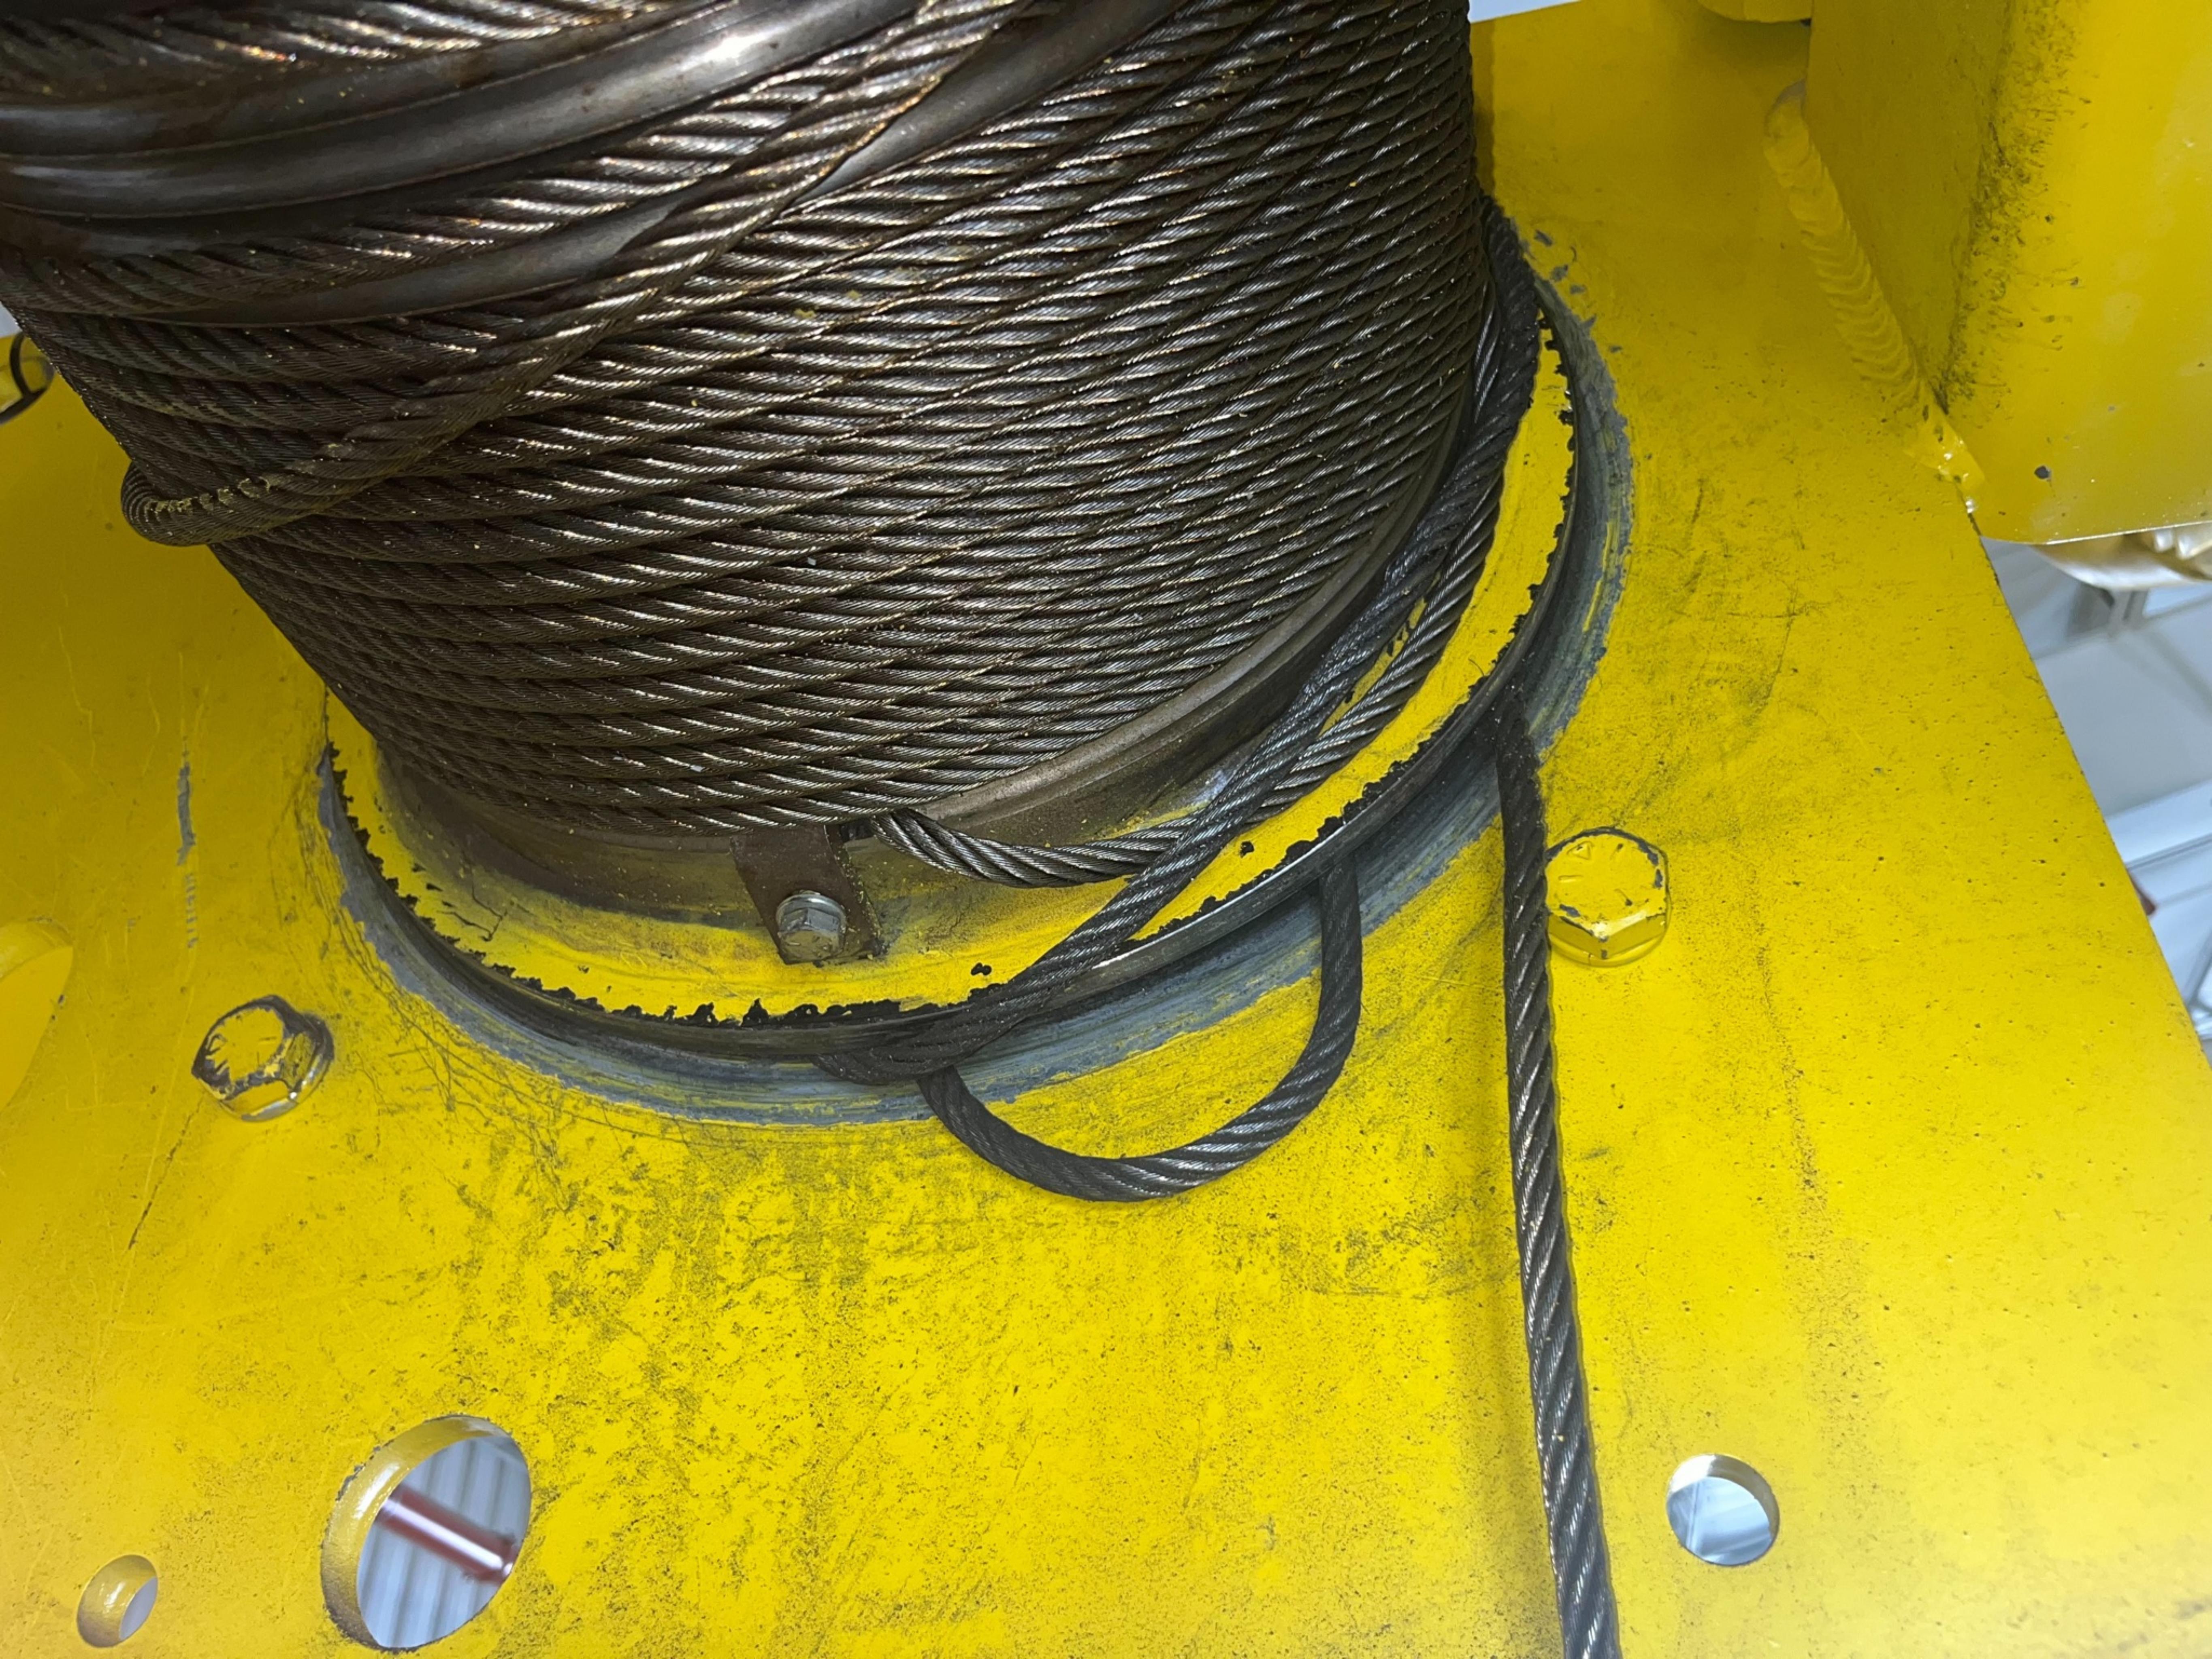
! Hoisting wire rope Measure 9.51 mm wire rope diameter

Date Reported Jul 10, 2023
Technician Tony Farquharson
Task Type Operational assessment
Fault Code Cross wrapped on rope drum
Risk **Safety Risk**
Recommendation Replace

Wire rope is wedged and wrapped around the drum a couple time at the motor side. Which causes the rope to jump two upper sheaves and kinked wire rope in multiple sections. I recommend replace wire rope and this crane needs to lockout from any further used for safety reasons.
