WORK ORDER ESTIMATE

Repair leak in DPW Supply room of 1st floor of B200.

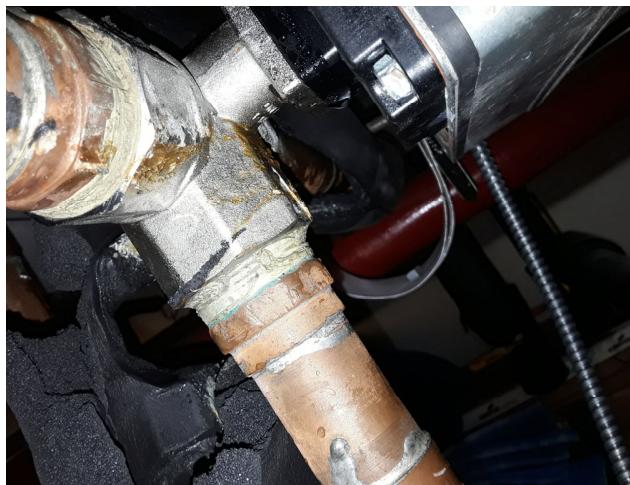
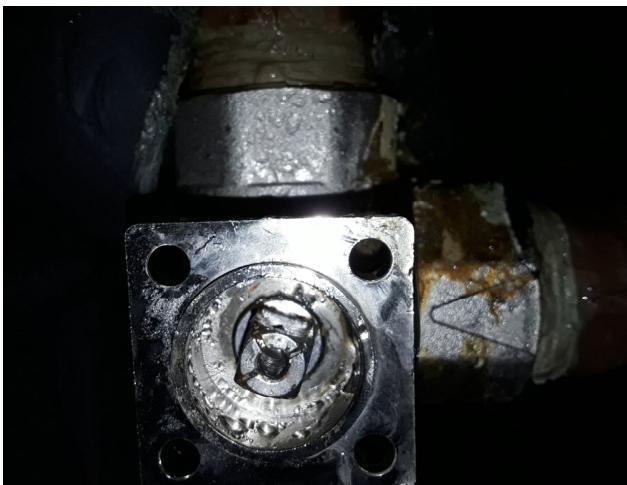
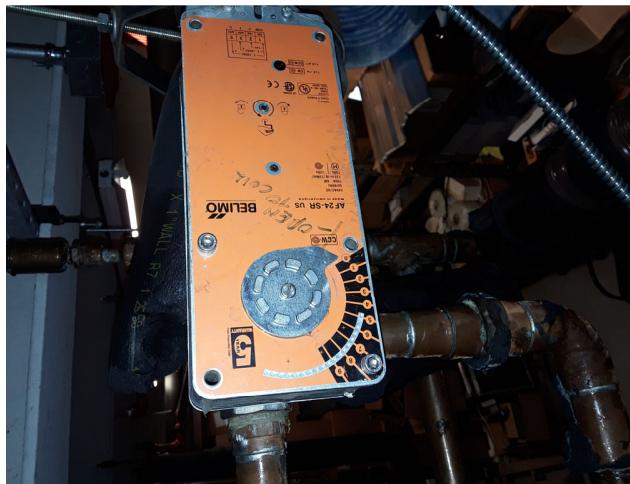
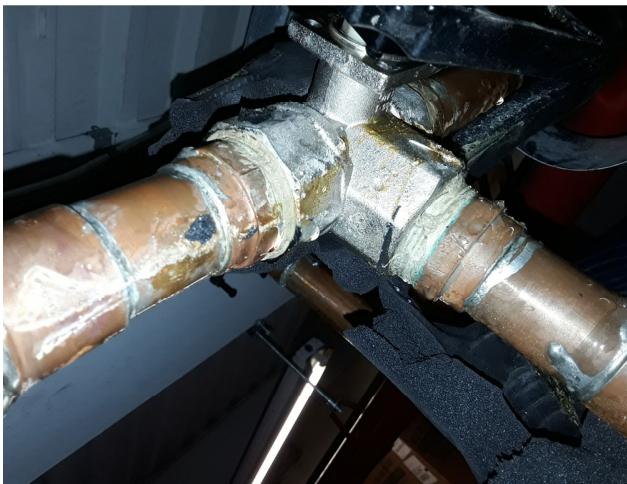
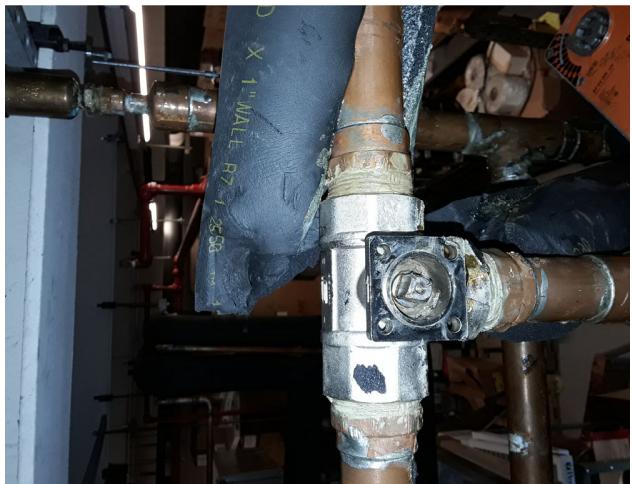
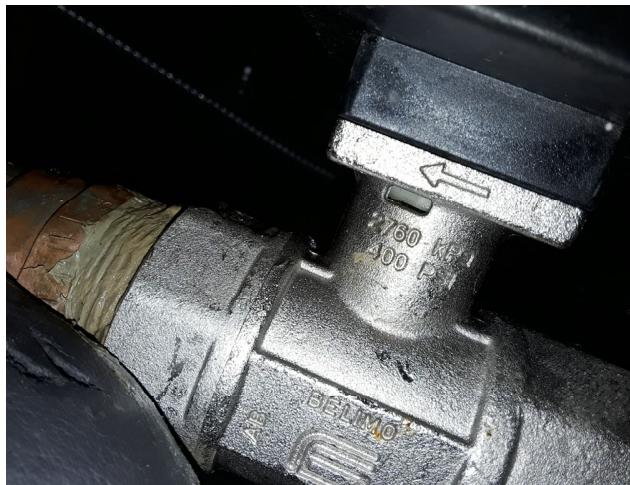
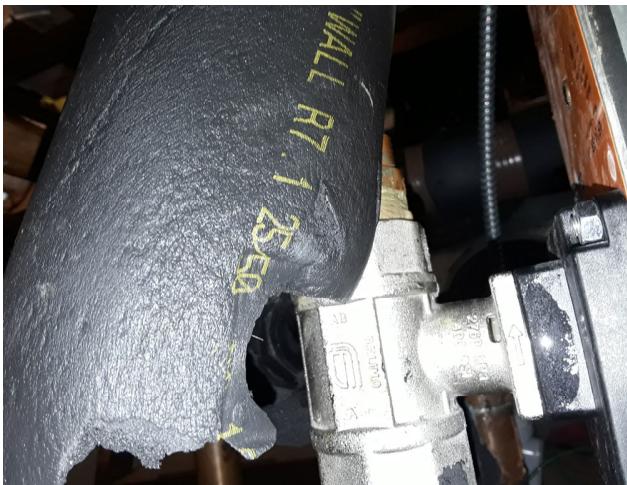
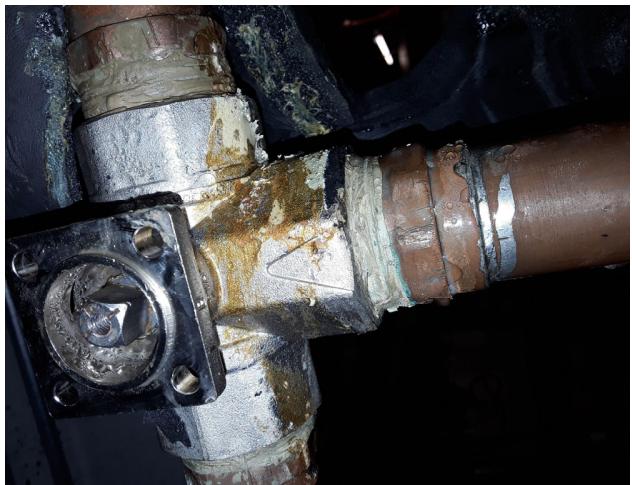
Found the system leaking water so i removed the insulation to see the bare pipe. Thats when i noticed the actuator leaking water. So i removed the actuator and saw that the control valve was still leaking. The control valve must be replaced in order to stop the leaking.
