Additional Funding Request

Site: NY058	WO#20594 CSS # 91289
Description of Repairs	Troubleshoot the firing system, switches, and relays. Circulator pump #1 only operates at 30% capacity. Pump #2 is not working at all. Replace broken Tstat in 1 st floor mens latrine (Not the same stat reinstalled by ISG). Note: the alarm system in the building has been triggered and has shut off all the supply fans for heat. A Fire Alarm Company should be called to reset the system.
Diagnosis: Initial Work Order	Boiler # 2 is not working. There is power to the boiler but no ignition.
Explanation of Additional Costs for Repairs	
Additional Labor Cost to Perform Repairs	2000.00
Additional Material Cost to Perform Repairs	289.00
Total Cost of Repair	\$2289.20

ESTIMATE 122722 CSS91289 WO20594

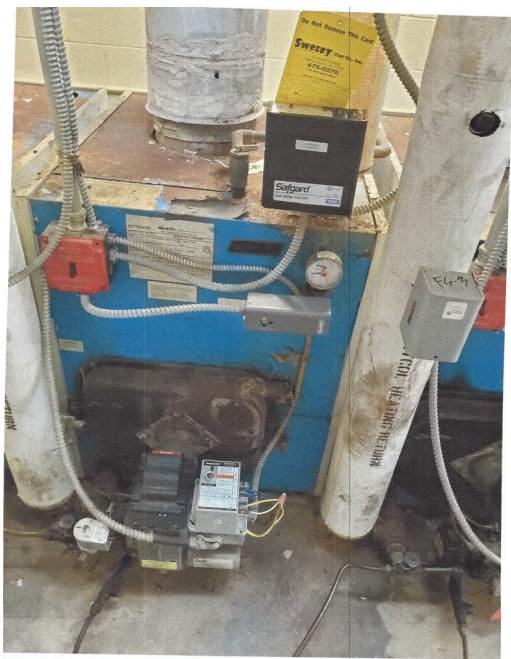
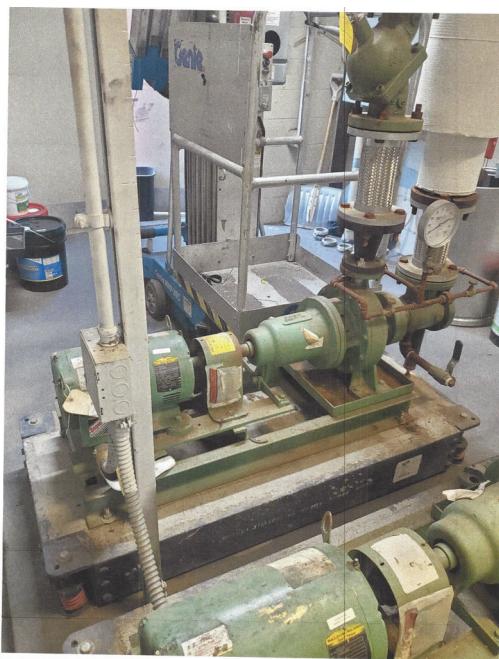
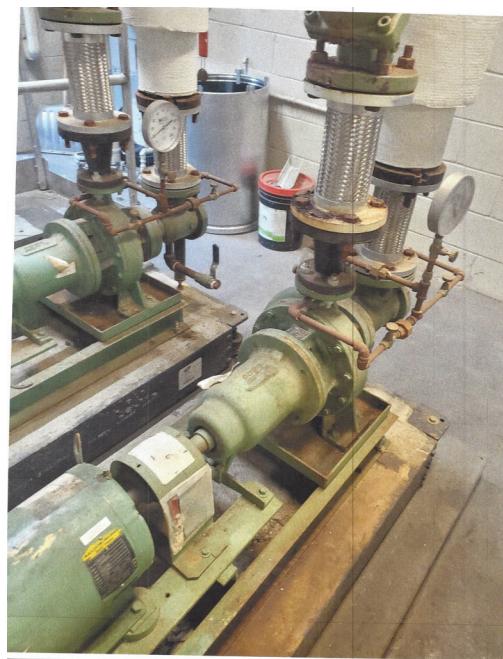
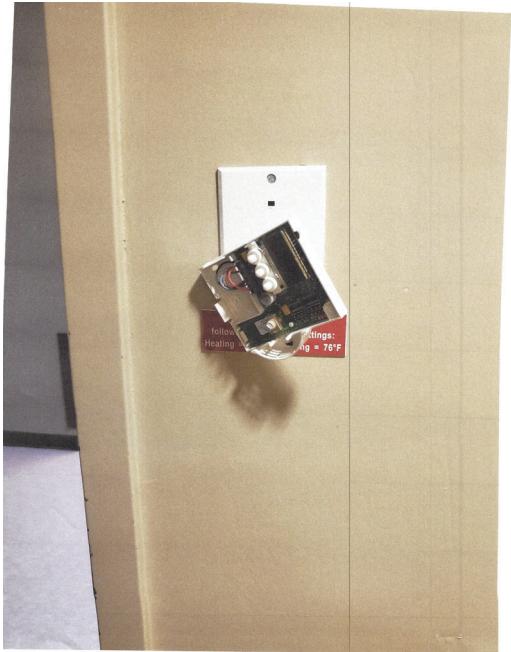
Qty.	Item #	Description	Unit Price	Line Total
1	1	NY058 MAIN BLDG #2 BOILER NOT FIRING NO POWER TROUBLE SHOOT FIRING SYSTEM SWITCHES AND RELAYS CIRCULATOR PUMP #1 ONLY OPERATING AT 30% PUMP #2 NOT WORKING AT ALL FOUND BROKEN THERMOSTAT IN 1ST FLOOR MENS LATRINE <u>MATERIAL</u> 1EA HONEYWELL T7560A1042 DIGITAL THERMOSTAT		\$289.20

Qt y.	Item #	Description	Unit Price	Line Total
		LABOR 8 HRS @ \$250.00 PER HOUR		\$2000.00
		TOTAL		\$2289.20
		IT MUST BE NOTED THAT THE FIRE ALARM SYSTEM HAS BEEN TIGERED IN THE BUILDING AND HAS SHUT OFF ALL THE SUPPLY FANS FOR HEAT. A FIRE ALARM COMPANY SHOULD BE CALLED TO RESET THE SYSTEM.		
16 84		TOTAL		\$2289.20
