Additional Funding Request

WORK ORDER ESTIMATE

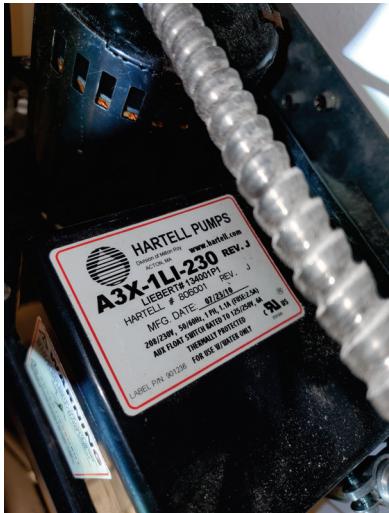
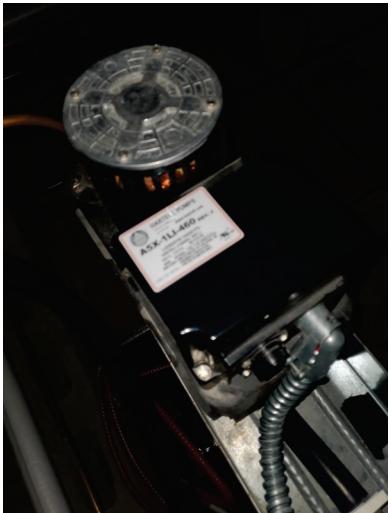
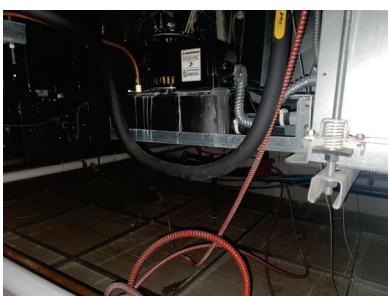
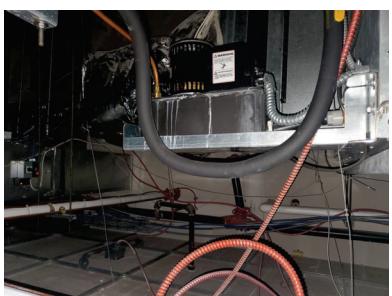
This is a water leak not a freon leak. Unit is cooling fine. The condensate pump is not leveled and has failed. In order to remove high water pan alarm the condensate pump needs to be replaced. Also the condensate pump sitting station needs to be leveled so that there will no longer be any leaks. Once the condensate pump is replaced the unit will no longer leak. The condensate pump will be replaced like for like.

Site: NY058	WO# 21779 CSS # 93068
Description of Repairs	Remove and replace condensate pump like for like and relevel.
Diagnosis: Initial Work Order	Repair HVAC leak in Electrical room within the storage area of the training building.
Explanation of Additional Costs for Repairs	
Additional Labor Cost to Perform Repairs	680.00
Additional Material Cost to Perform Repairs	689.13
Total Cost of Repair	\$1369.13
