Superior Cranes & Service

Tidewater - Army Corps Reserve

Webster NY Facility

Annual Inspections

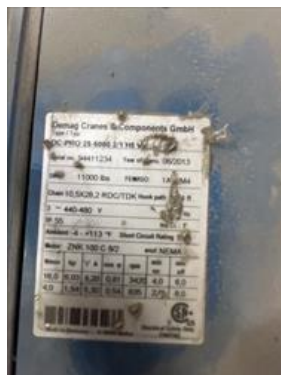
P13.1

<div> <div></div> <div>12. Level and Plumb</div> </div>		Caution	
<div> <div></div> <div>There are 3 structure bolts from mast to ground that have gaps between lock washer and nut. Recommend fastening nuts to avoid problems. Jib did not show signs of being unlevelled.</div> </div>			
Hoist [1]			
<div> <div></div> <div>13. Capacity Signs and Warning Tags</div> </div>		Good	P13
<div> <div></div> <div>Top of hoist</div> </div>			
<div> <div></div> <div>14. Pendant and/or Controller</div> </div>		Good	P14
<div> <div></div> <div>15. Control Enclosure</div> </div>		Good	
<div> <div></div> <div>16. Contactors and Wiring</div> </div>		Good	
<div> <div></div> <div>17. Limit Switches and Levers</div> </div>		Good	
<div> <div></div> <div>18. Motors</div> </div>		Good	
<div> <div></div> <div>19. Gear Cases</div> </div>		Good	
<div> <div></div> <div>20. Shafts and Couplings</div> </div>		Good	
<div> <div></div> <div>21. Brakes</div> </div>		Good
