Over and Above Estimate

Location: WV046

Maximo Work Order No.: 7586

Diagnosis: We are pleased to submit the following proposal for Repairs to the AMSA Shop Lube System. A variety of components require replacement including 5 flow control heads, one 50' hose, 4 regulators and 4 oilers.

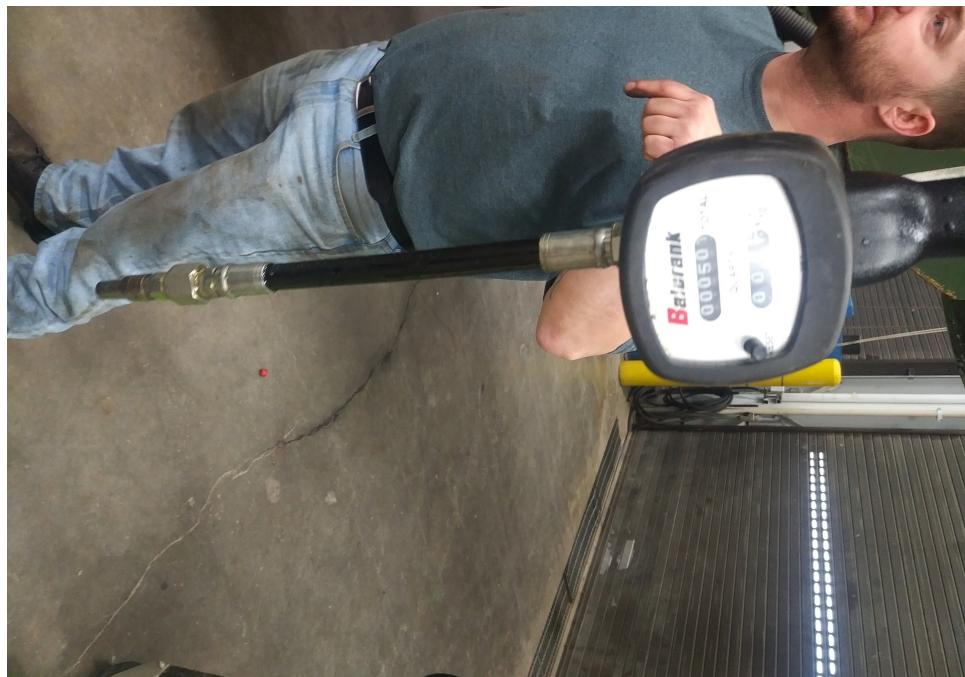
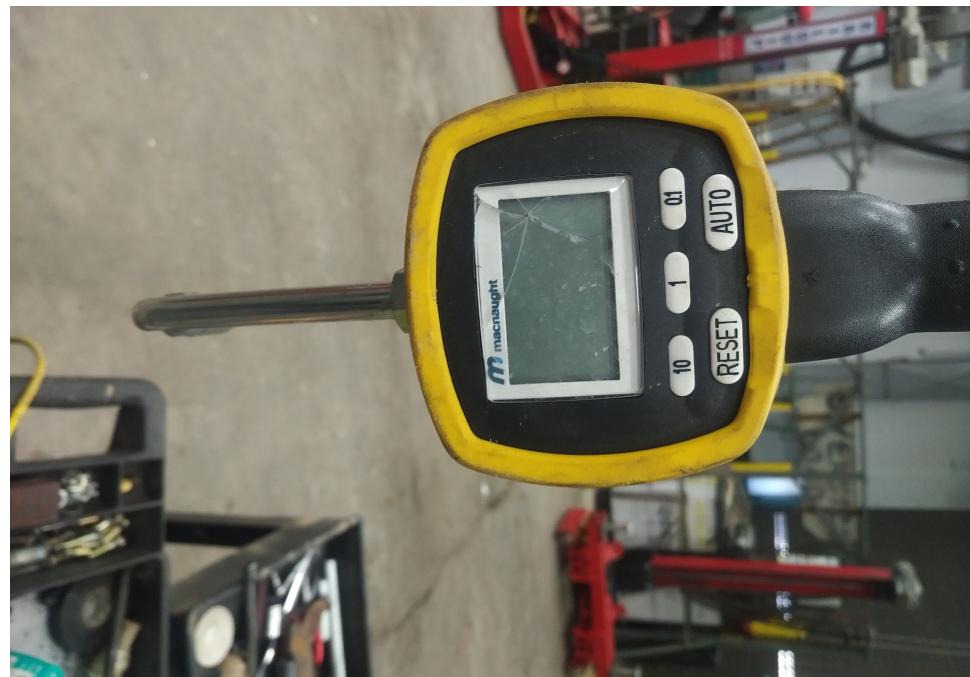
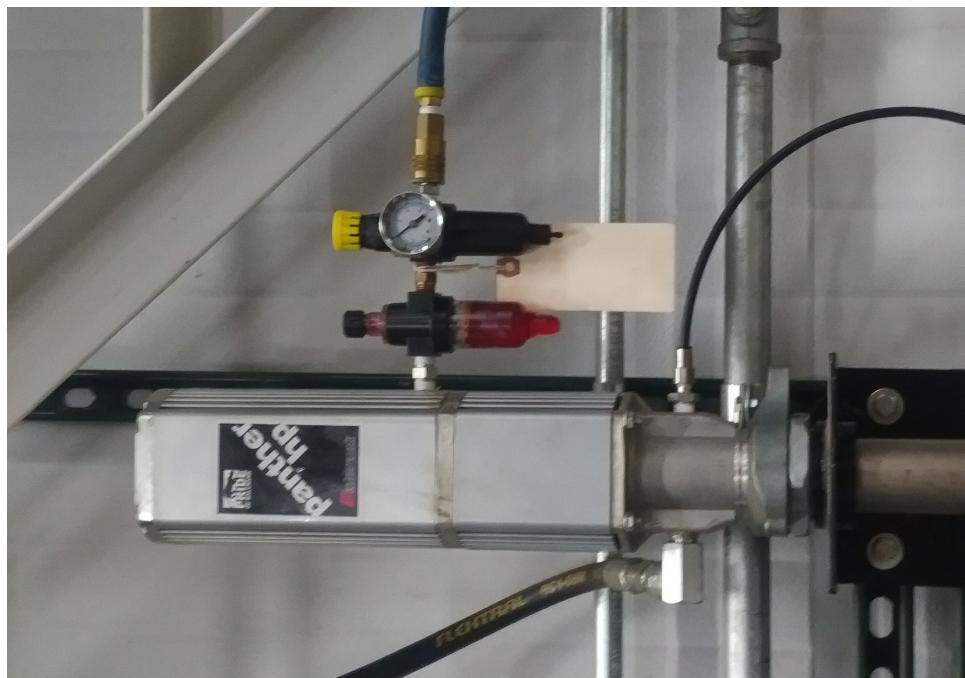
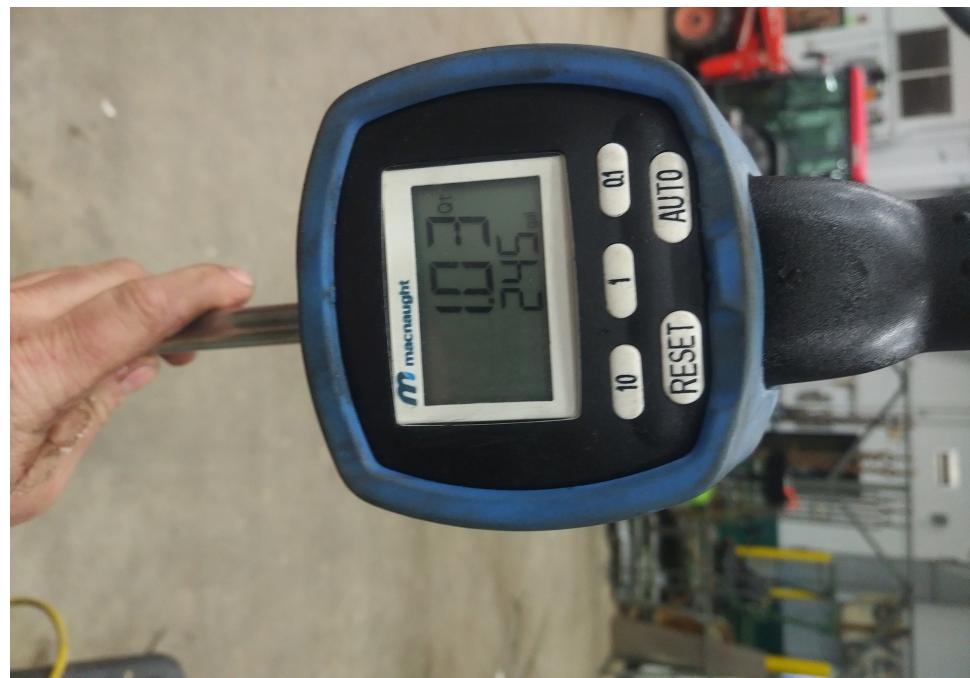
7587 Lube - BAY 2/3 Lenskit Hose BAY 6/7 Screen Broken. Yellow
BAY 6/7 worn smy Locked Bkt BAY 6/7 Blue worn worn out
BAY 3/4 15/16 Blue Broken Screen (And) Blue Hose Lents
BAY 3/4 15/16 - Yellow Doesn't work
7587 Lube Pump Area - NEED 4 NEW O-RINGS, ALL 4 regulation links
Oil Recovery - AIR valve Doesn't shut when tank is full - Spill Risk!
Parts washer - ROTATION motor seized, Electronic Controls Burned up
7586
