Over and Above Estimate

Location: WV046

Maximo Work Order No.: 7585

Original Description: The pump motor on the Parts Washer in BMA 102 does not function and the Siemens PN 5-00-0076 DP Contractor supplying power to the unit is showing signs of overheating and has melted plastic on exterior. Please trouble shoot and repair. Unit is currently disconnected from power.

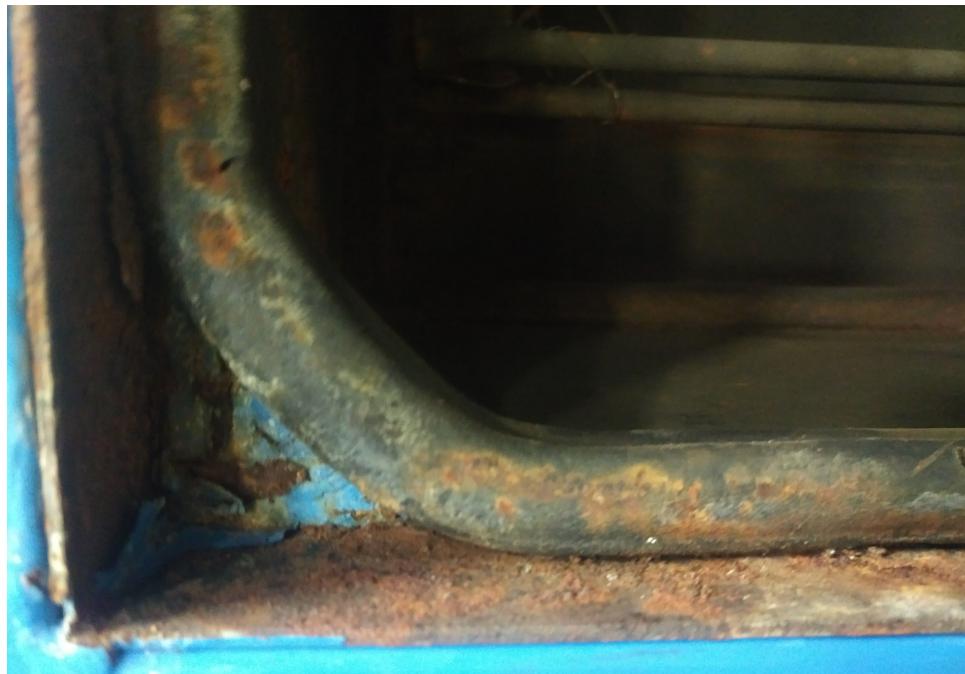
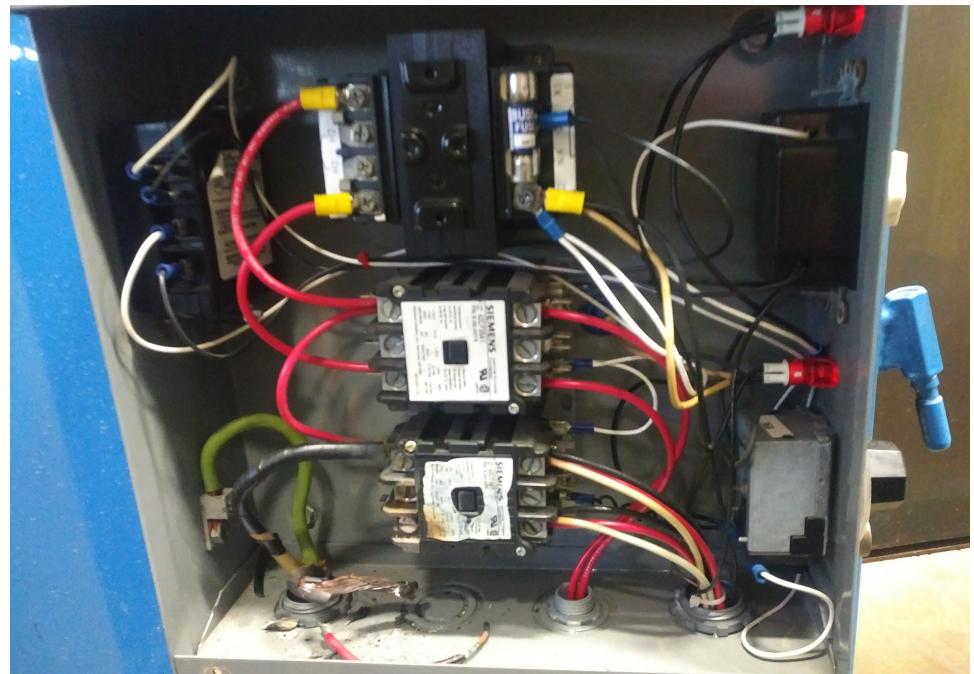
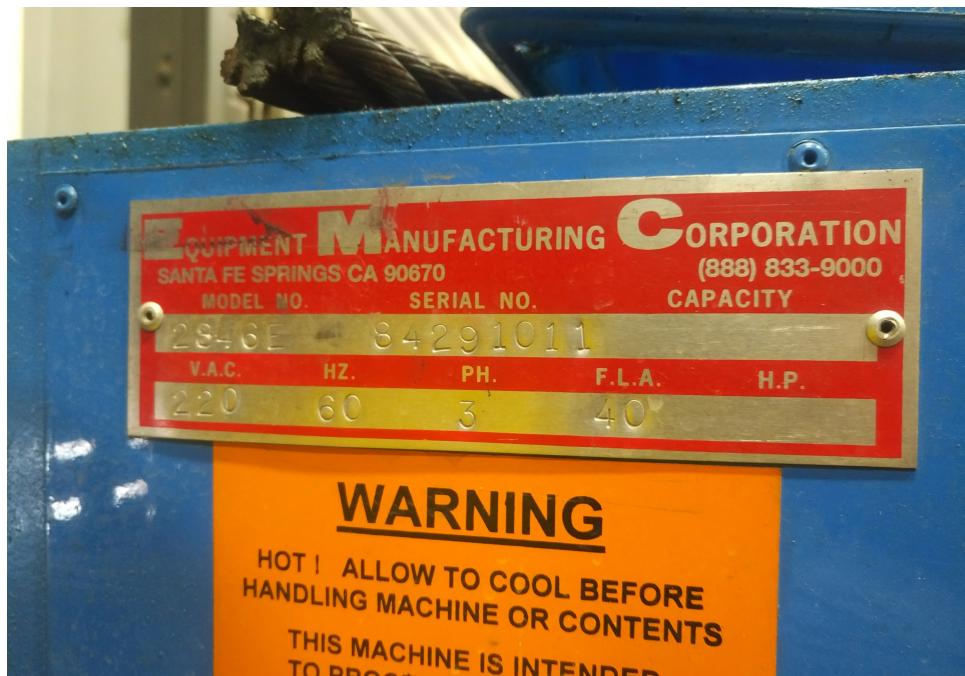
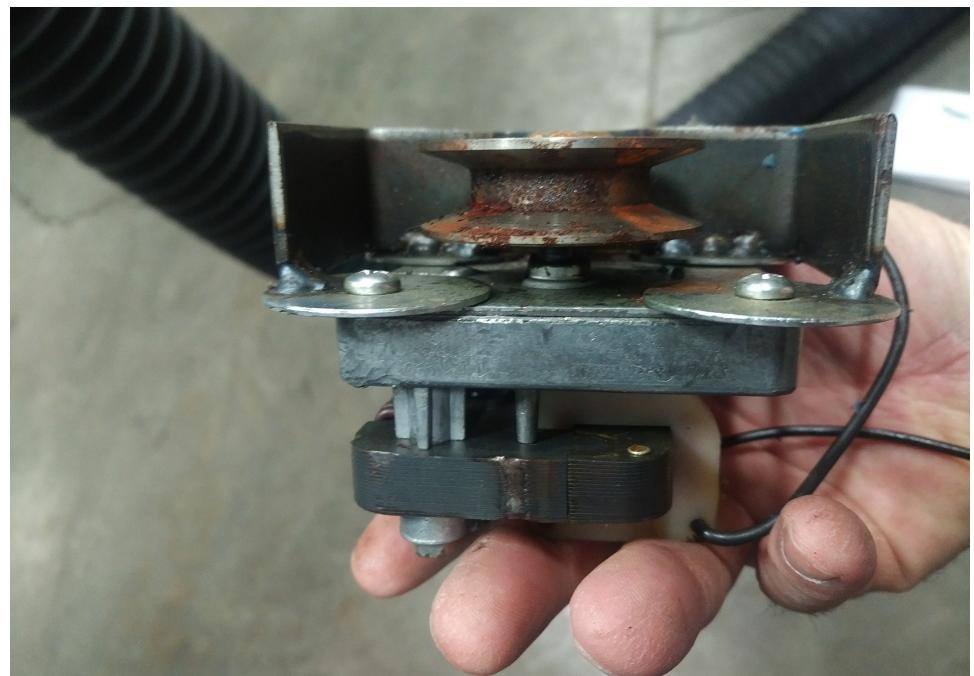
Diagnosis: We are pleased to submit the following proposal for Repairs to the EMC Model 2846E Parts Washer that was apparently subjected to significant energy overload resulting in the destruction of the wiring and components within the control panel. Proposed activities along with detailed costs are listed below.

7587 Lube - BAY 2/3 Lenskit Hose BAY 6/7 Screen Broken. Yellow
BAY 6/7 worn smy Locked Bkt BAY 6/7 Blue worn smy
BAY 3/4 15/16 Blue Broken Screen (And) Blue Hose Lents
BAY 3/4 15/16 - Yellow Doesnt work
7587 Lube Pump Area - NEED 4 NEW O-RINGS, ALL 4 regulation links
Oil Recovery - AIR valve Does not shut when tank is full - Spill Risk!
Parts washer - ROTATION motor Seized, Electronic Controls Burned up
7586

Quantity	Line Item Number	Description	Labor Hours	Unit	Labor	Materials	Equipment	Total
1		Control Panel				\$985.00		\$985.00
1		Rotation Motor				\$87.00		\$87.00
