CMI Cost Estimate								
Over & Above								
PA013 Butler								
OH door on BMA								
CSS #15386- CMI # 5794								
Prepared By: J. Bayne								
12.11.18

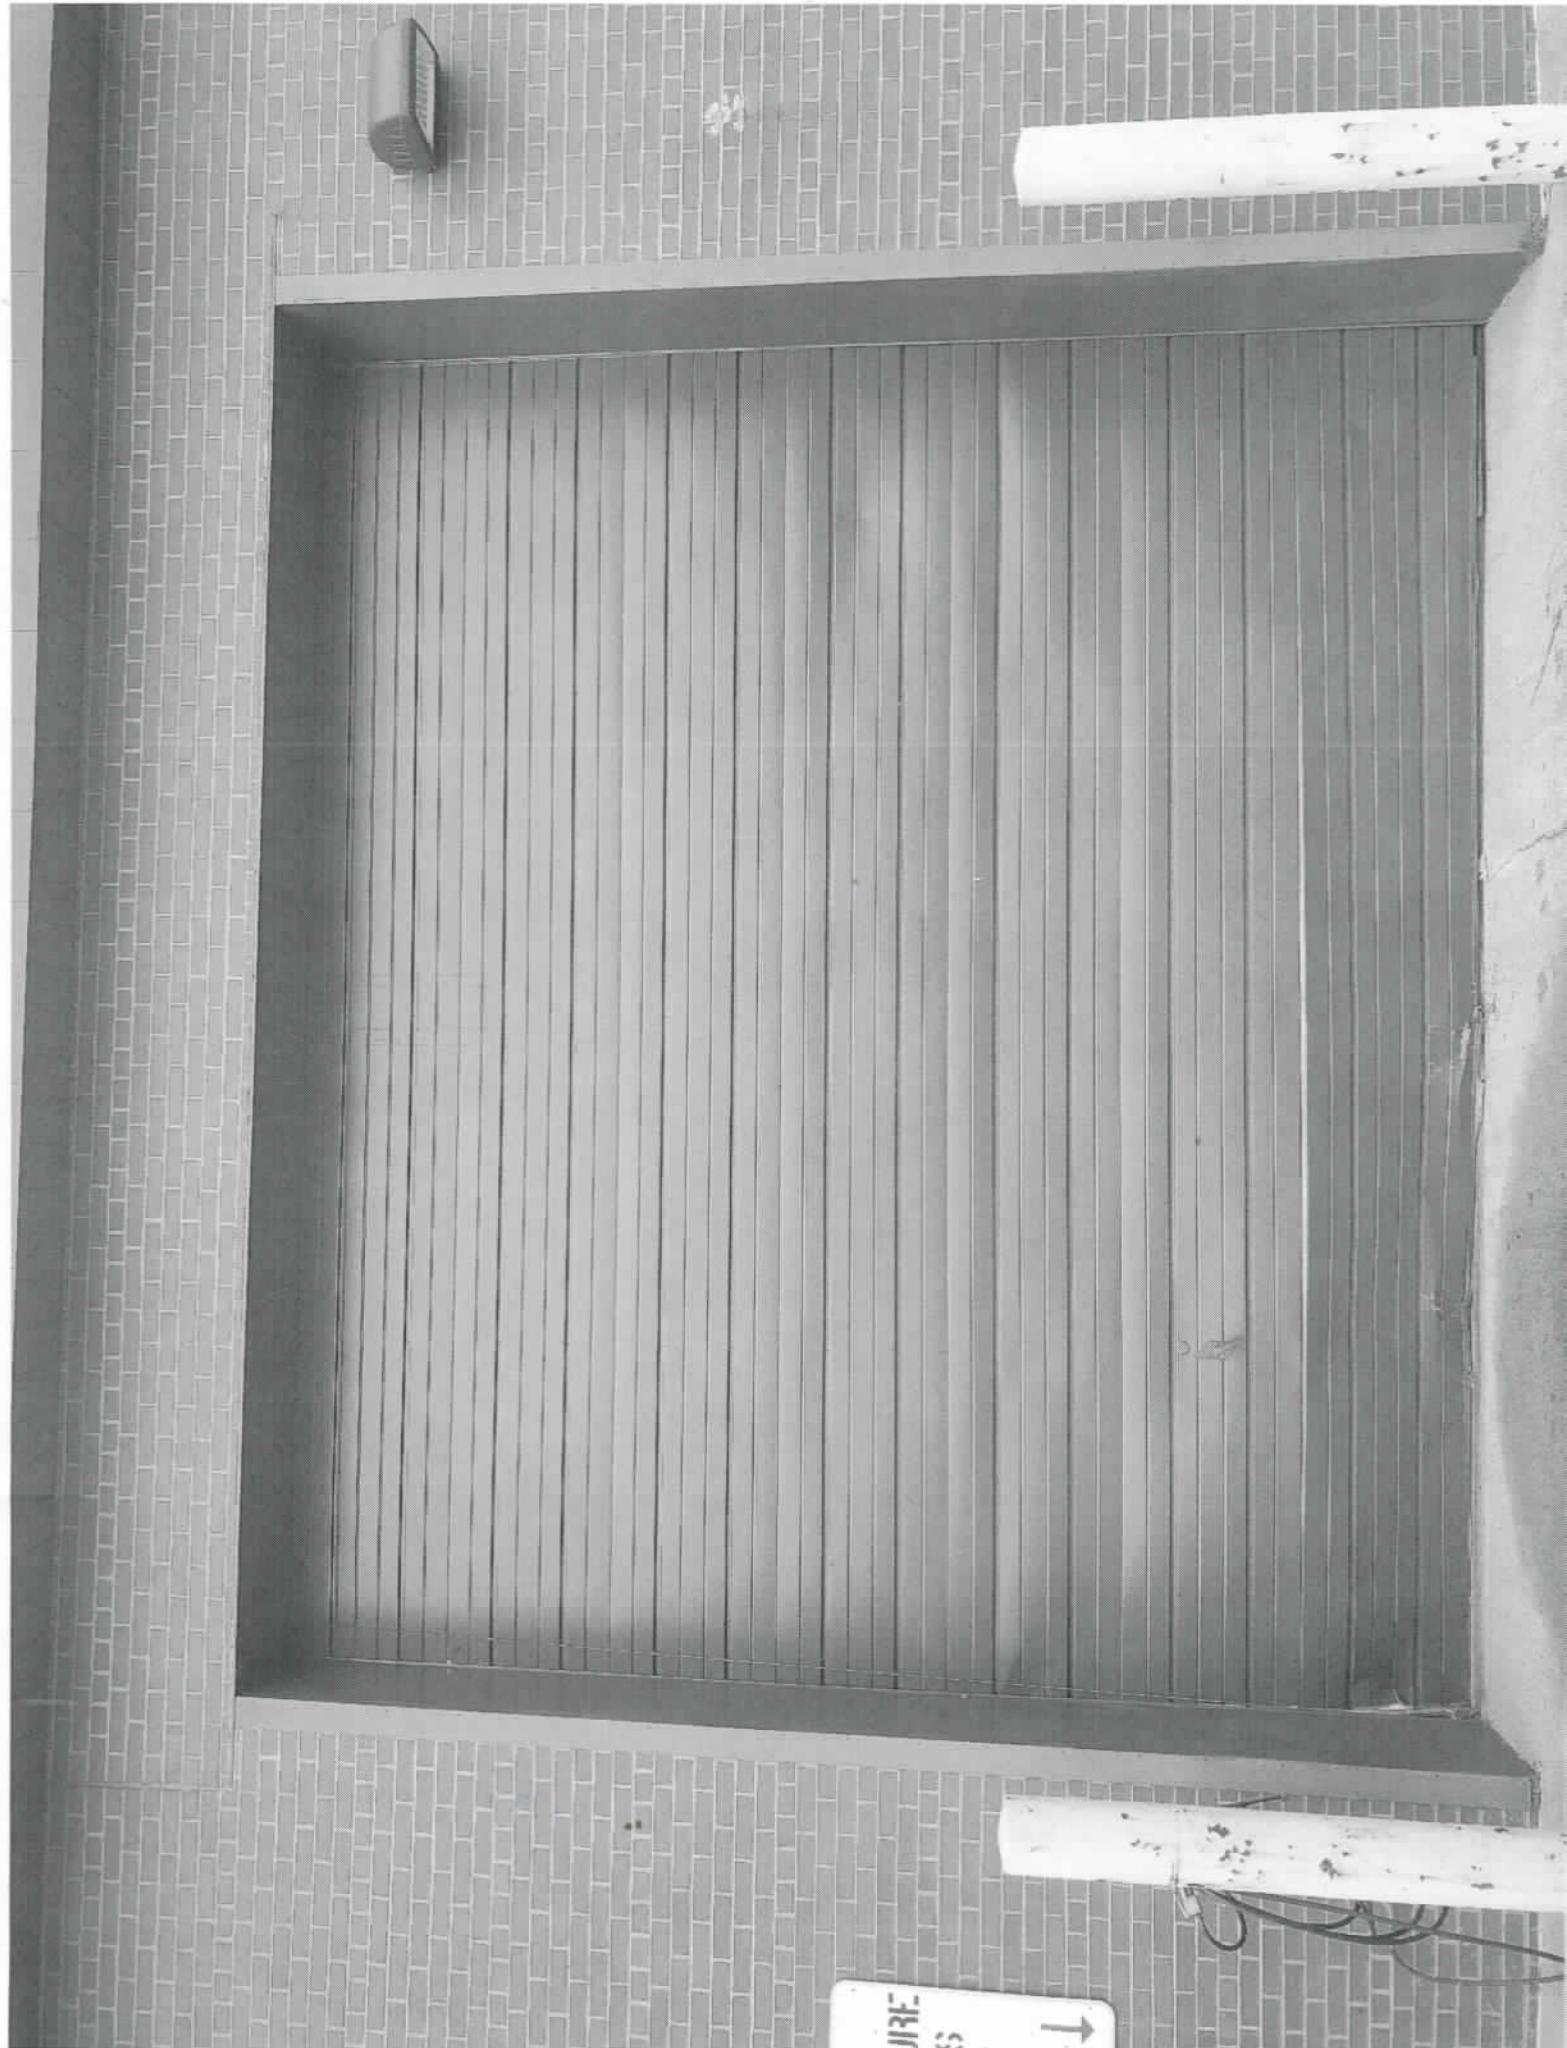
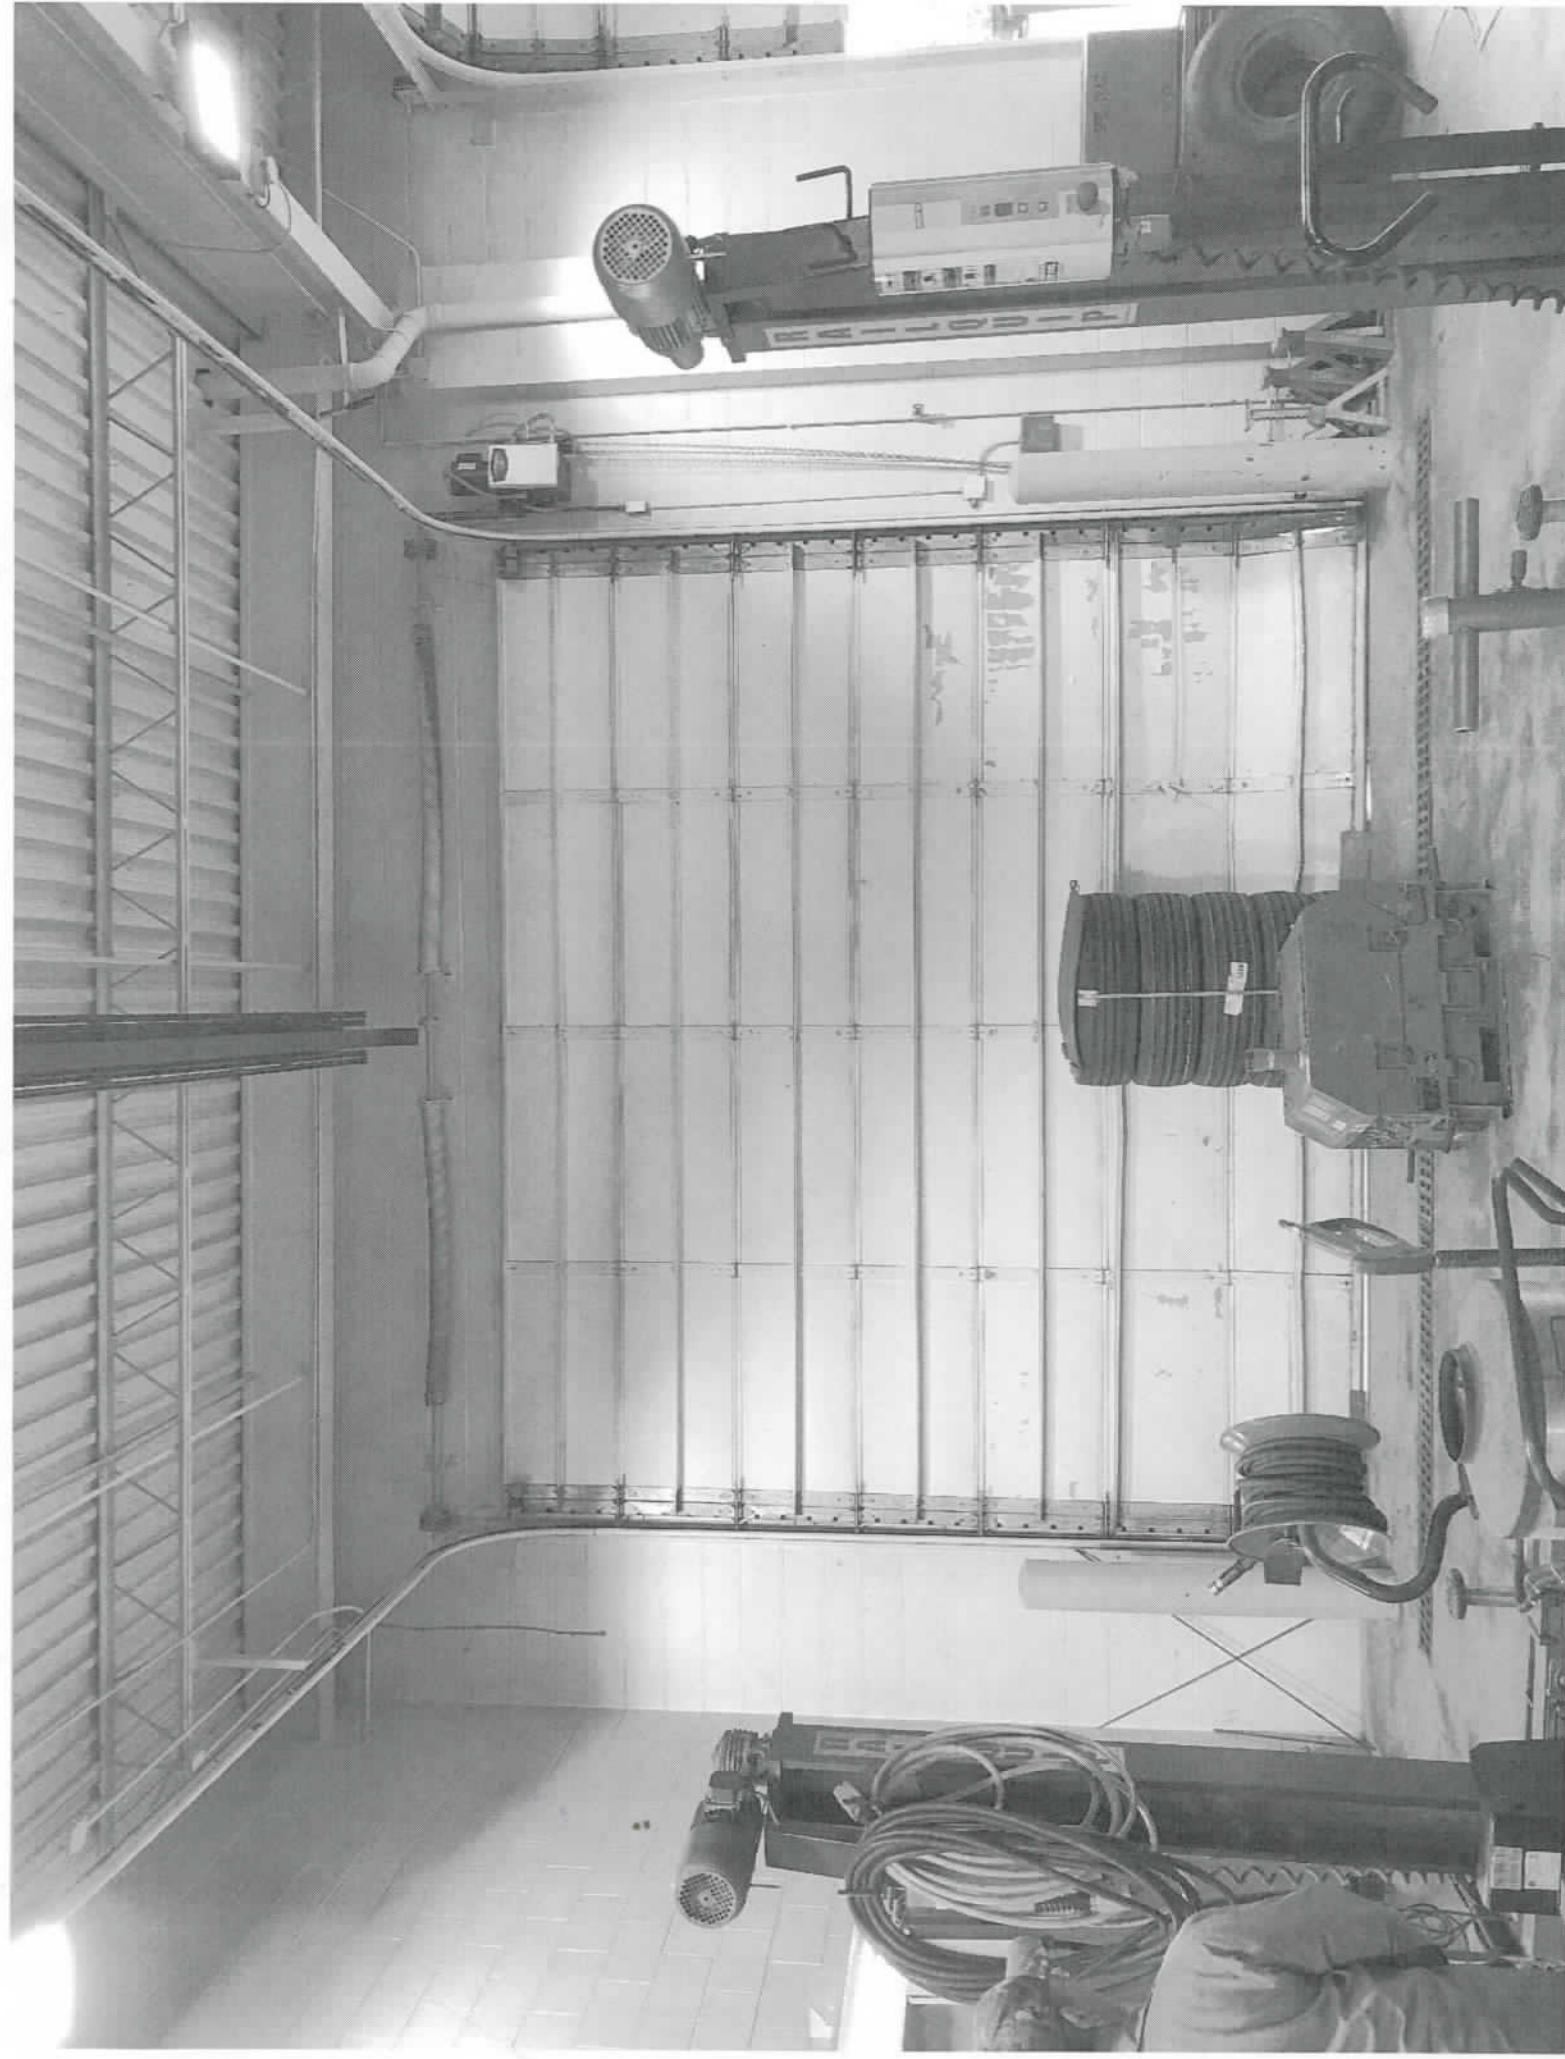
Repair rollers, roller mounts, roller brackets, lifting cables, and bottom panel of OH door on BMA. Door was in open position when run into by a vehicle entering the garage bay. Lower door panel was dislodged from the track on the left side and twisted on the right side. Panel was disfigured, rollers were partially detached, and left side lifting cable is currently outside the door. Door will not open/close automatically due to the damage and requires repair and realignment. Assess opener for damage that may have been caused by having to manually force door closed in order to secure bldg. Door is in the bay where the overhead crane is located. Need to repair soon just in case shop needs to use crane to conduct operations.

We Proposal to furnish & install.

One (1) 16'2 x 14'1 Thermacore Series 591 Insulated Sectional Door.

- Standard Lift 3" heavy duty track
- Reconnect existing operator
- Take down existing
- Door to be painted white
