## Facility Repair Proposal

**Region:** 4A  
**Fac ID:** PA118  
**Date:** 2/6/23

**CSS #** 91250  
**Maximo Work Order No.:** 11755

Estimate Name: CSS 91250 - WO 11755 - PA118 Repair Flashing and Metal Above OH Door

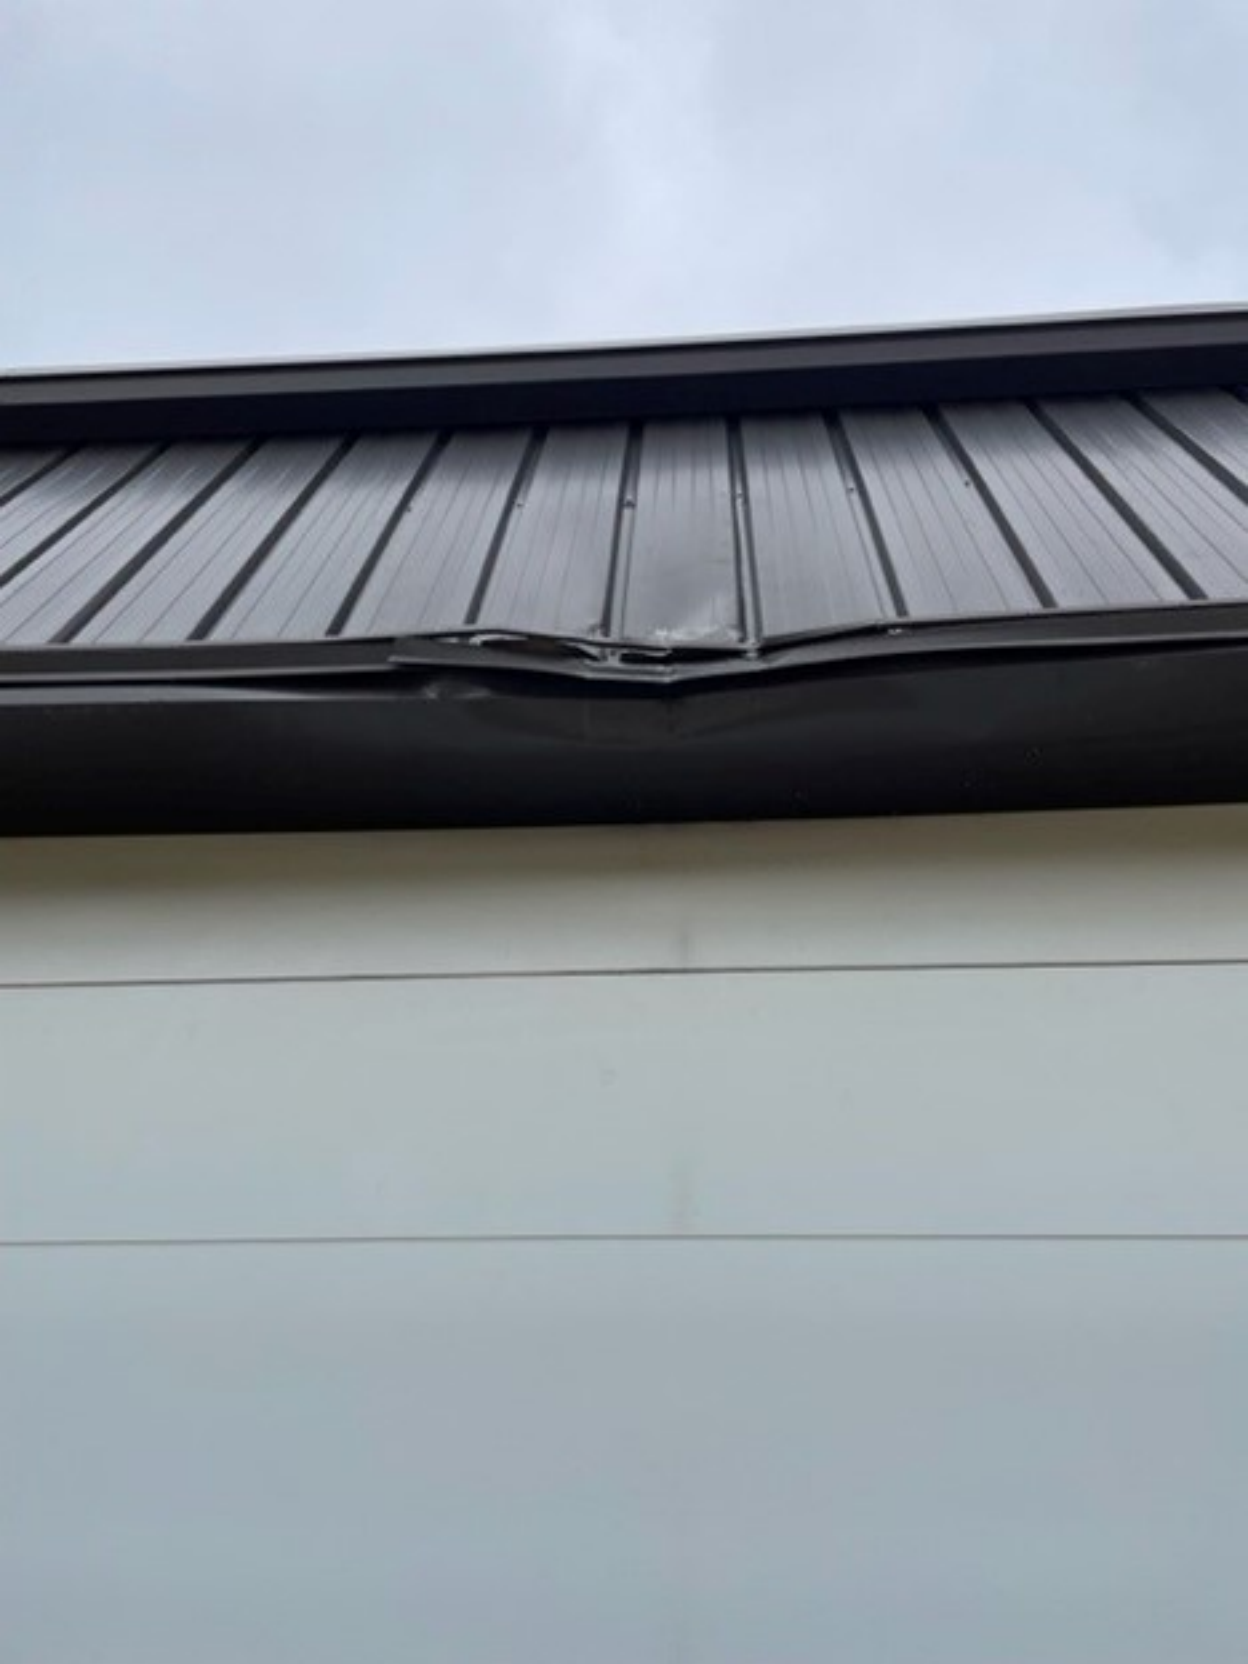
Flashing over door #9 needs repaired (rivets) as it is interfering with the overhead door, picture attached

Labor (approximately 40 hours) and material to a.) repair the flashing over door #9 needs repaired (rivets)  
as it is interfering with the overhead door.
