Region: 4C
FAC ID: VA012

CSS No.: 92080
Maximo Work Order No.: 12084

Replace 2 Pump in Vehicle Oil Motor Pool

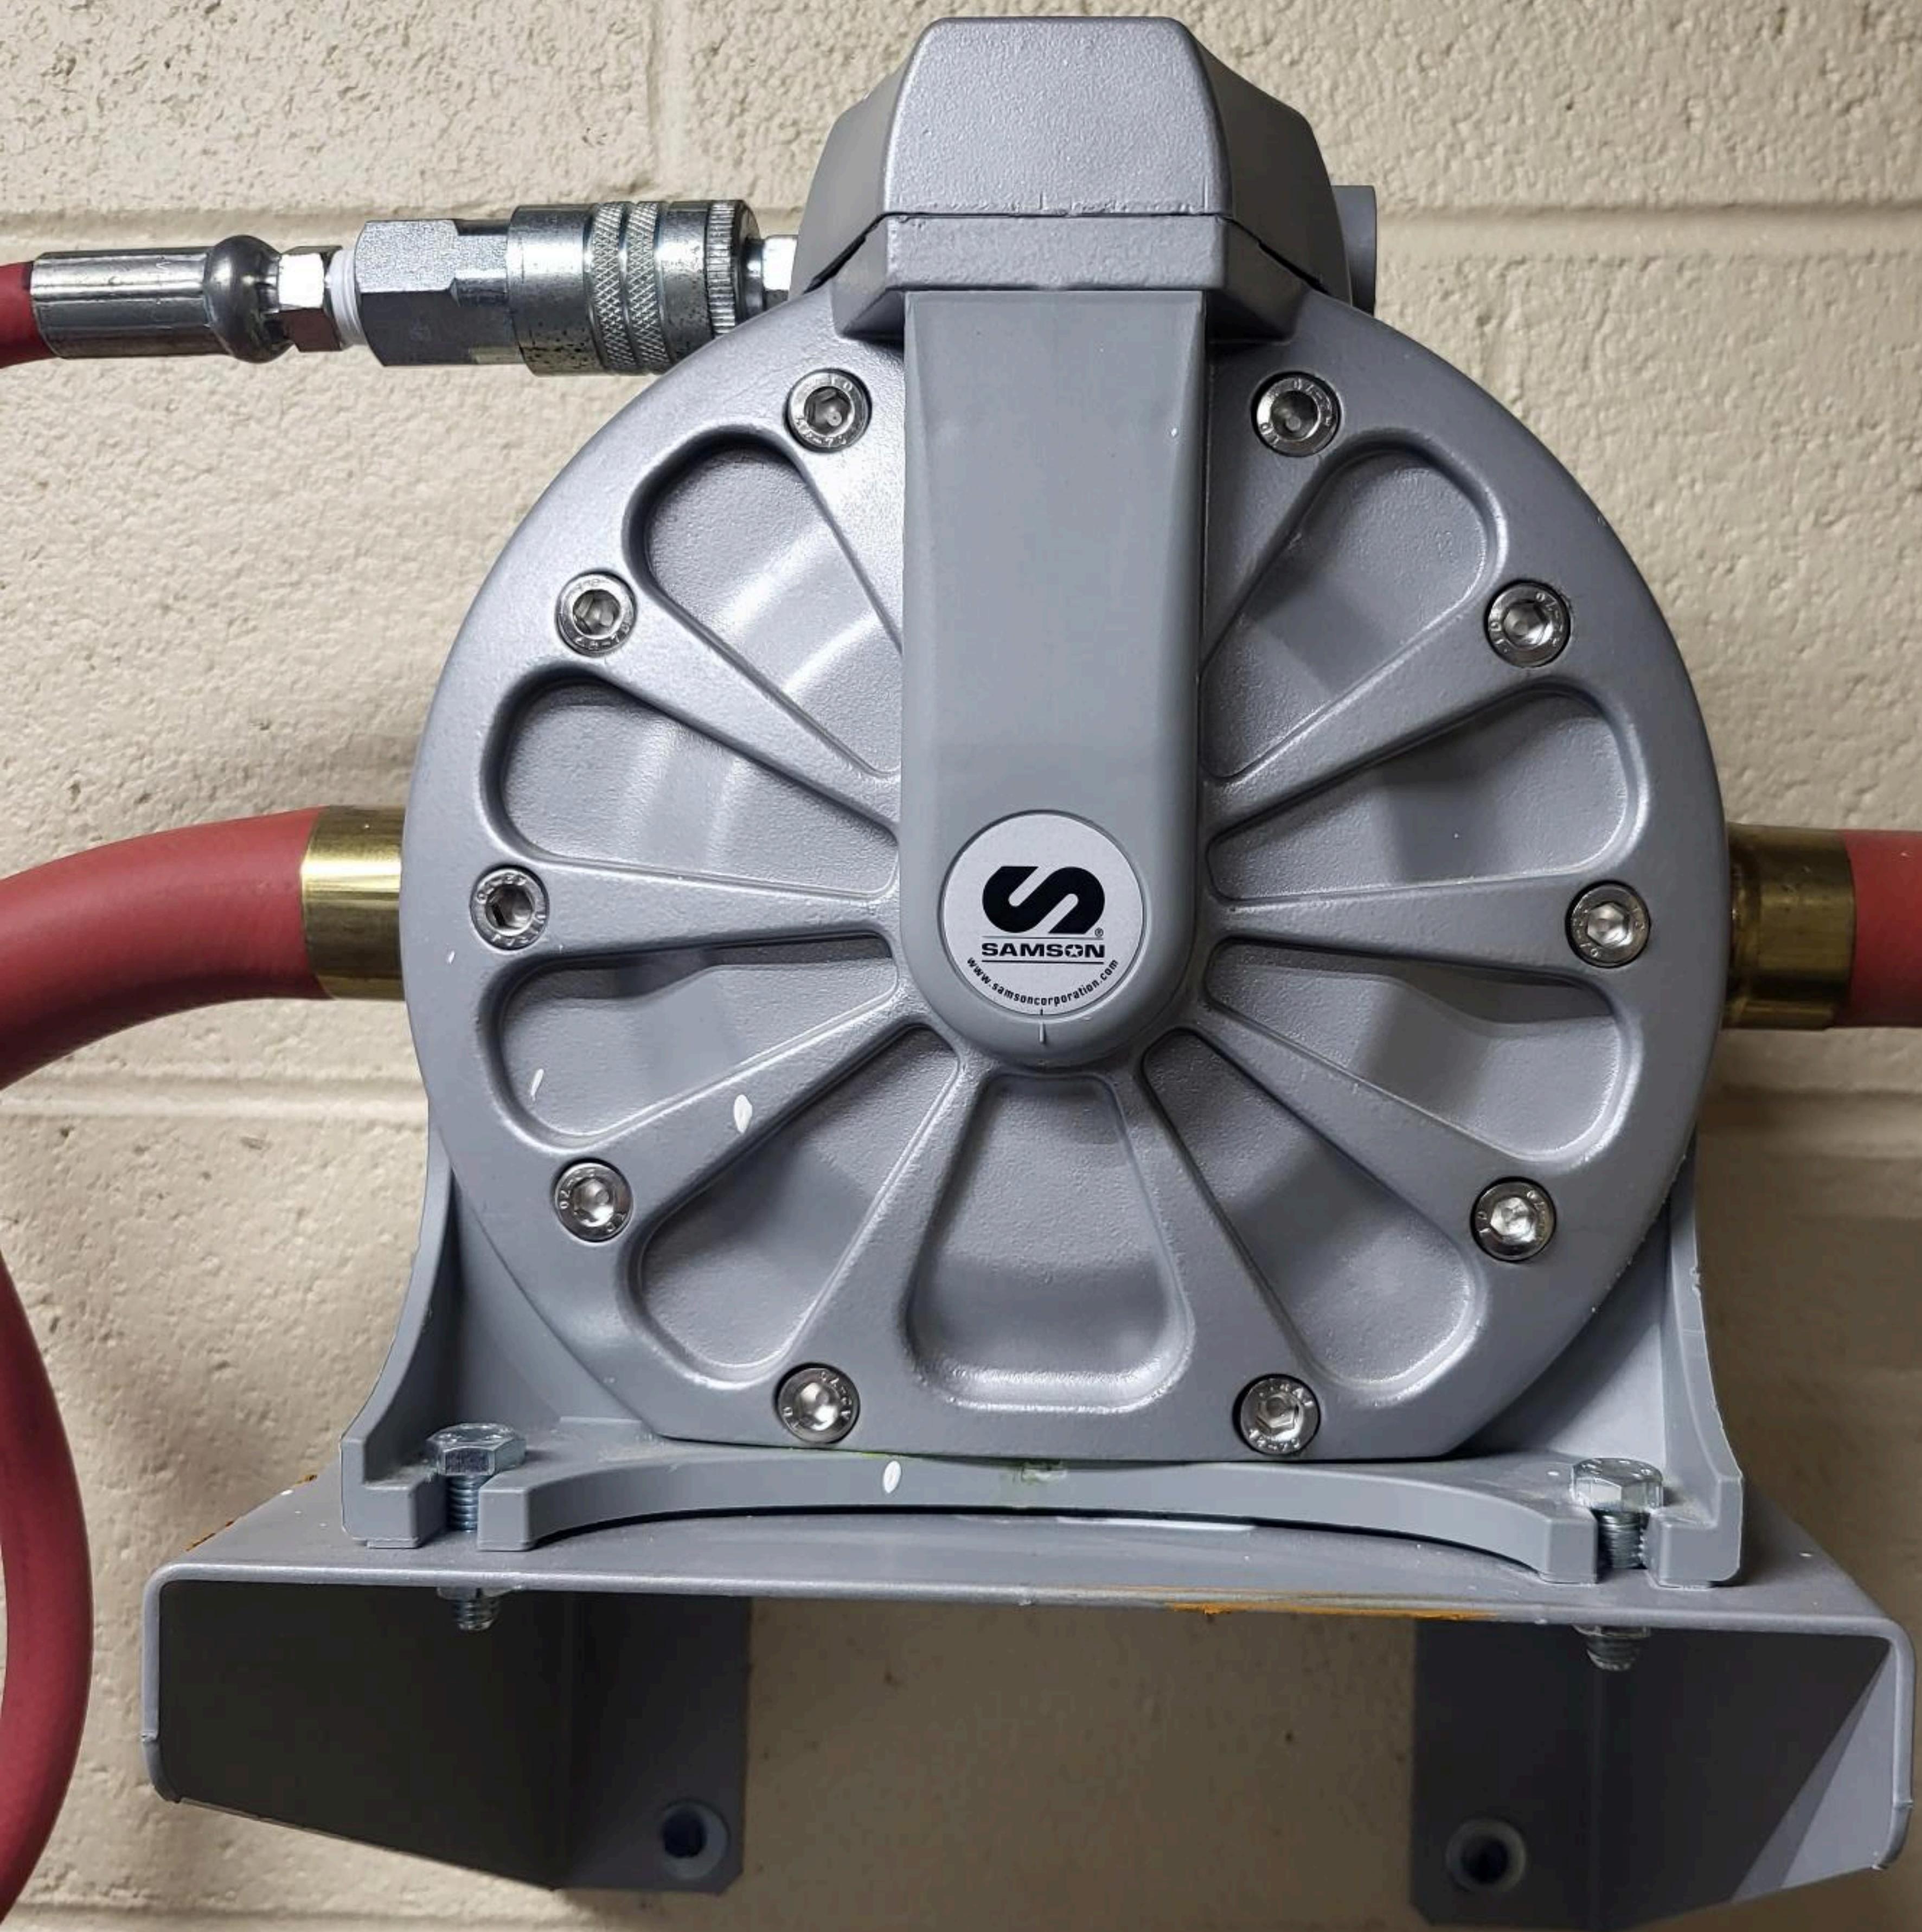
SAMSON CORPORATION
Swannanoa NC 28778
Phone 828 686 28778
PUMP TYPE: DF 100 8511
PART No.: 551015.300
YEAR: 07/18
MAX AIR / FLUID PRESSURE: 100 lpm - 26.5 US gpm
FLUID IN/OUT: 1" NPT + Flange
SERIAL No.: 551015X
FLUID IN/OUT: 1" NPT + Flange
SERIAL No.: 402738 7002

Labor and material to a.) to replace the (2) pumps in the vehicle motor pool. (1) Model 551030 – Directflo, 100 – Aluminum NBR Diaphragm Pump (1) Model 4ZT44 – Legacy – Air Operated Drum Pump

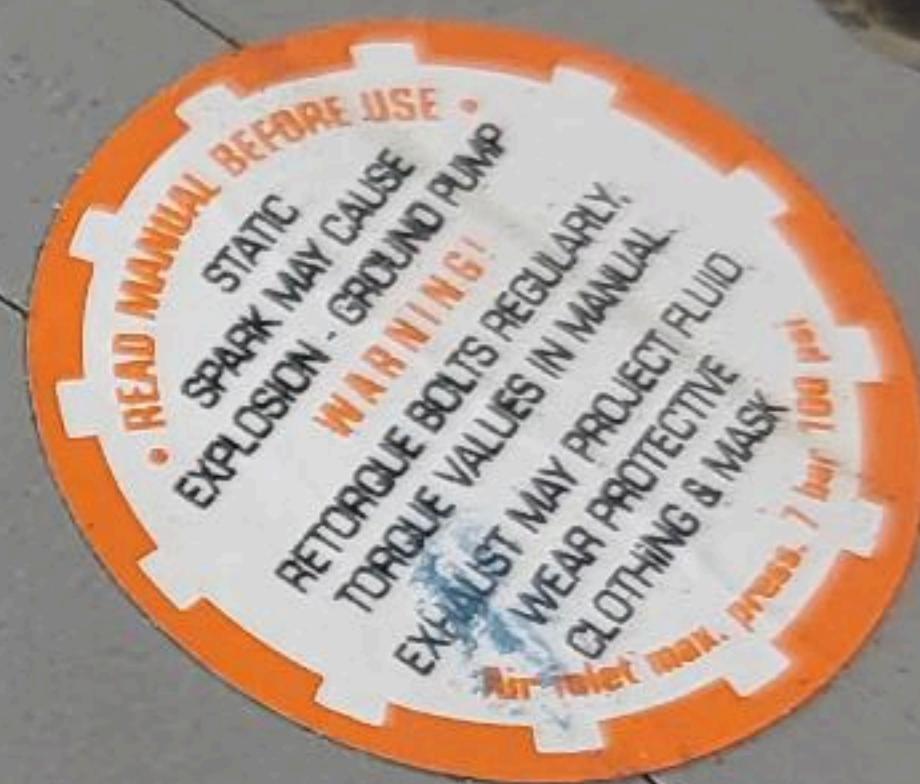
RATIO5:1/HD-S PUMPMASTER 4

PART No.: 347120.350

SERIAL No.: 000030083 0007 01/20
