1-19-23 ECS AHU5  
AHU6 actuators

FACID/Building: PA118 Date of Visit: 1/19/23

1. CSS# 91588. Looked at the hot water actuators on AHU5 & AHU6

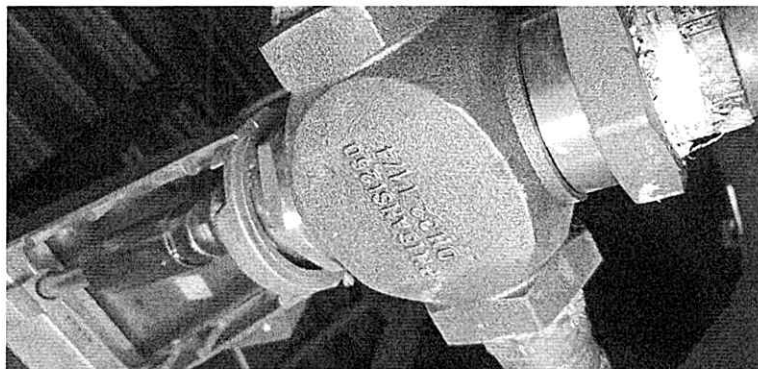
Title	File Name
Actuator on AHU-5	9b0d0aa0-f88c-4cab-885f-480698b602e0.jpg

<b>Daily Form</b>	Fill out every day. even on PMs, and projects
<b>TECH NAME</b>	Tom Timlin
<b>DATE</b>	1/19/23
<b>TOOLS USED</b>	hand tools
<b>MATERIALS USED</b>	none
<b>DESCRIPTION OF WORK PERFORMED</b>	<p>AHU-5: Found the 3 way actuator on the hot water coil bad and not moving. It was over heating the spaces. Got the information off the actuator and sent it to the office got get a quote sent out. Set the valve manually to a slightly open position to be putting off about 92° to help keep the area warm and not overheating. There are radiators in the rooms but one radiator in the men's and women's locker rooms did not seem to be getting warm.</p> <p>AHU-6: Found the 3 way actuator motor spinning on the shaft. Took it off and made sure the valve would move easily and it was. Put the motor back on and tightened it down again. Cycled the valve on the controls and it was working properly.</p>
<b>HOURS</b>	<p>REGULAR:</p> <p>OVERTIME:</p>

**DESCRIPTION OF WORK PERFORMED** Replaced broken actuator on AHU 5. Unit at normal operation
