MD021, Rockville, MD

## MD021

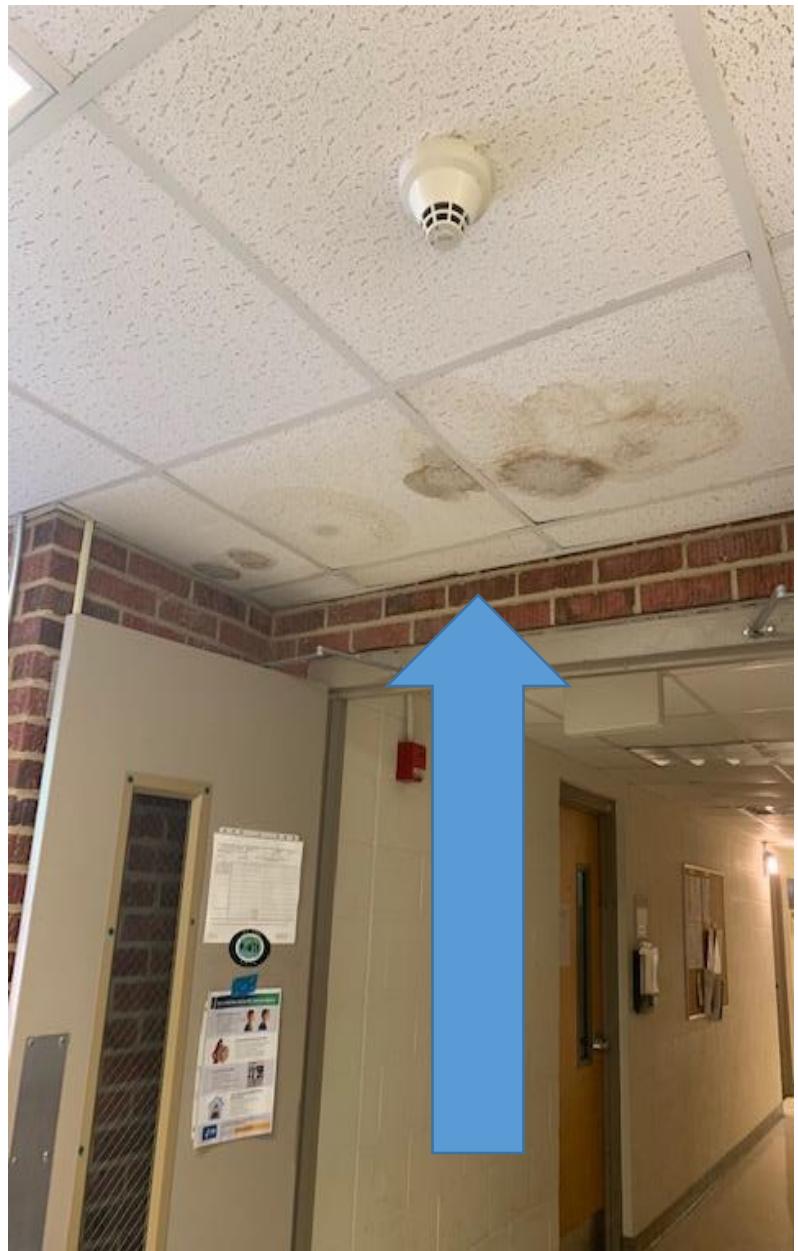
End of hallway where elevator is located. Lower level to MP Company starts.

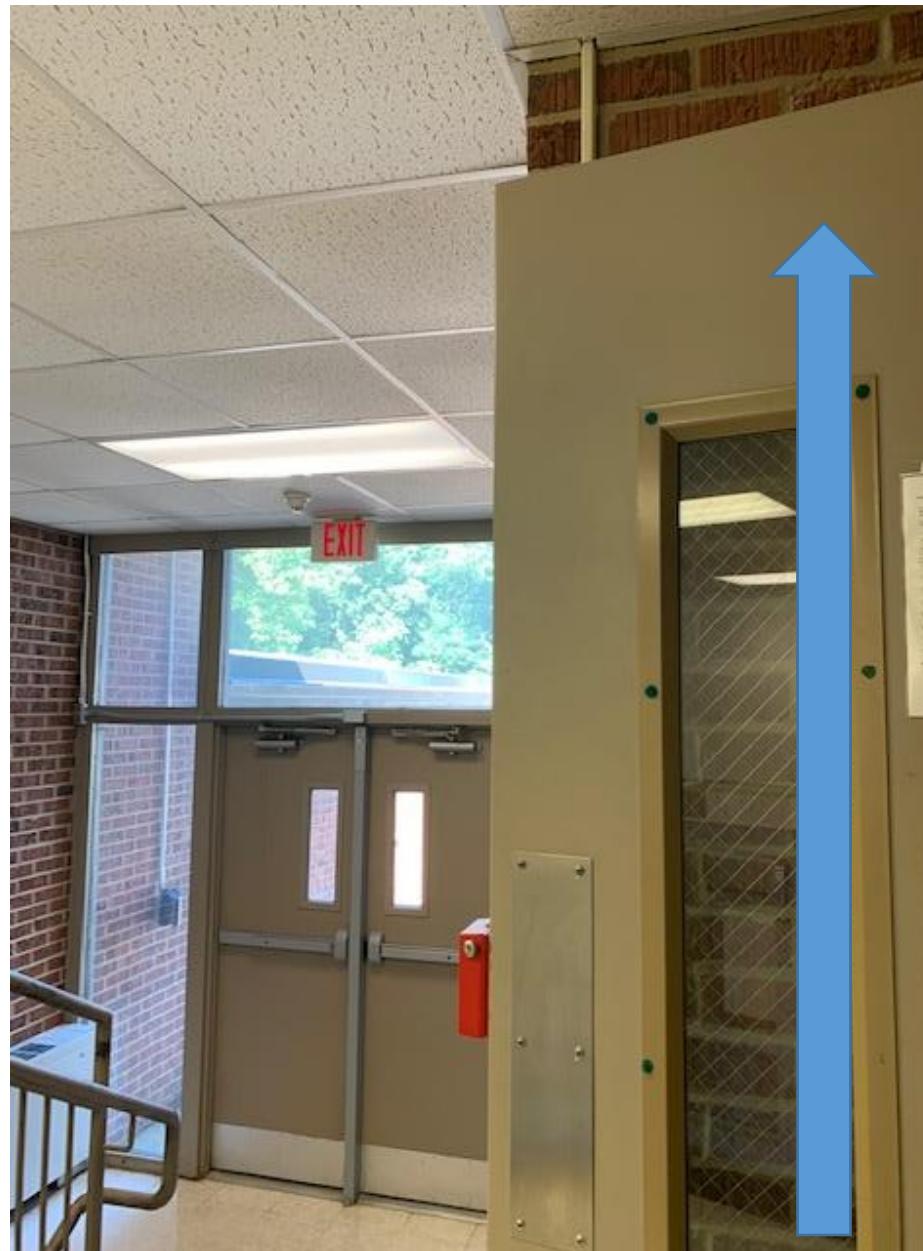
Transition area where the main training building and lower building was attached.

Location Photo: Blue Arrow shows area of leaks above doors. Transition areas where the building join together.

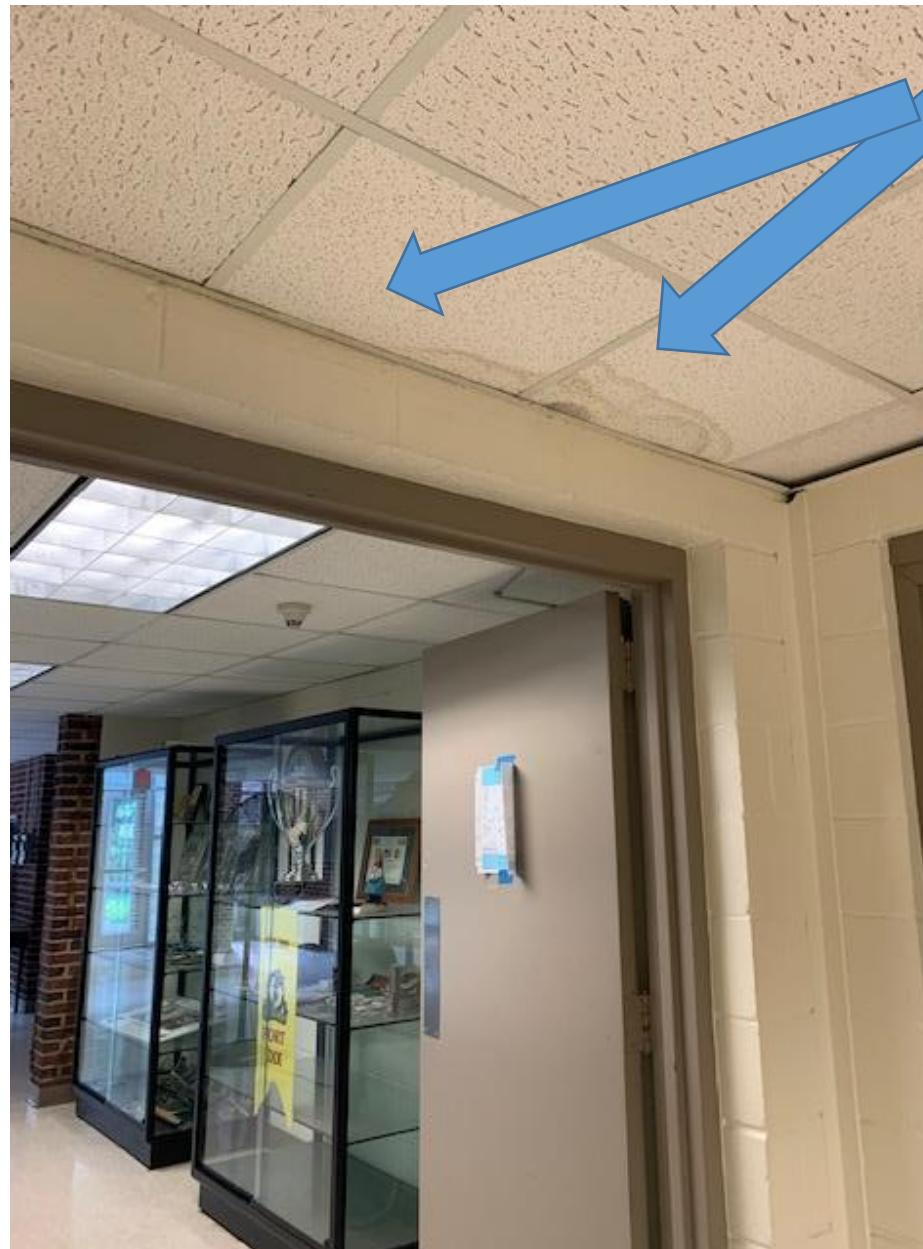
## Entrance Hall way

Location: Hall way as you come into the Training Building across from Restroom.

Leaks: above doorway where the Training building and Assembly hall transition. Both ends of this hallway leaks above the door ways.

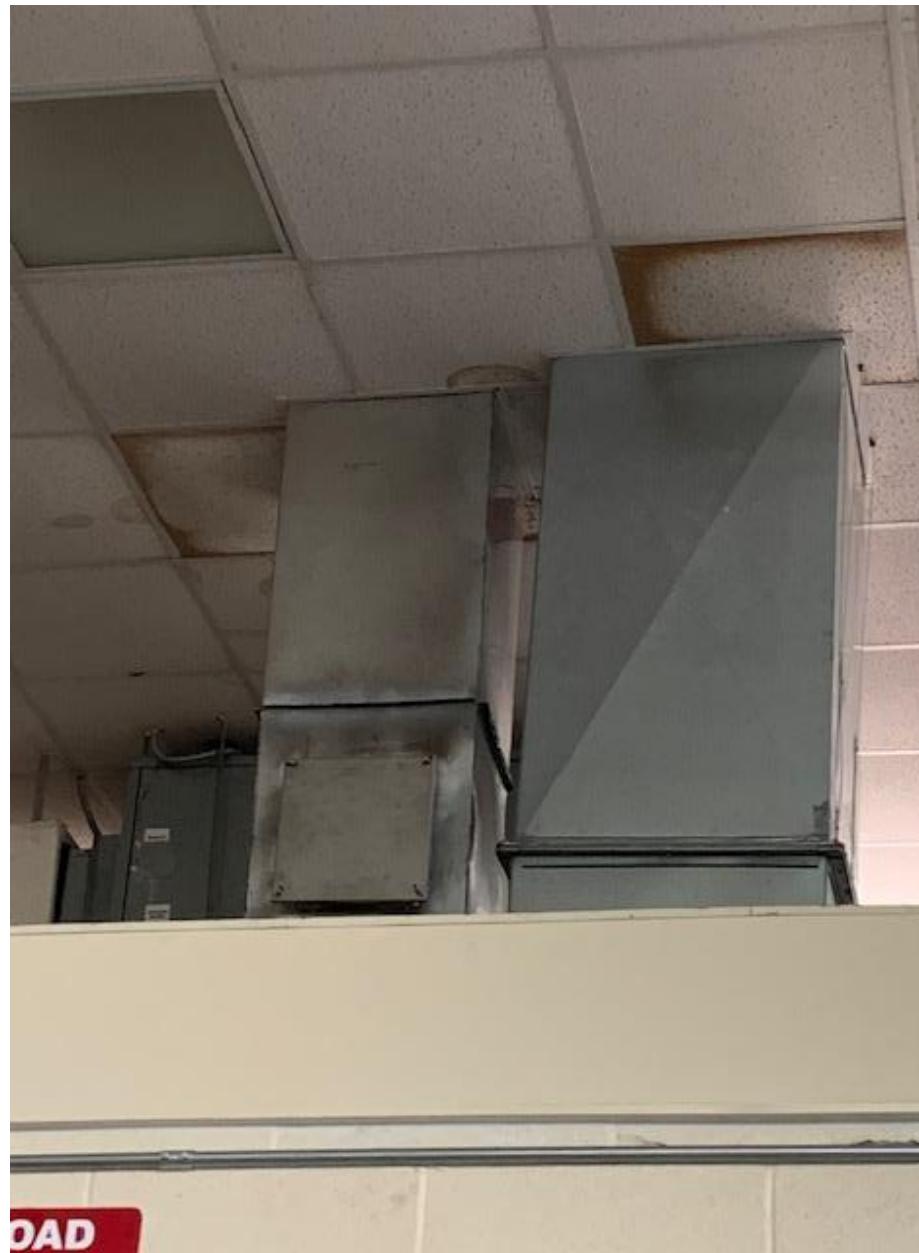
## Assembly Hall

Flashing around Ductwork leaking.

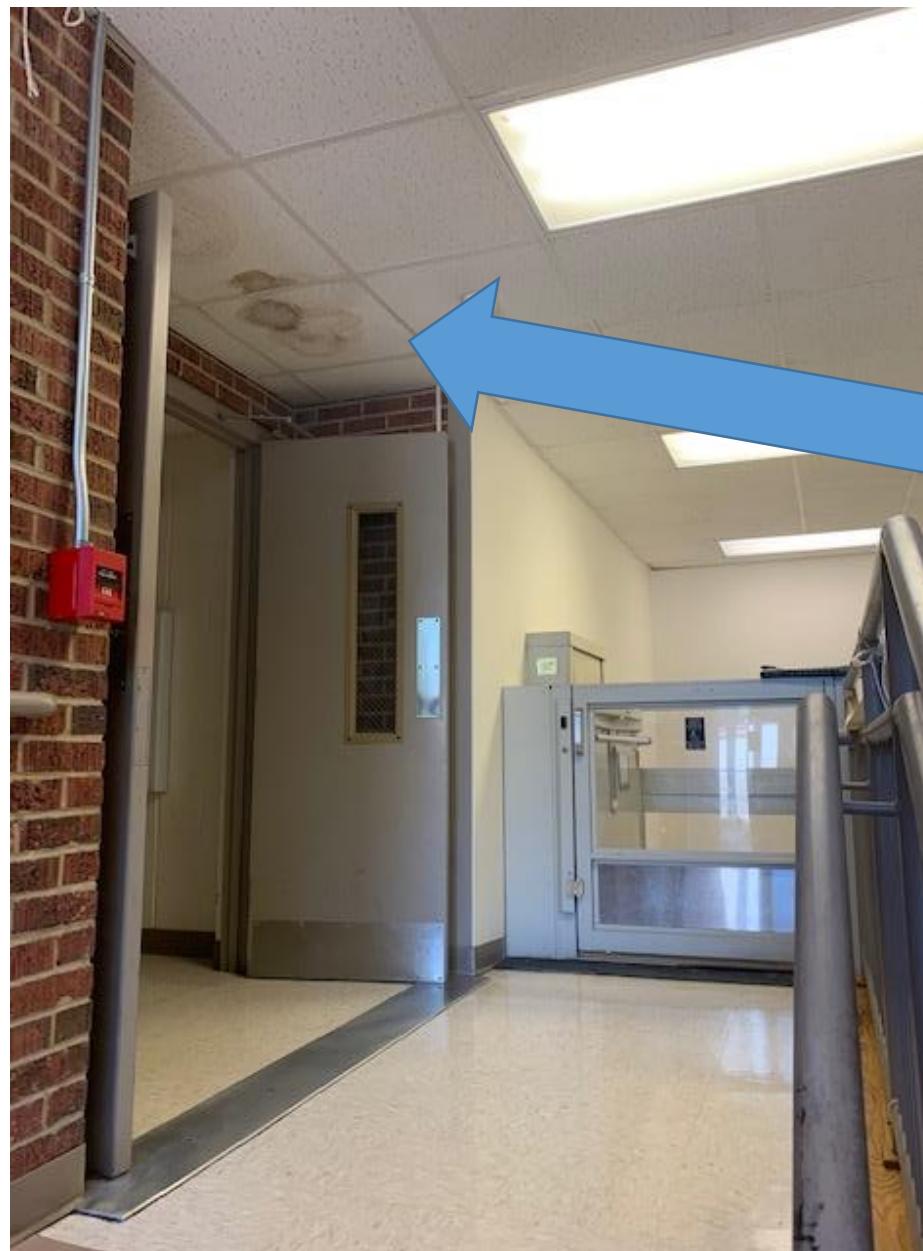
Location: Transition level same as above area. Soldiers placed large trash cans under door way to collect the rain water.
