Microbial Assessment & Mitigation Recommendations

Project ID: 25-0327MN-A

United States Army Reserve Center
DCSA Office Room #14
100 North Forest Road
Amherst, NY 14221

Conditions as of: March 27th, 2025

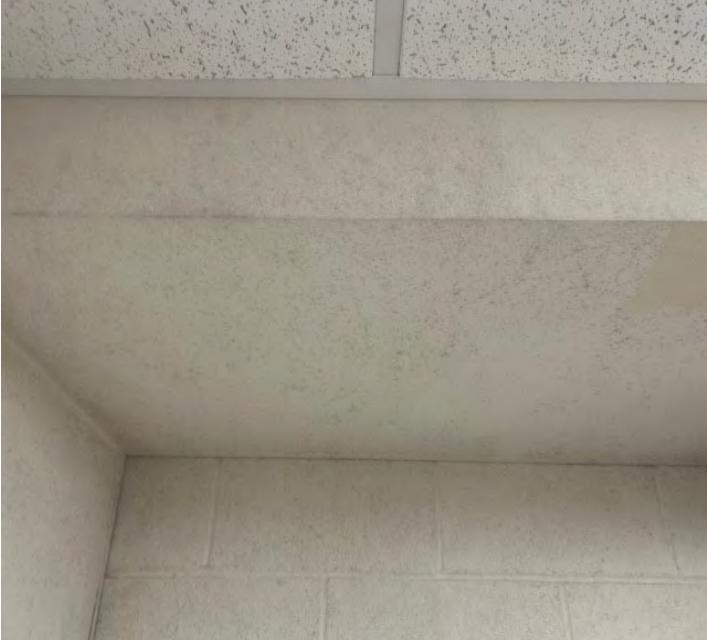
<p>Location: DCSA Office -Room #14</p> <p>Observation: -Visible suspect microbial growth in a spotting pattern on all surfaces below suspended ceiling.</p>

- **Surface mitigation** to all affected areas to include walls, baseboards, doors, floors, attachments, furniture, and stored items per section 4.4 and 4.5 of the “**Microbial Mitigation Work Scope**” included with this report.
Affected Area 500 SF

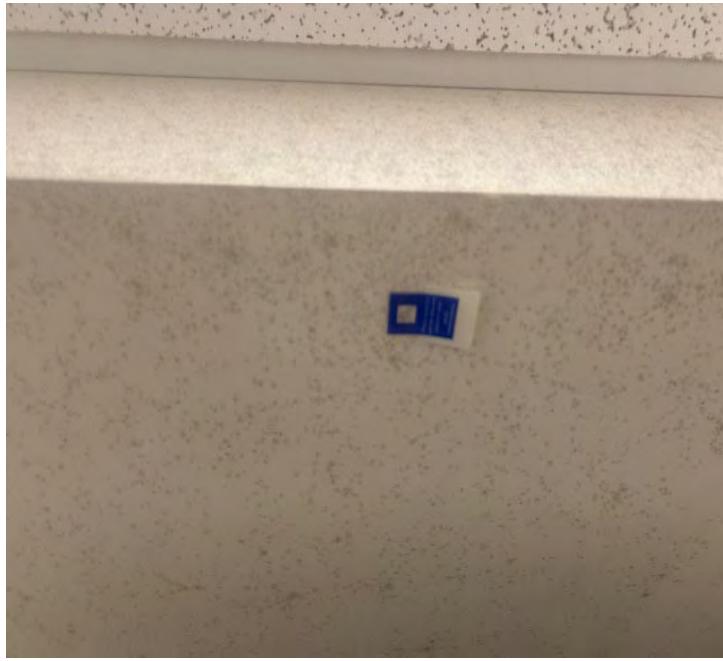
<p>Location: DCSA Office -Room #14</p> <p>Observation: -Representative surface tape lift sample from drywall confirms microbial growth.</p>

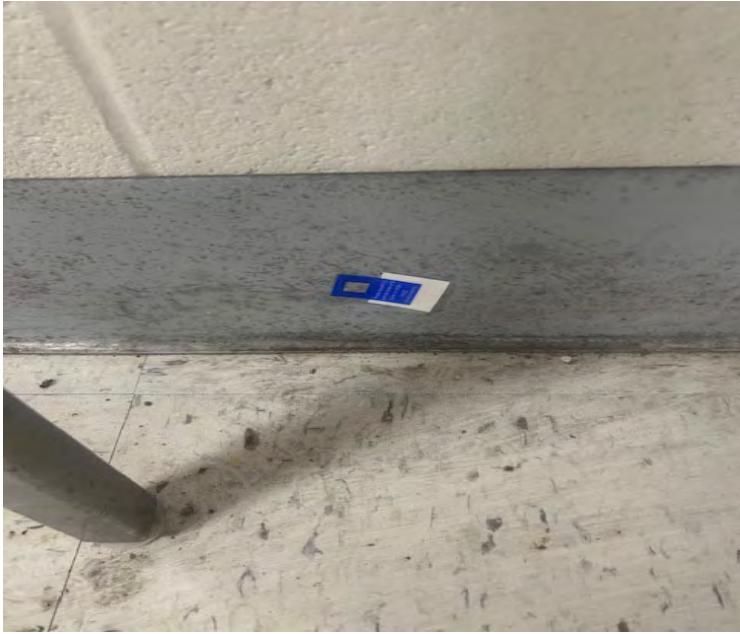
<p>Location: DCSA Office -Room #14</p> <p>Observation:</p> <ul style="list-style-type: none"> -Representative surface tape lift sample from rubber cove base confirms microbial growth. -Moderate debris load and soiled condition at floor and lower walls.

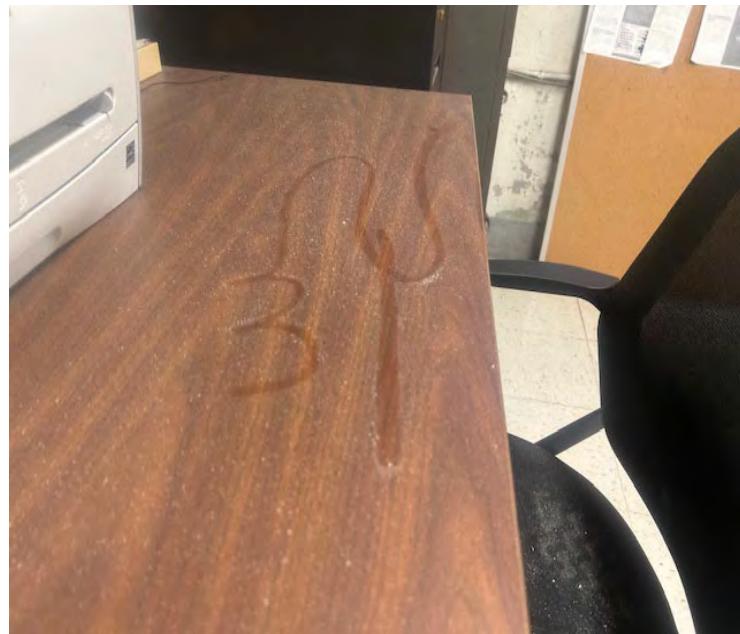
<p>Location: DCSA Office -Room #14</p> <p>Observation:</p> <ul style="list-style-type: none"> -Light to moderate debris load on horizontal surfaces throughout.

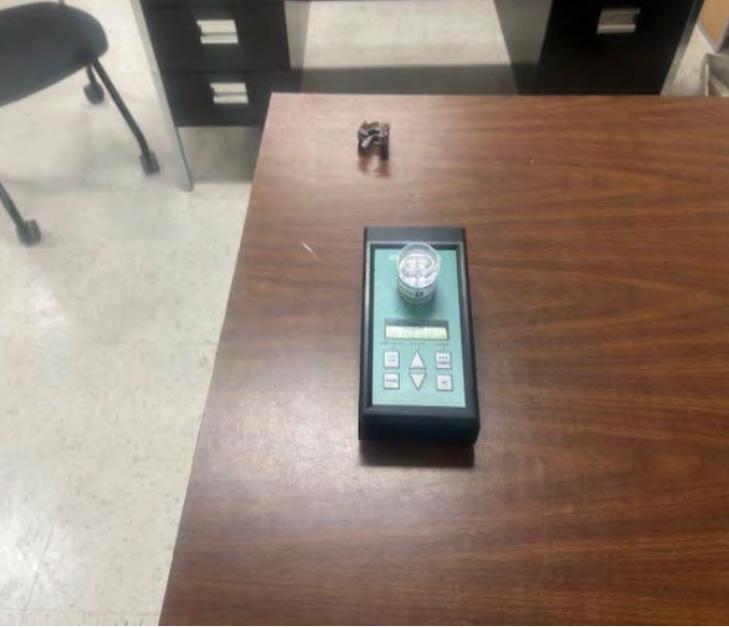
Location: DCSA Office -Room #14 Observation: -Representative air sample #1 collected from the affected area confirms elevations in mold spore concentrations.

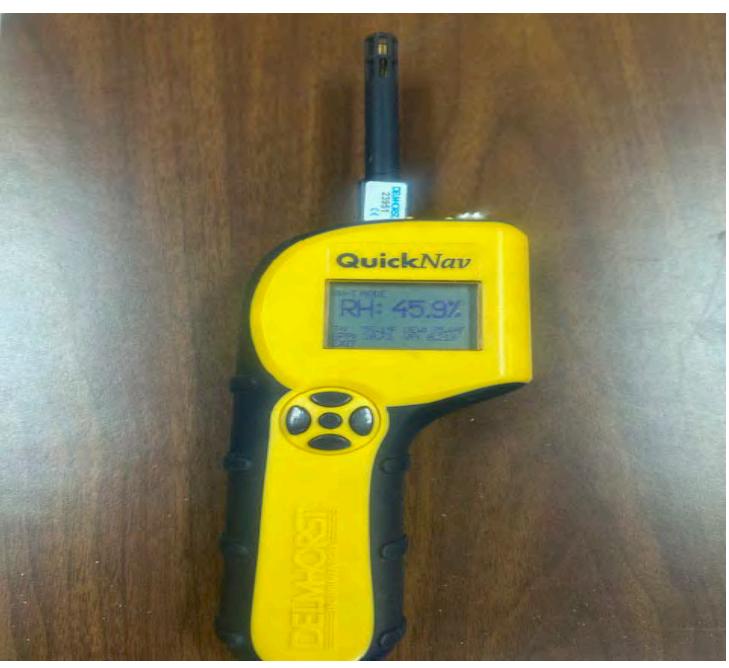
Location: DCSA Office -Room #14 Observation: -Relative Humidity (R/H) was within an acceptable range on the day of the inspection at 46%.
---	---
